UKOPA – CATS INCIDENT

Tuesday 9th June 2009

Mark Kelso
NSI Pipelines
Engineering & Maintenance T/L

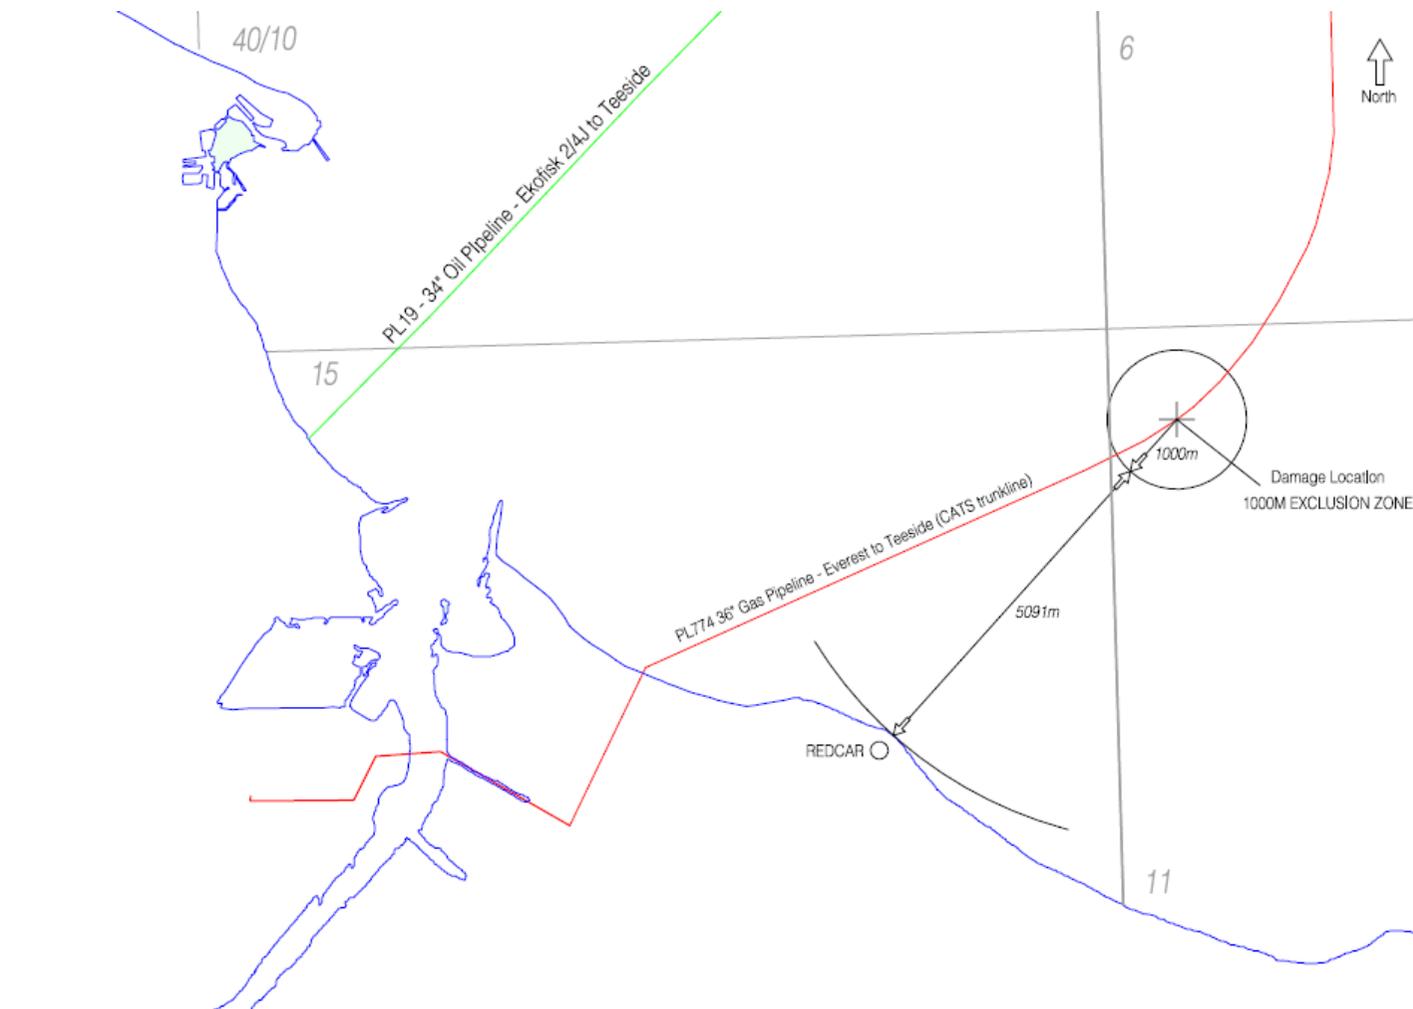
Location

- Approx 5kms offshore from Redcar, in 30metres of water

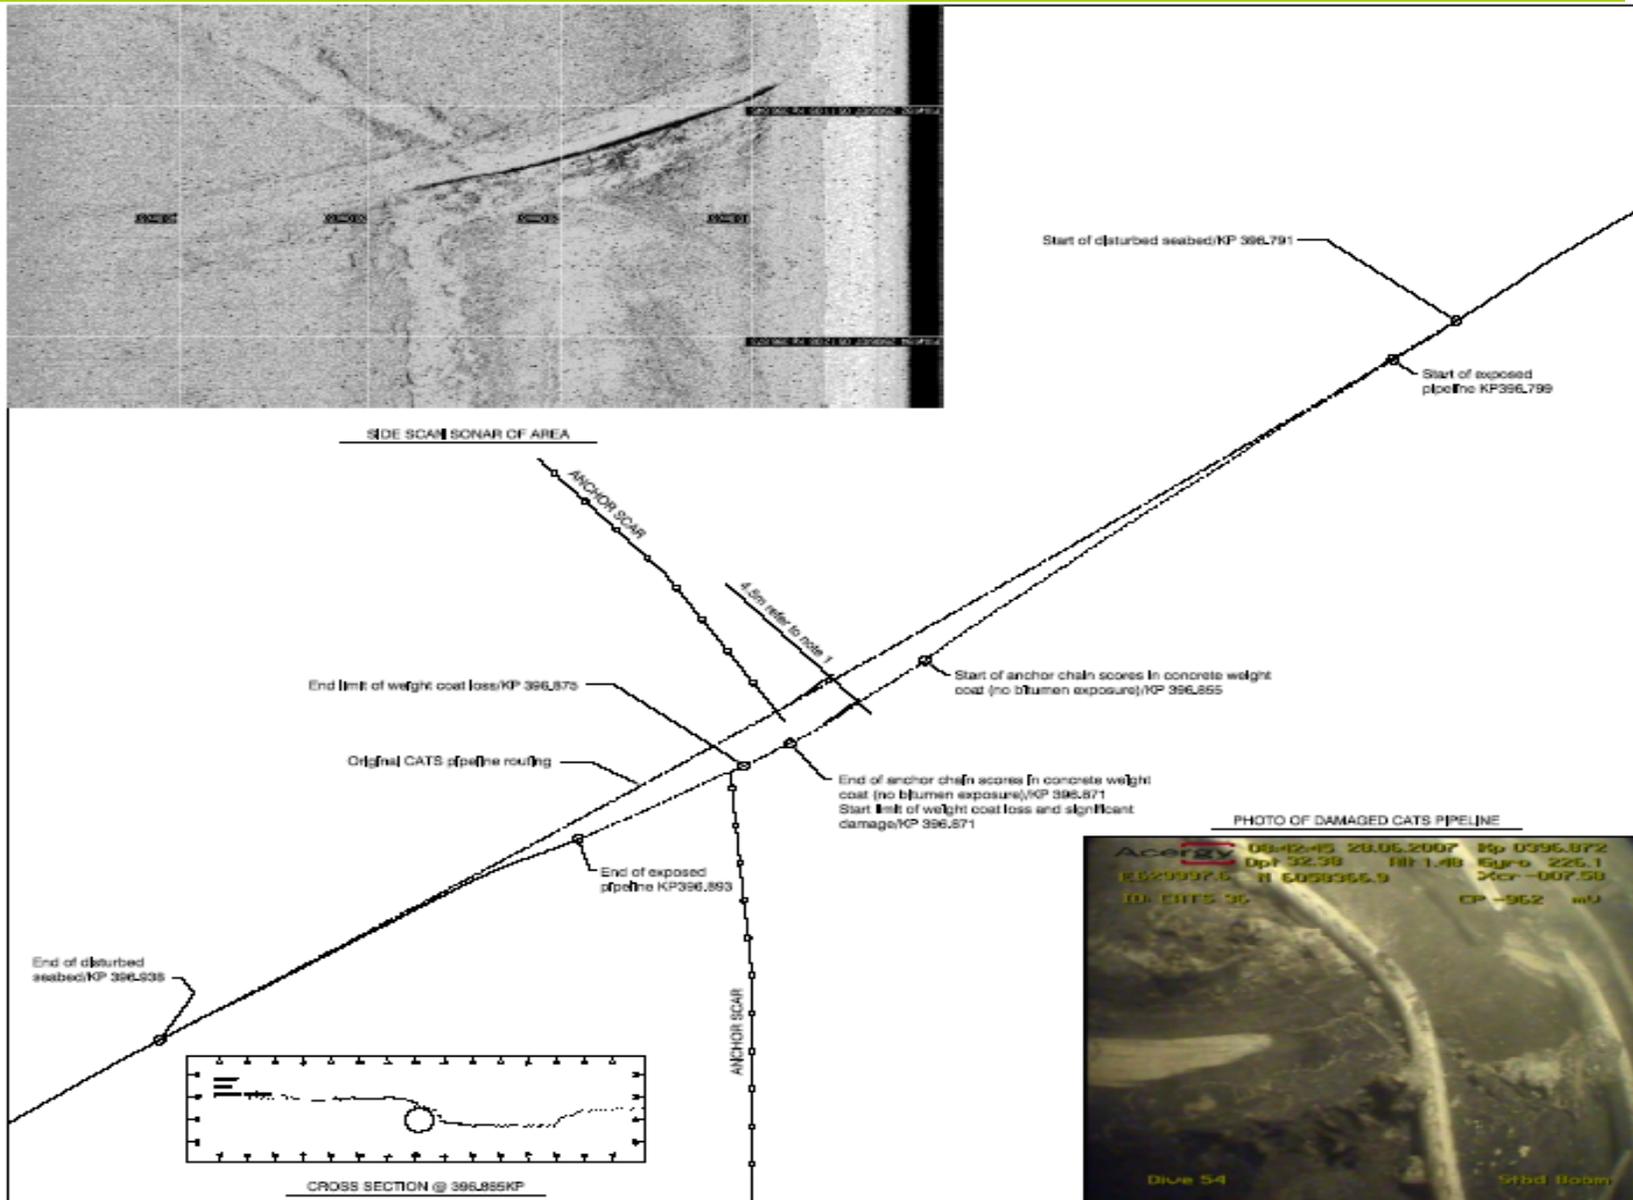
Initial Inspection

- Vessel anchor snagged on pipeline
- Notified to Port Authority by vessel then de-snagged and sailed away
- ROV inspection carried out – found pipeline had been removed from trench with extensive concrete and coating damage

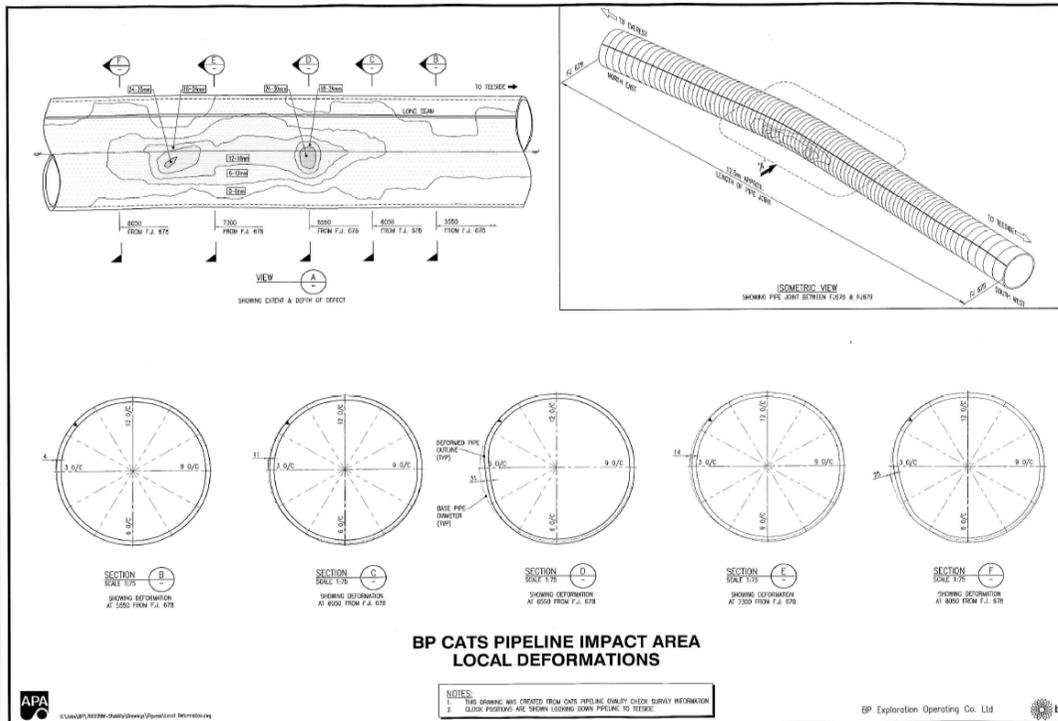
Inspection - results

1.5m vertical displacement
 4.5m horizontal displacement
 Damage over a 4m length in middle of spool

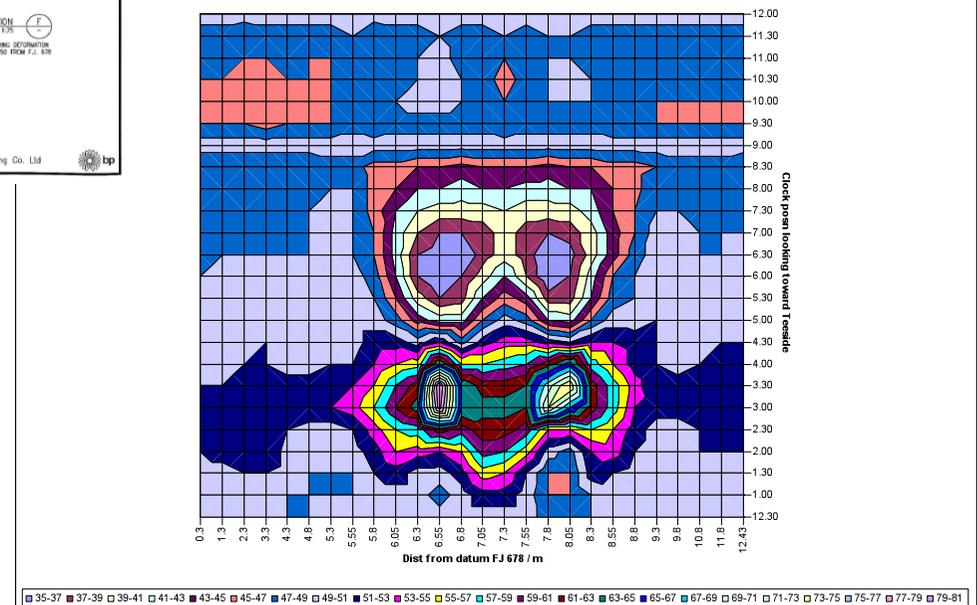
CATS Pipeline ovality checks FJ 678 to 679

2 Dents within a larger deformed area
 31mm and 25mm max. depth (3.4%D)
 2 Protrusions of max. depth 15mm
 No ovality problems (other than dents)
 No weld defects / cracking

- **Permanent structural sleeve repair required to address fatigue concerns**
 - **BP Engineering Technical Practices require that pipeline defects / features are assessed using the Pipeline Defect Assessment Manual (PDAM)**
 - **Assessment performed for both internal pressure (burst) and fatigue limits**

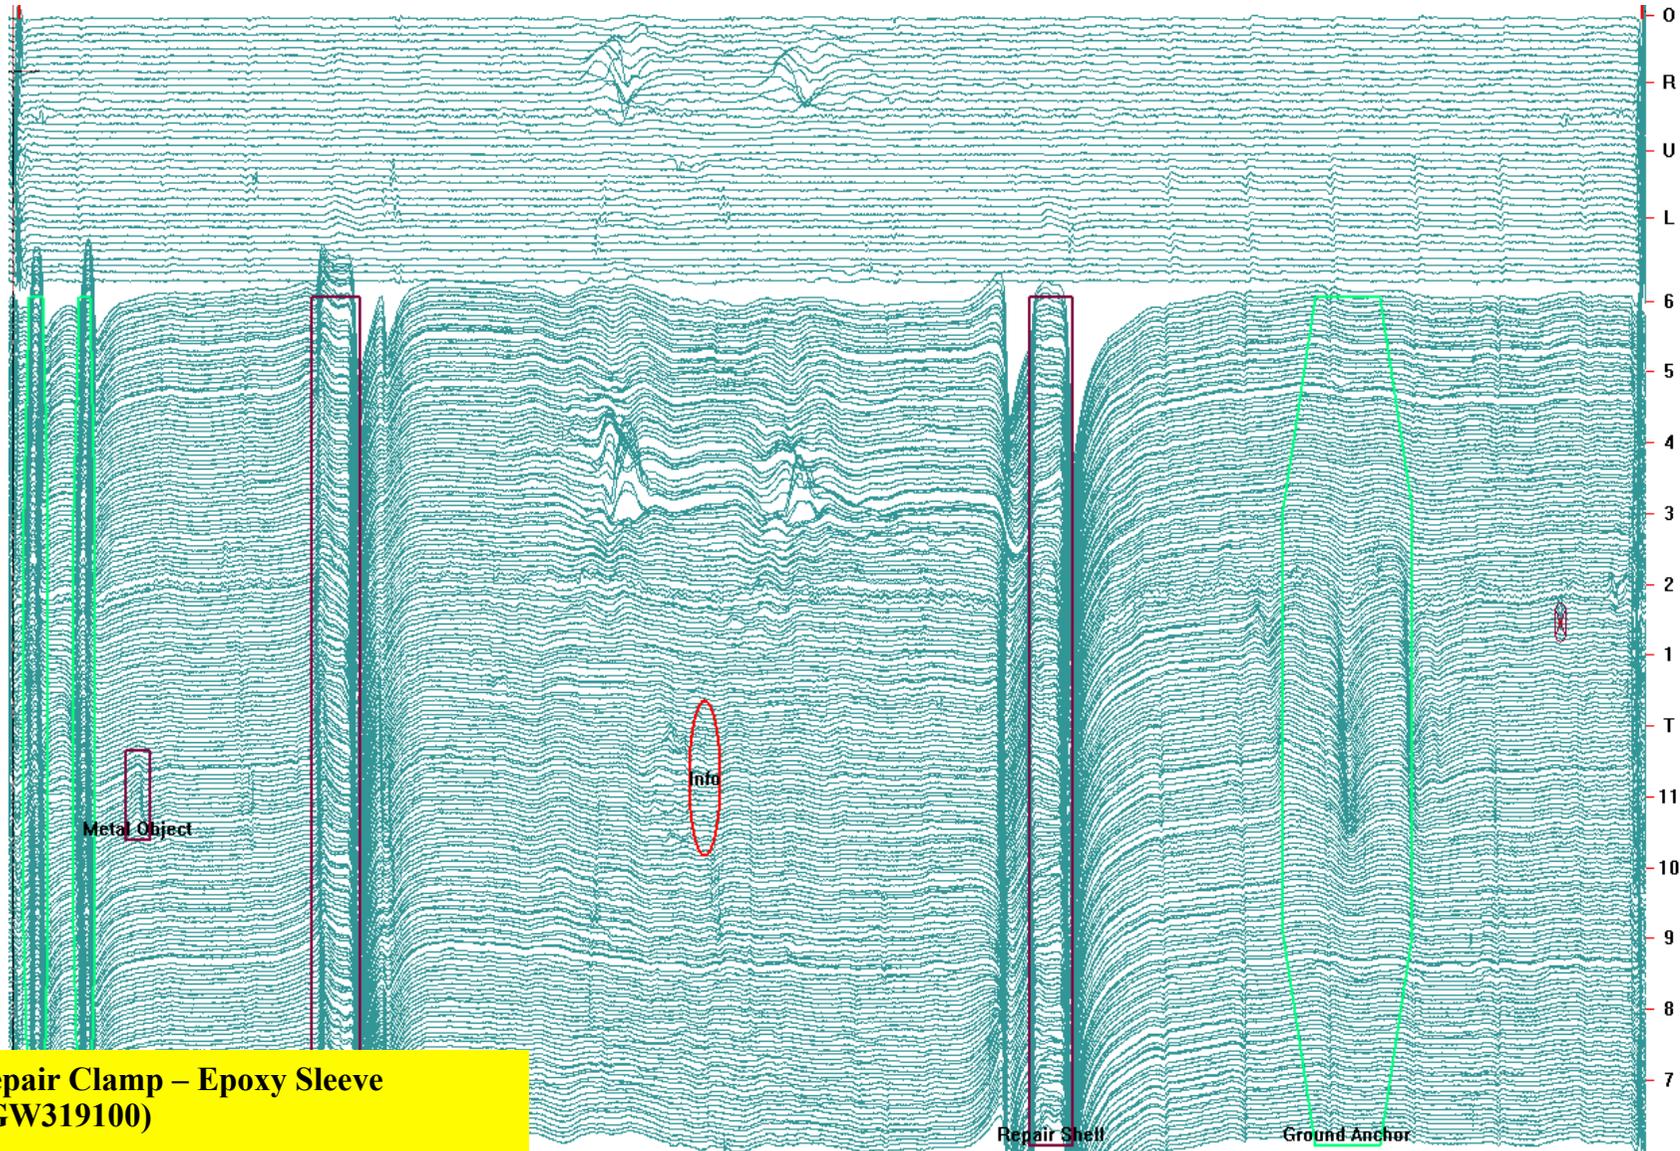
Inspection Data

**Repair Clamp – Epoxy Sleeve
(GW319100)**

Absolute Distance 397072.2 m
