Pipeline Integrity

CASE STUDY: Failure of a dent in a refined products Pipeline

Wilson Santamaria
Esso Petroleum Company.
UKOPA Technical seminar
Eakring, UK – 9th June 2009

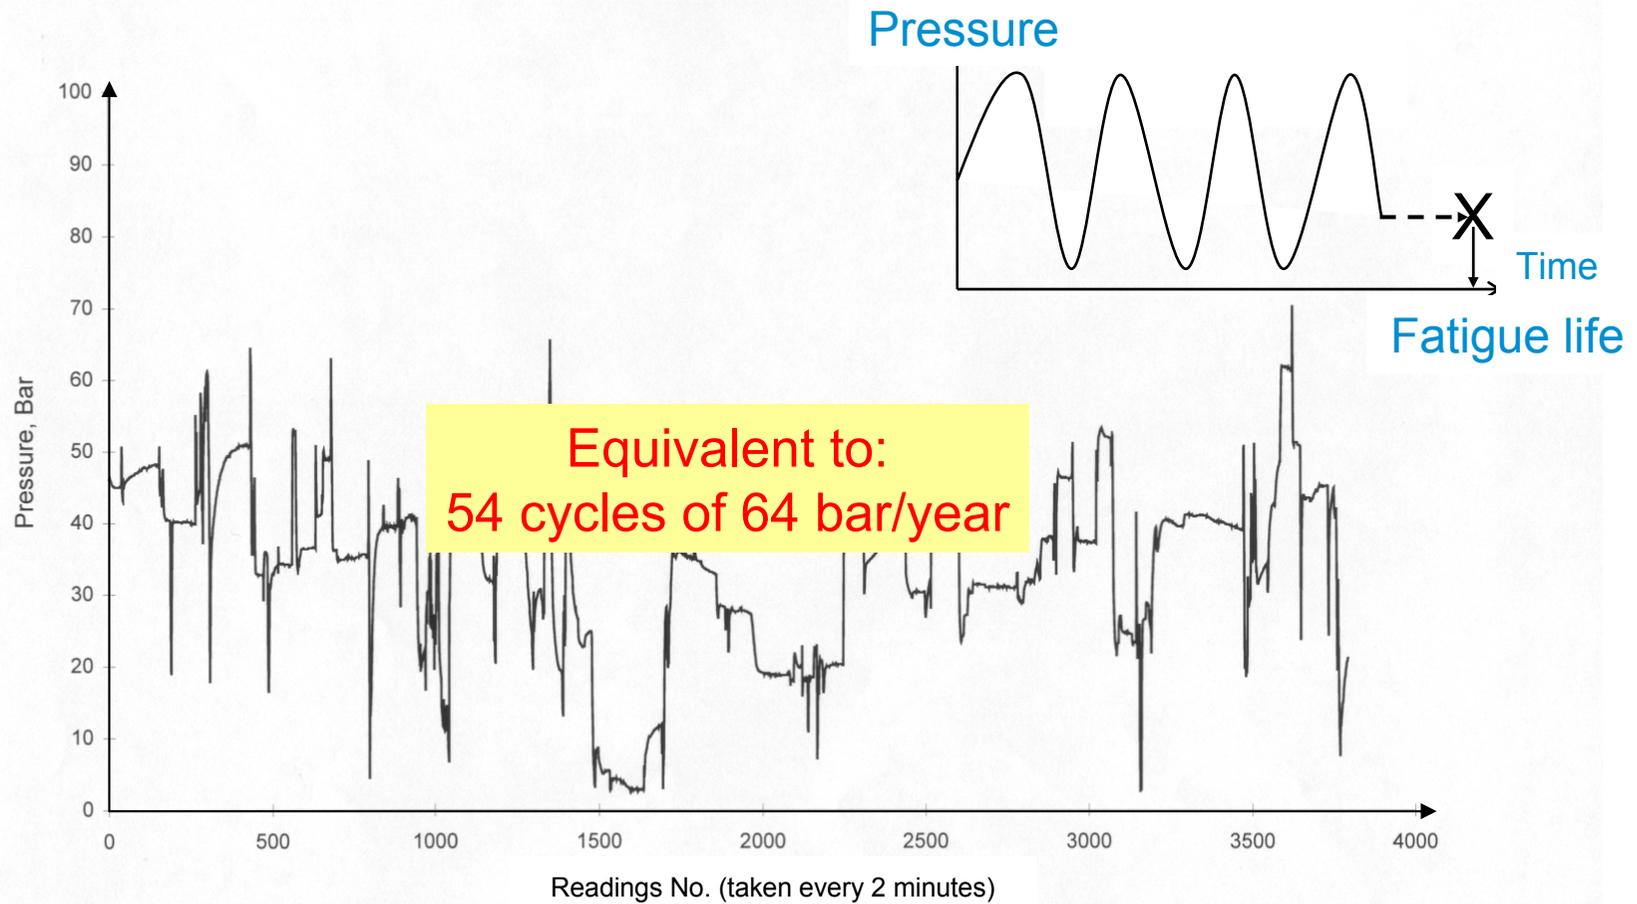
Pipeline Pressure Cycling

Typical Pressure Variations

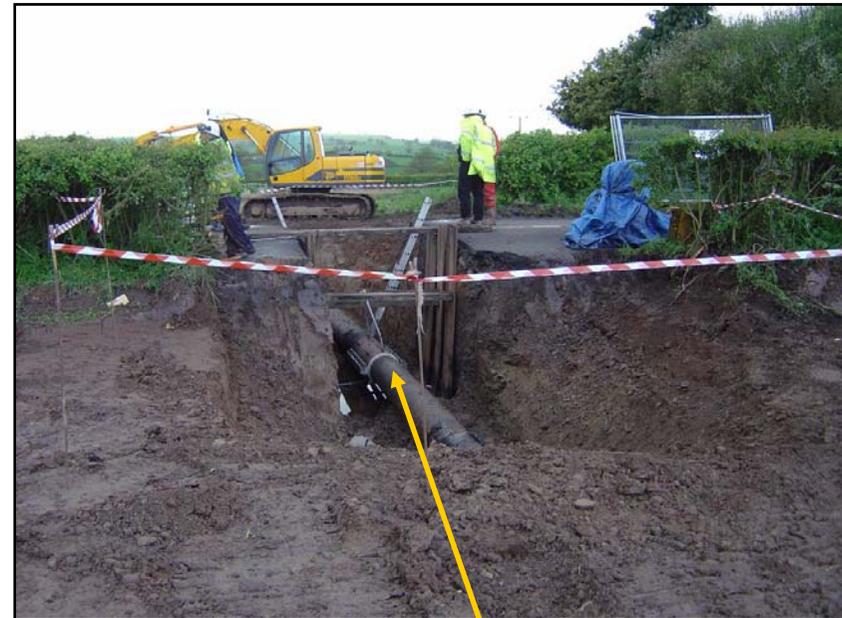
Epoxy-filled repair

- Member of public reports hydrocarbon smell at pipeline road crossing.
- Pipeline shut-down, after visit by operator staff to site.
- Emergency procedures put into action.
- ‘temporary’ repair using epoxy-filled shell was installed.
- Pipeline Operation restarted.
- Failed section and temporary repair replaced with new pre-tested line pipe and line restarted.

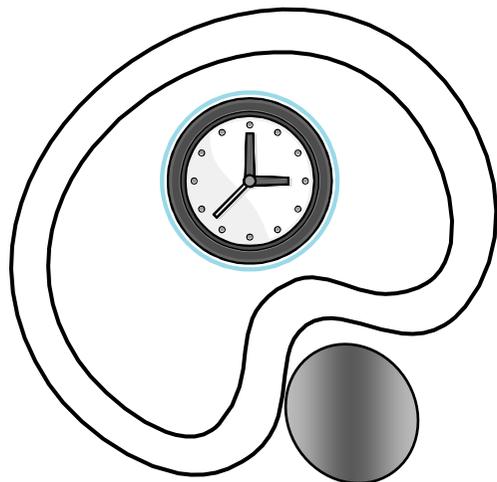
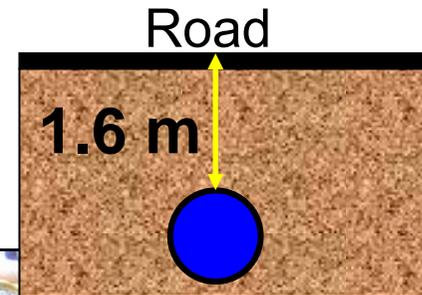
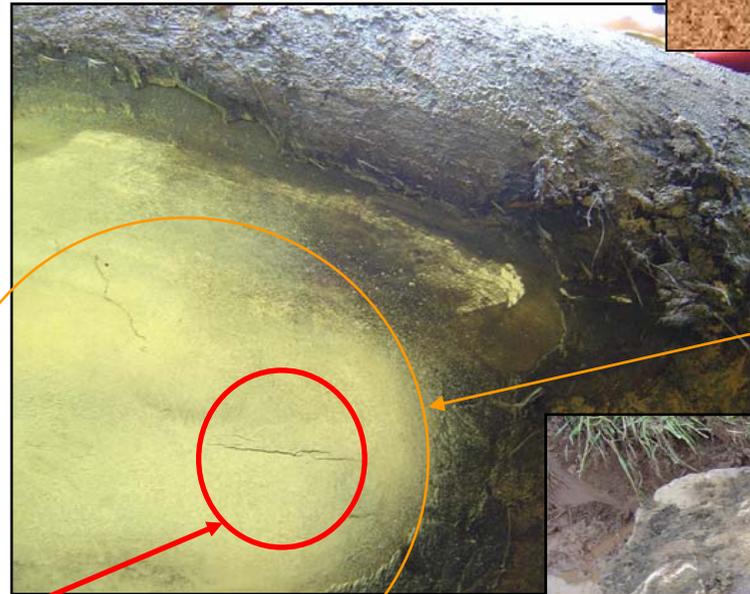
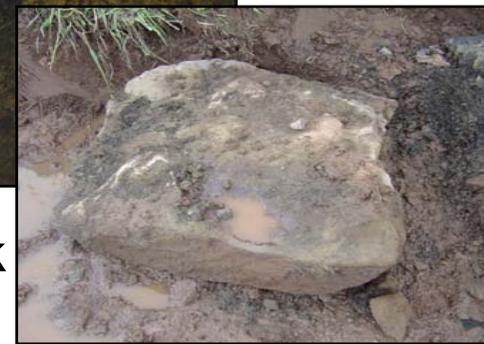
- Failure was a leak through a crack in a dent
- Depth of cover = 1.6 m below a minor road
- Dent at 04:30, resting on large rock

Dent

Crack

Rock

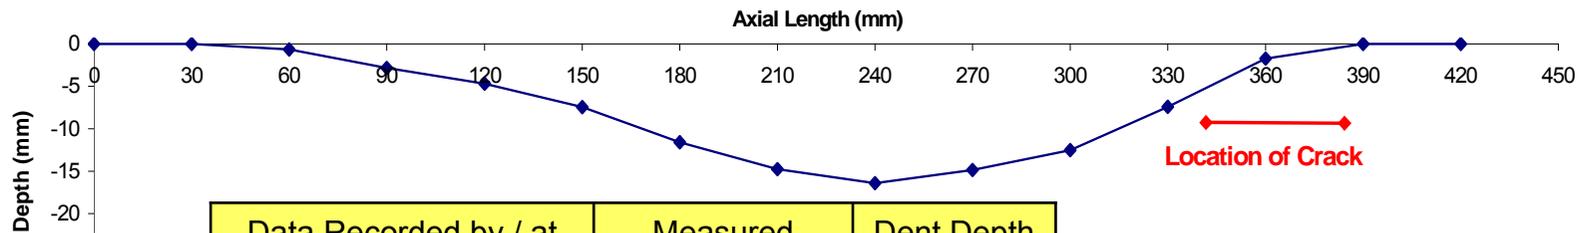
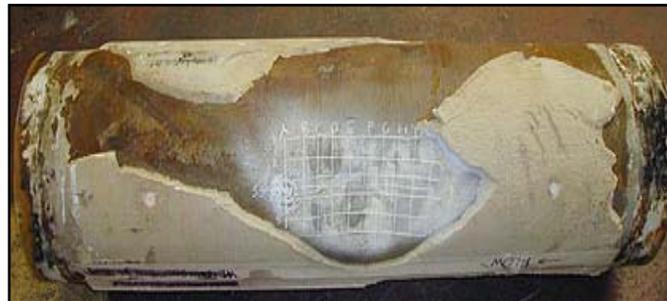
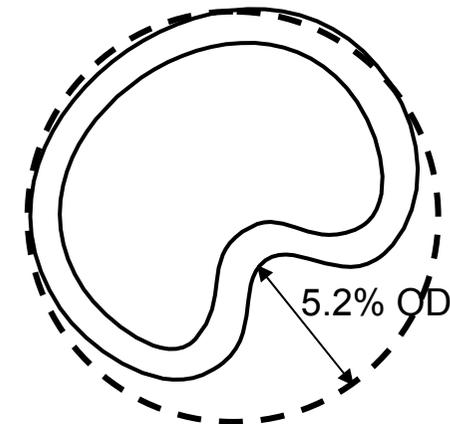
- Caliper pig reported dent had a depth of 5.2% of pipe diameter (OD). This was deepest dent in line.
- This dent was 11th on a 'Priority Listing'

Data Recorded by / at	Measured Depth (mm)	Dent Depth (%D)
Caliper Pig (at pressure)	21	5.2
site (no pressure)	16.4 - 18.5	4.0 - 4.5

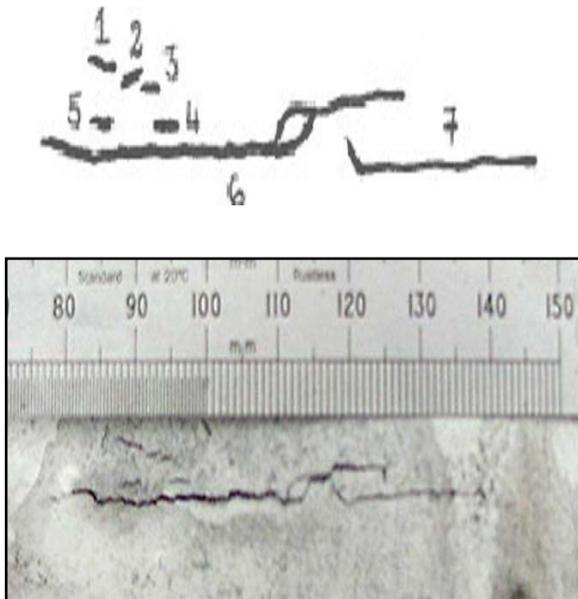
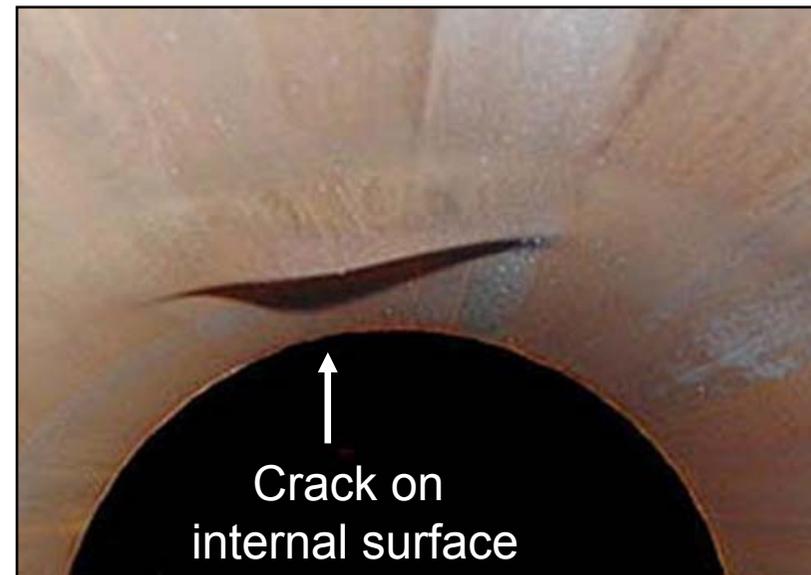
- 7 cracks on external surface
 - Longest crack was 45 mm
- Single crack on internal surface, coincident with 45 mm crack

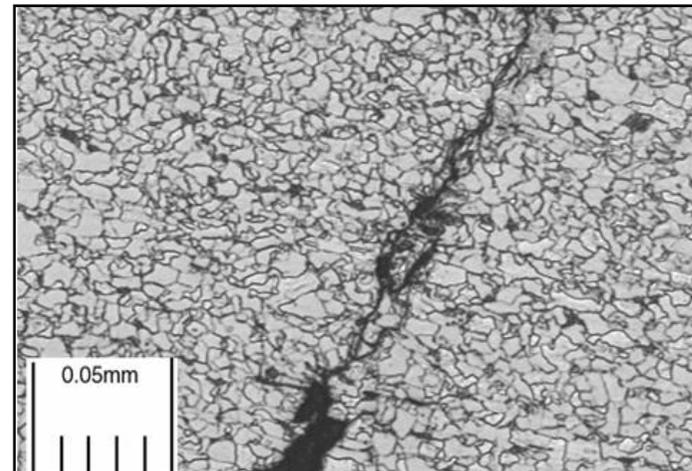
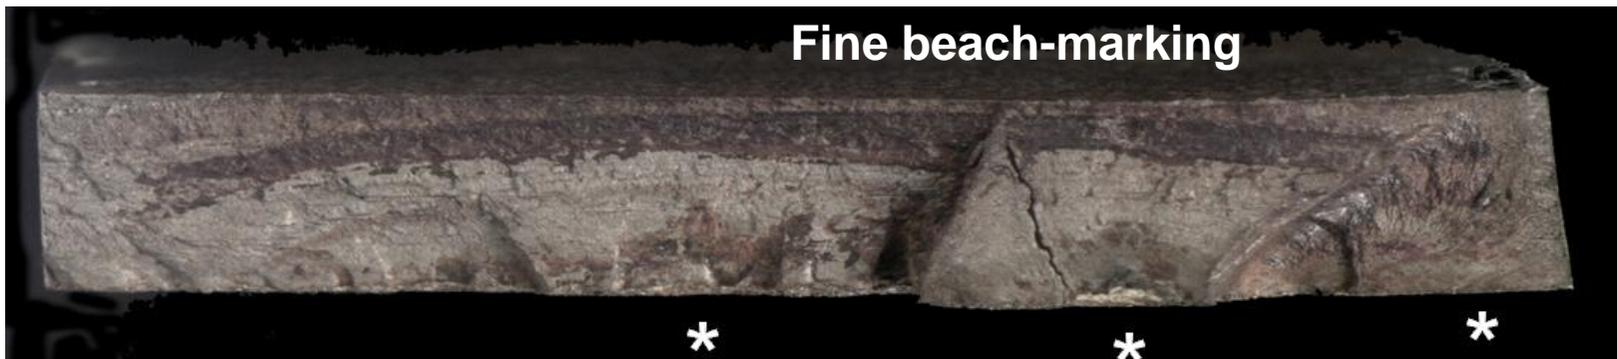
- Three separate initiation sites visible
- Fine beach-marking visible on surface
- No initial starter crack could be identified
- Crack was 'transgranular'
- 'SCC' and 'HIC' ruled out
- Hence, this is a fatigue crack

Crack was transgranular

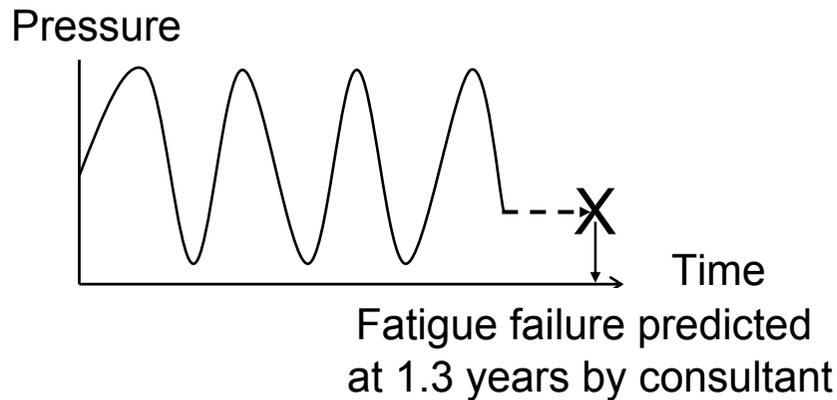
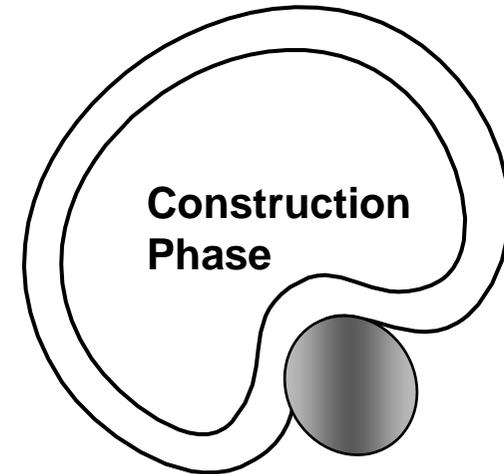
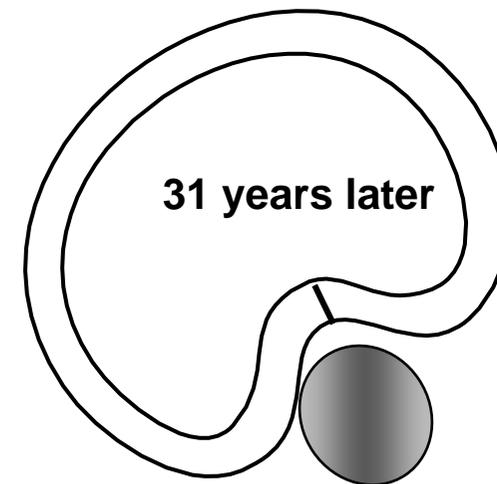
- Pipeline laid on rock during construction – dented.
- Rock may have been dislodged due to position (04:30), settlement, overburden load, and/or pipe product weight;
 - hence, rock could not ‘constrain’ any movement, and improve fatigue life.
- Pressure cycling created fatigue crack.
- Crack caused leak.

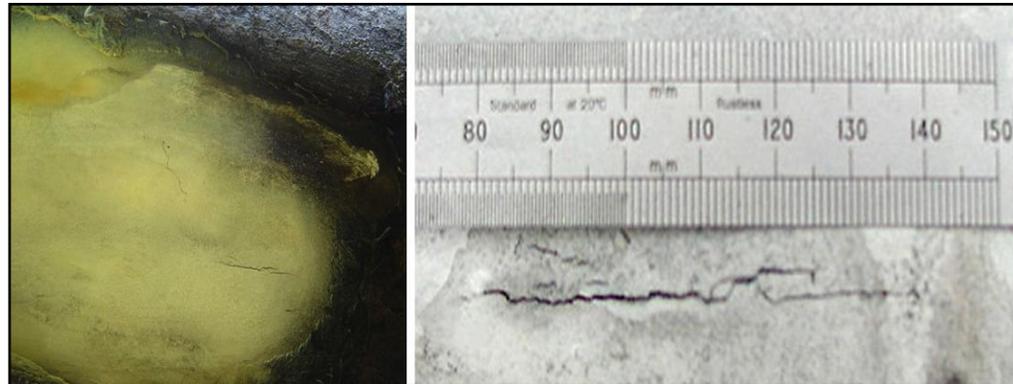
Fatigue crack grew from outside, indicating no rock restraint
