AGI Corrosion Issues

Graham Canty
*Senior Asset Integrity Engineer,
Bord Gáis Networks*

UKOPA 2012 Technical Seminar
Date: 29th May 2012

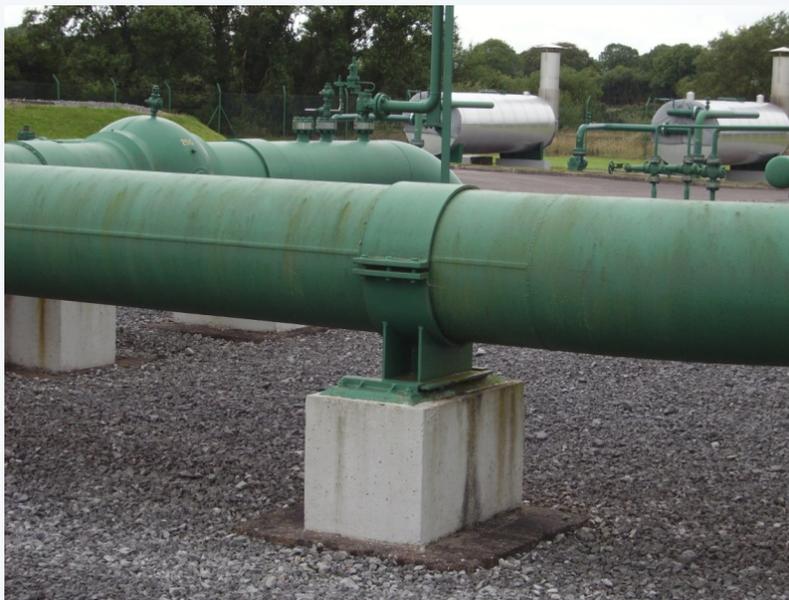
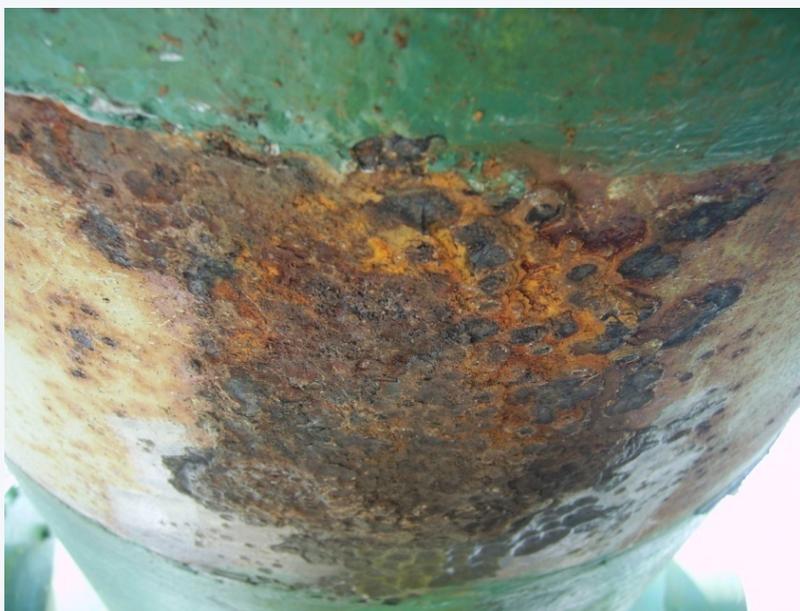
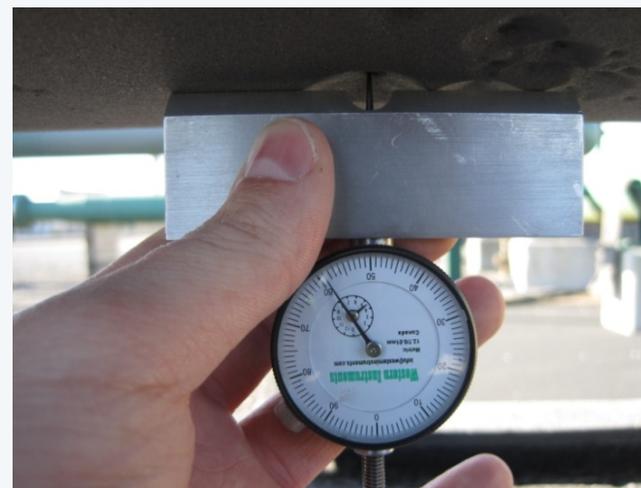
Corrosion Under Sliding Steel Supports

- Metal loss discovered at AGI following Online Inspection. AGI constructed in 1977

- Pitting of up to 4.6mm measured on 14.27mm W/T pipe.
- ILI run 10 years earlier showed no metal loss so corrosion growth rates of at least 0.46mm per year.

- Sand blast the surface of the pipe and the internal surface of the support to Sa 2 1/2
- Apply a 2-part polyurethane, multi-component liquid, protective pipe coating to a dry film thickness of 2.0mm.
- Put neoprene circumferentially between the supports and the pipe.
- To be done in accordance with standard and specifications. Expected life approx 30 years.
- Risers to be excavated to at least 500mm and same coating to be applied.

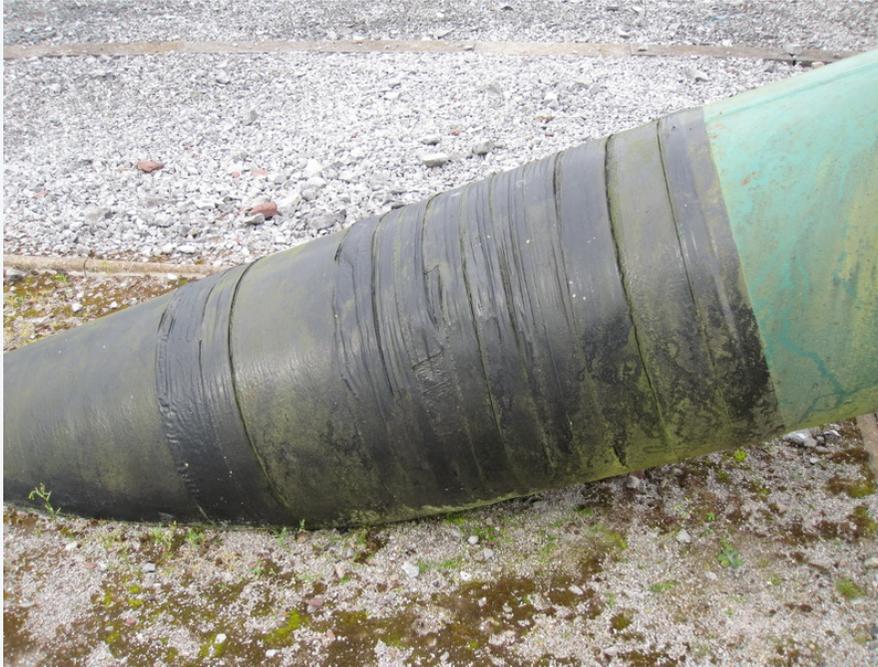
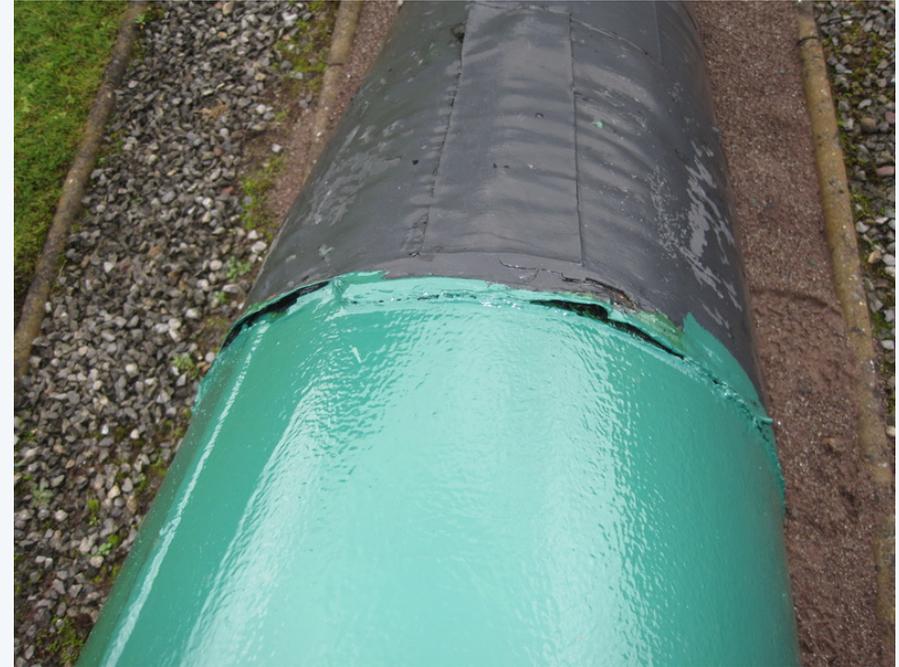
Corrosion on Pipe Risers

- Incorrectly wrapped in the first place
- Wrapping in poor condition
