## ILI Case Study

**Brian Woodhouse – Integrity Manager National Grid UK**  
**UKOPA Technical Seminar**  
**Eakring - 29 May 2012**

- Bathgate to Longtown
- Feeder 12
- Isolation between Bathgate to Pettinain
- 915 nom OD (36")
- 12.7mm nom W/T
- Constructed 1978
- 85 barg MOP
- > 72 % smys
- Inspection May 2011

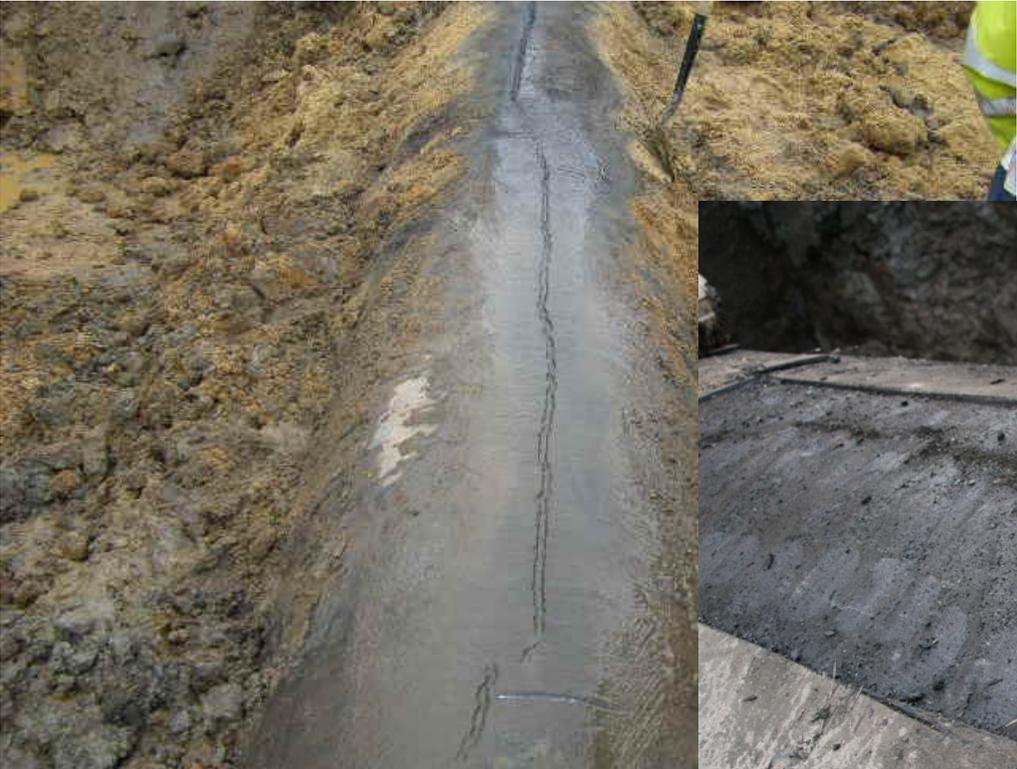
- Typical Excavation Finding

Coating Removed

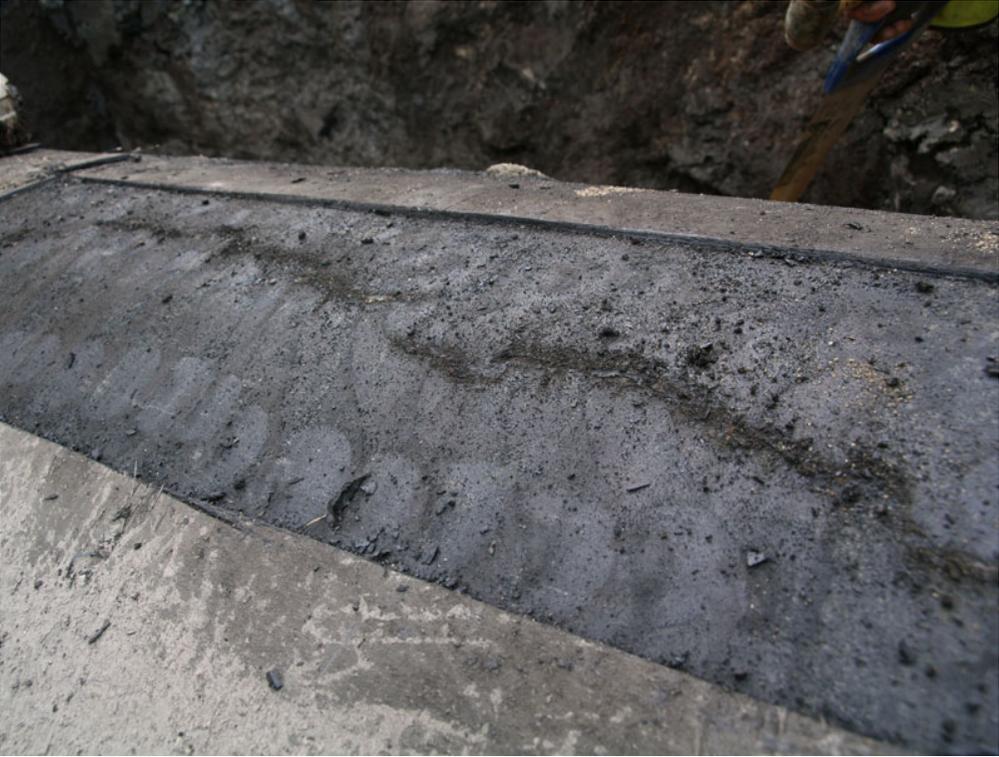
Coal Tar Coating split along 12 c

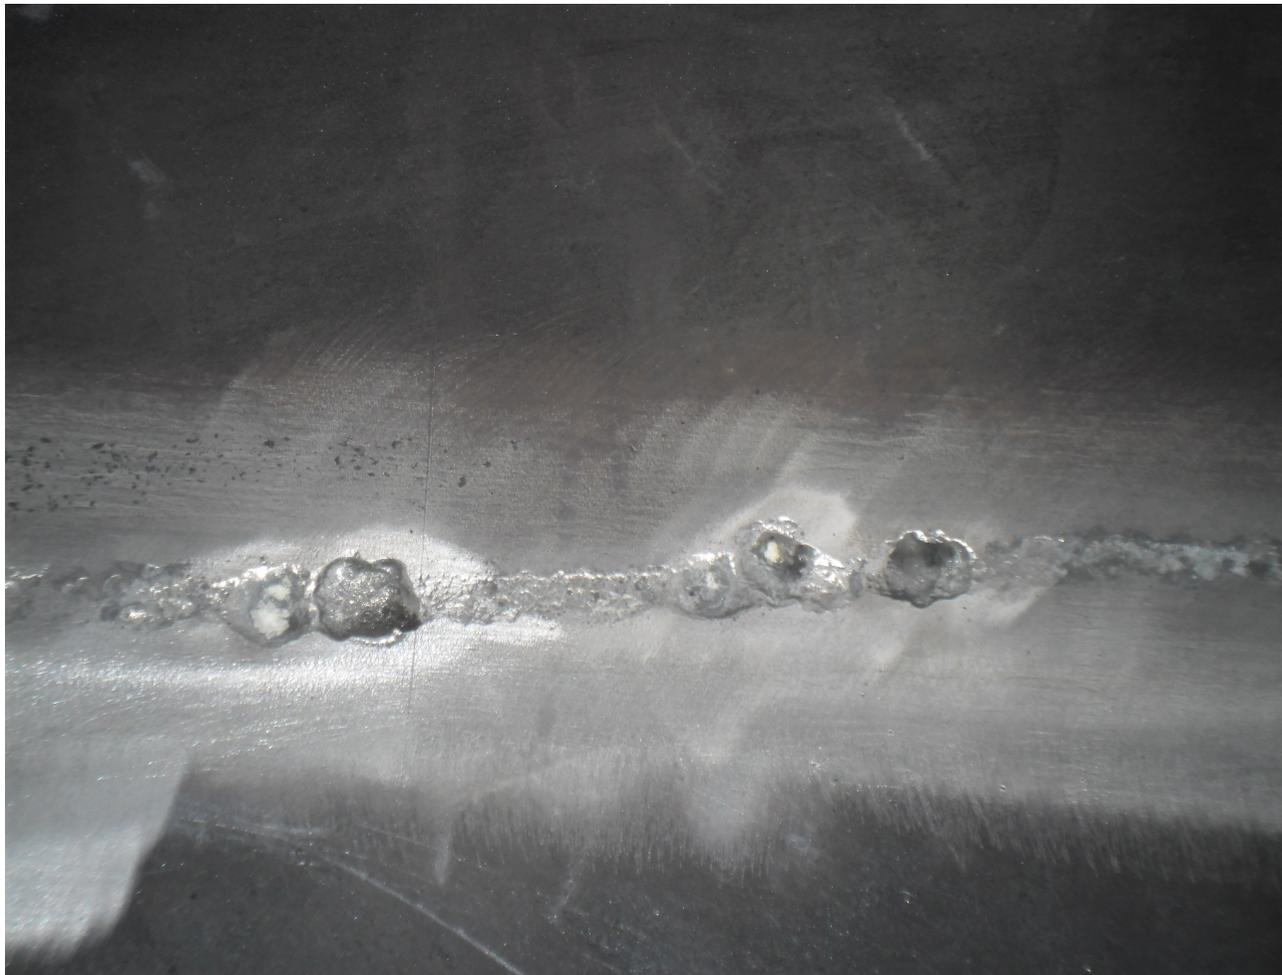
- Defect cleaned up

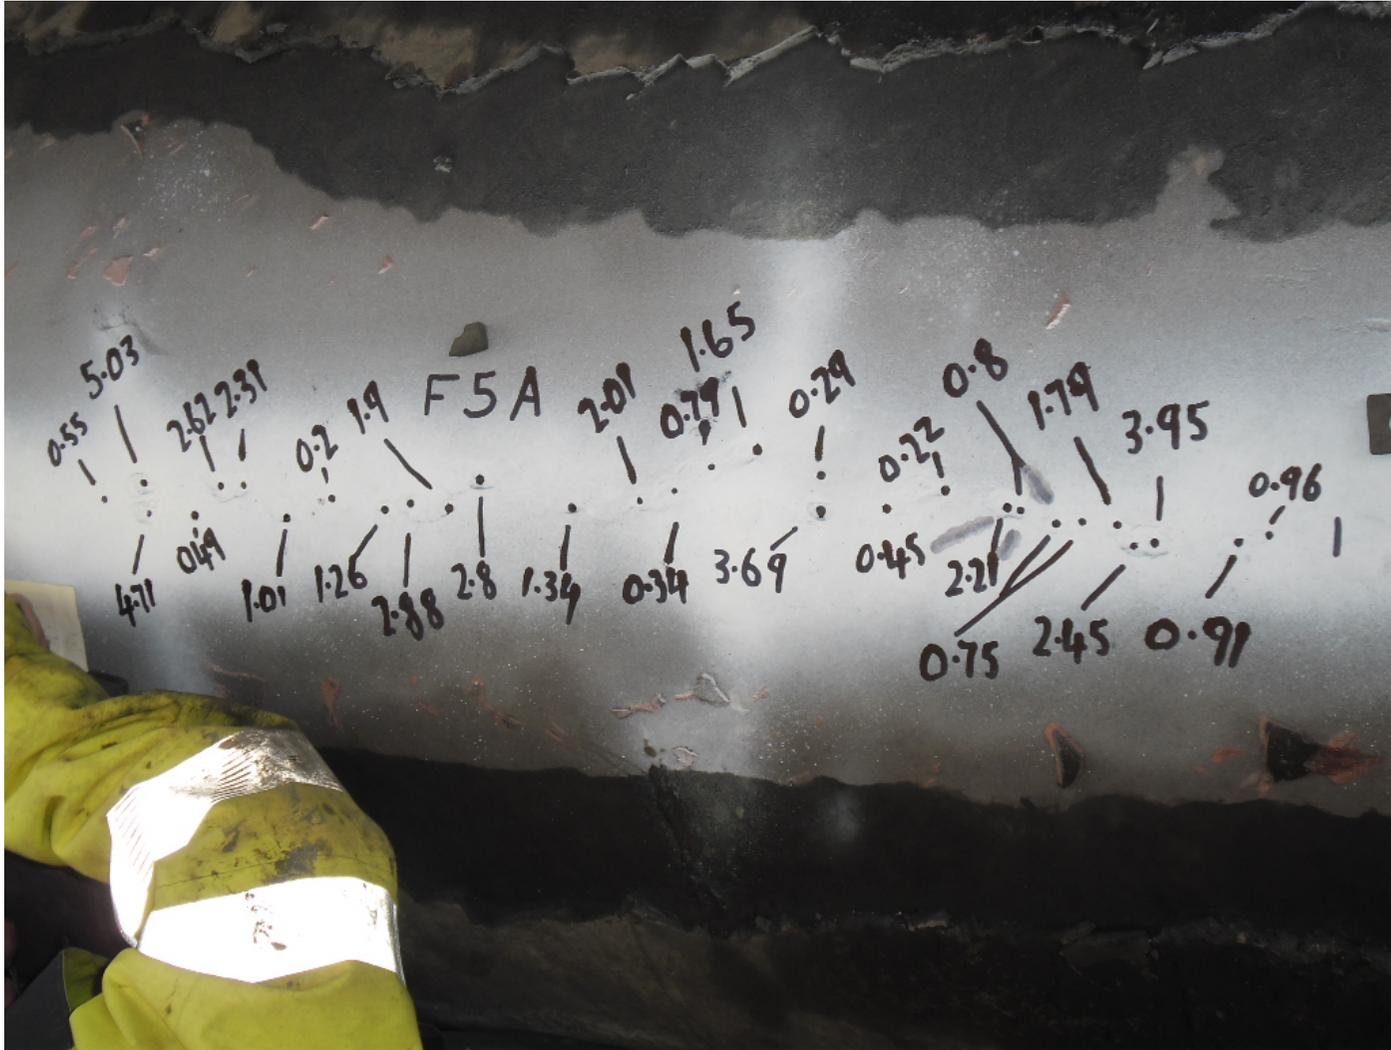
**Peak 5.03 mm –  
39 % Loss of  
wall**

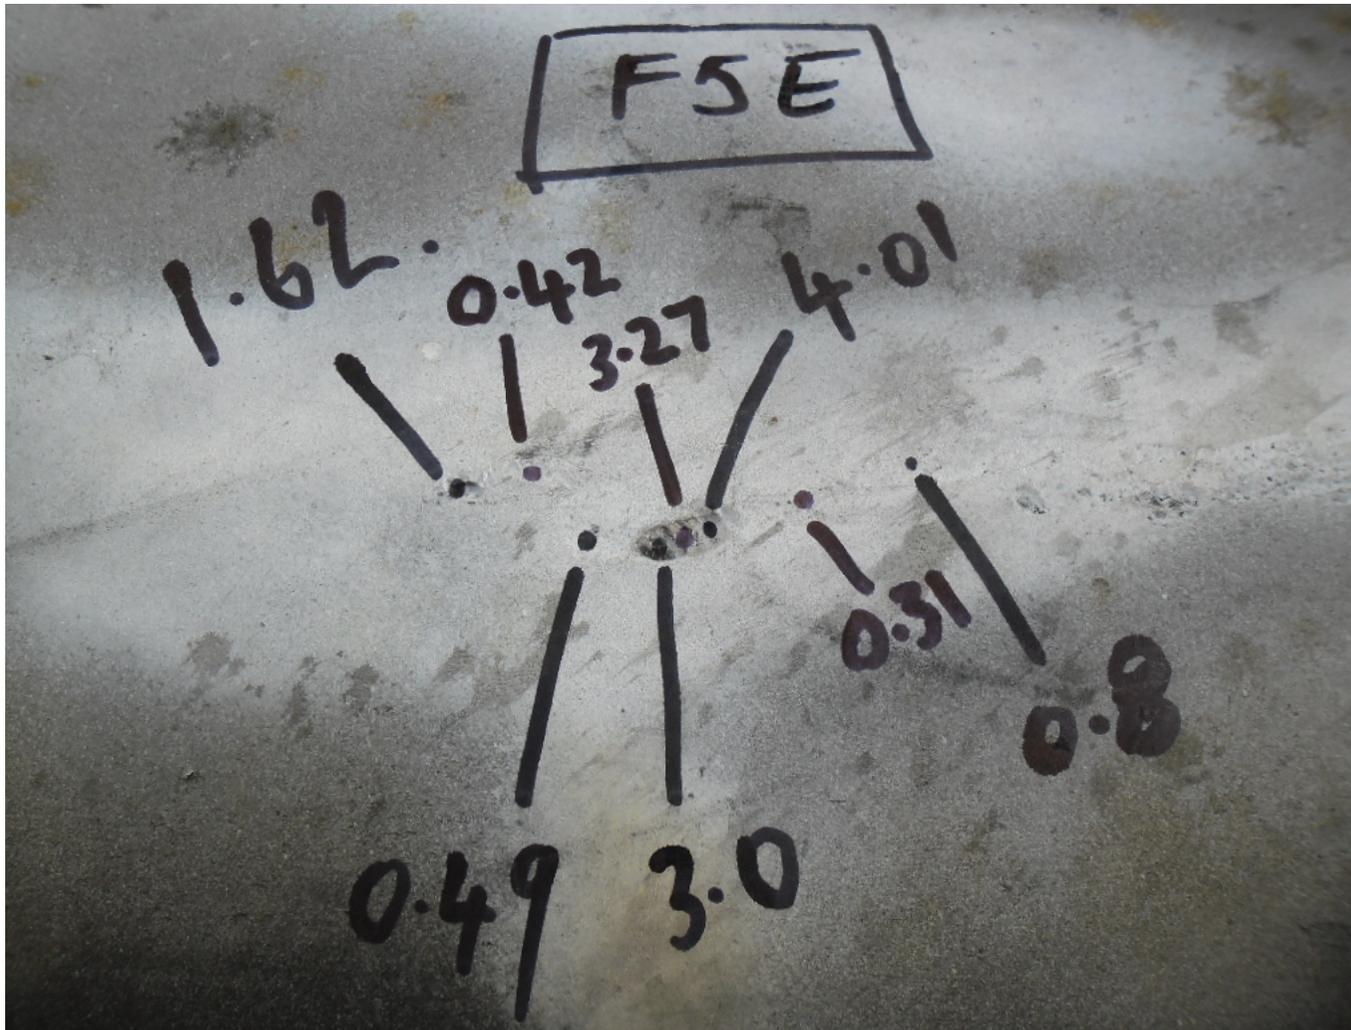
Peak 4.01 mm –  
31 % Loss of  
wall

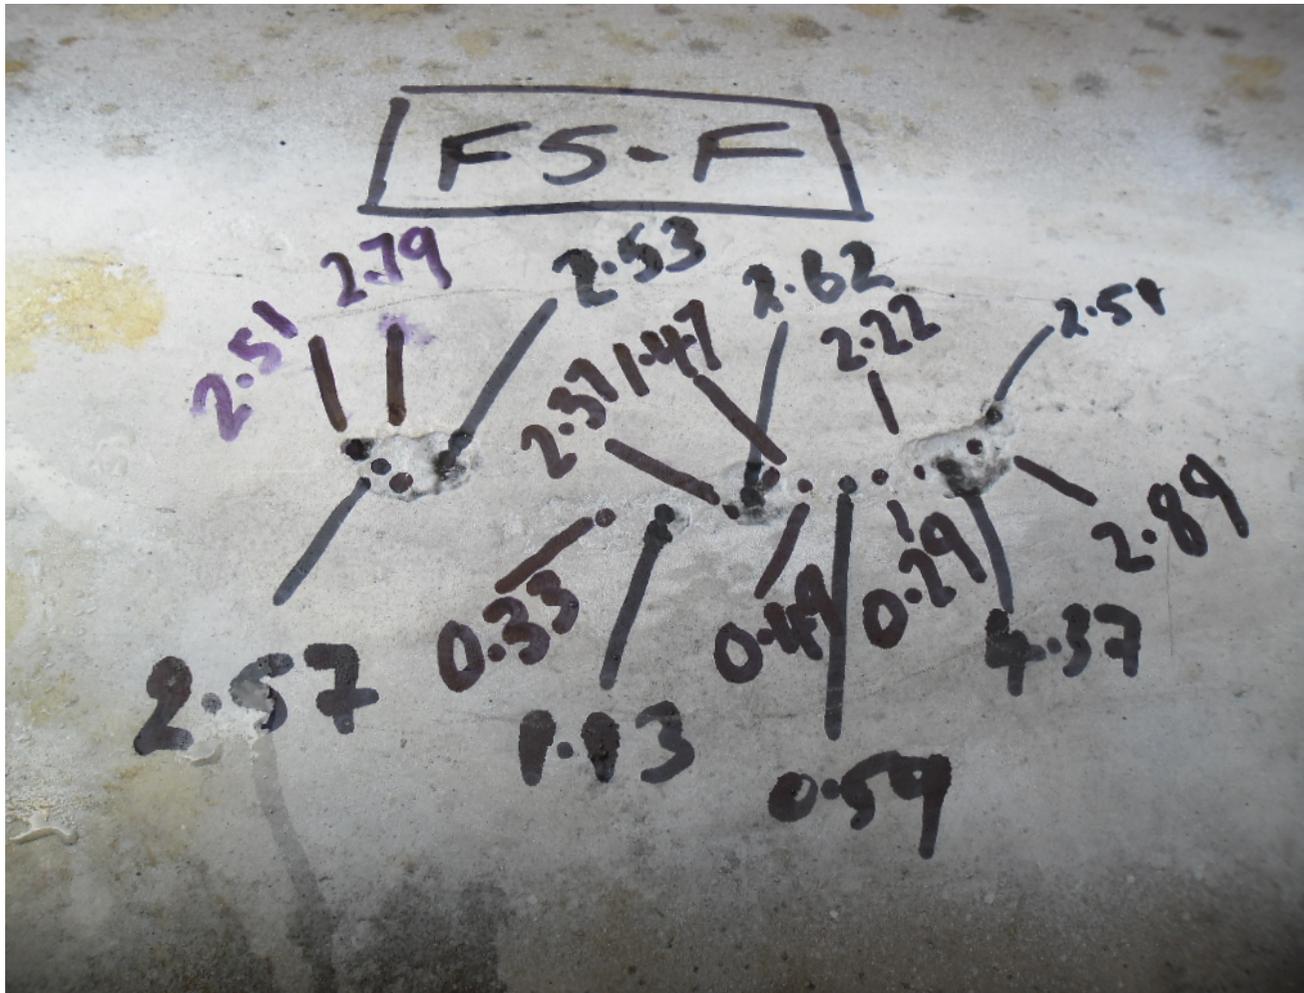
Peak 4.37 mm –  
34 % Loss of  
wall

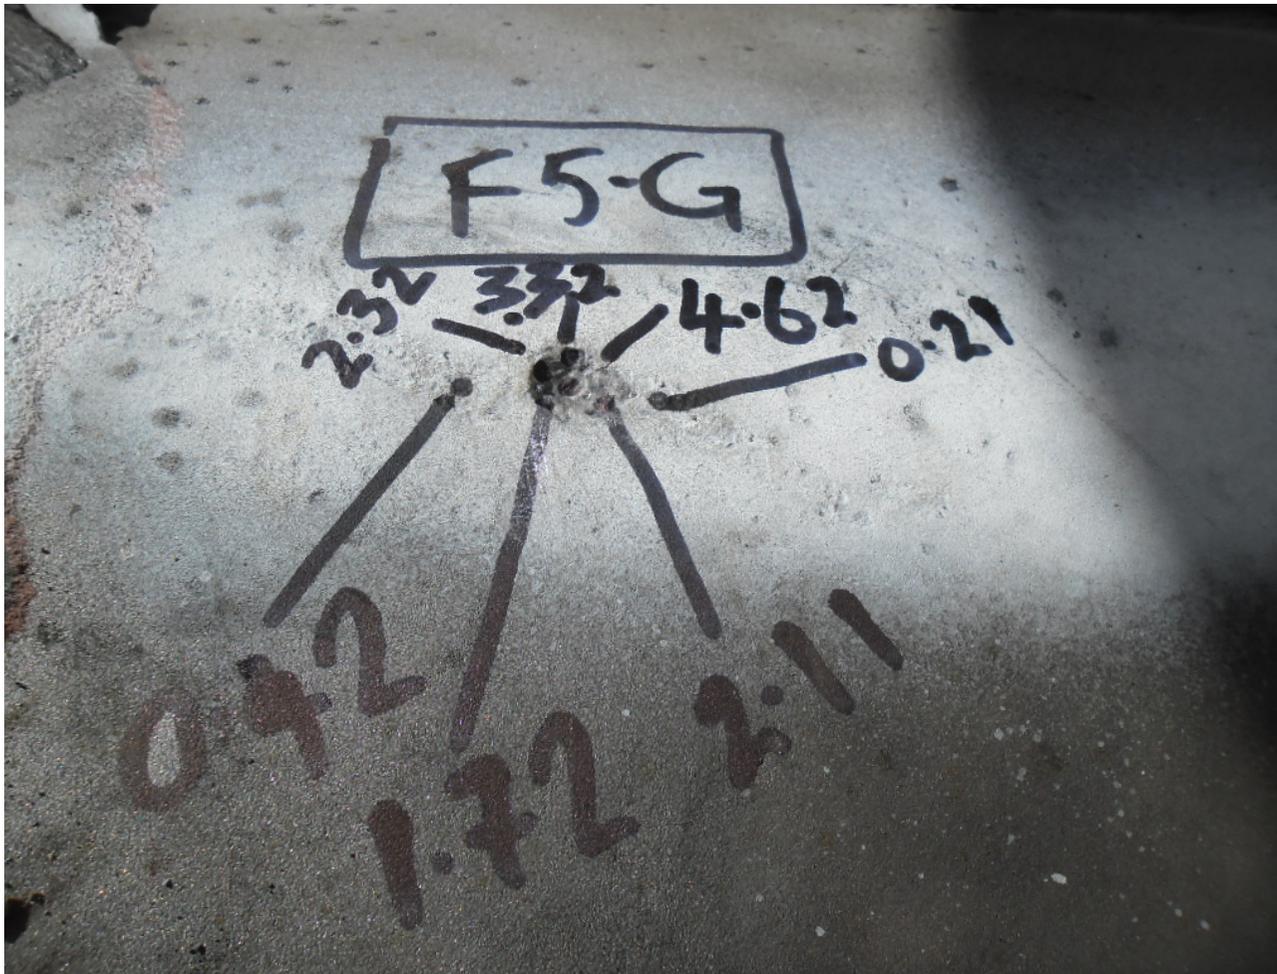
Peak 4.62 mm –  
36 % Loss of  
wall
