Example of Pipeline damage and failure causes and case histories

Tony Stonehewer

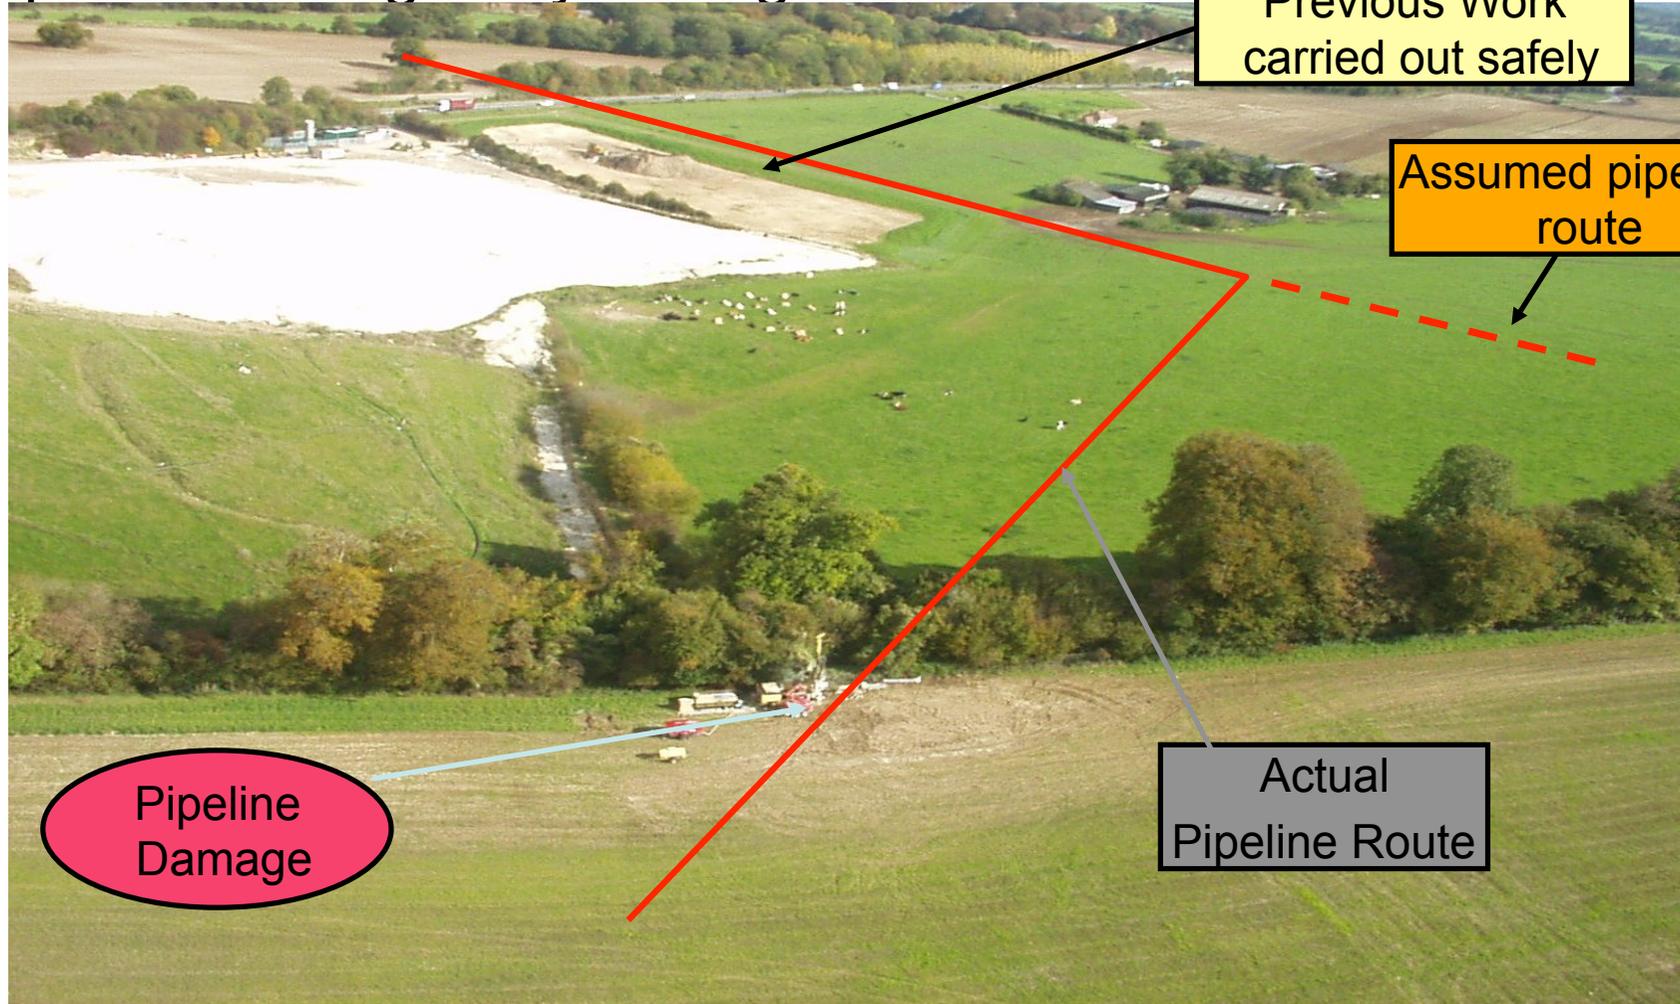
Pipeline damaged by drilling machine

Previous Work
carried out safely

Assumed pipeline
route

Pipeline
Damage

Actual
Pipeline Route

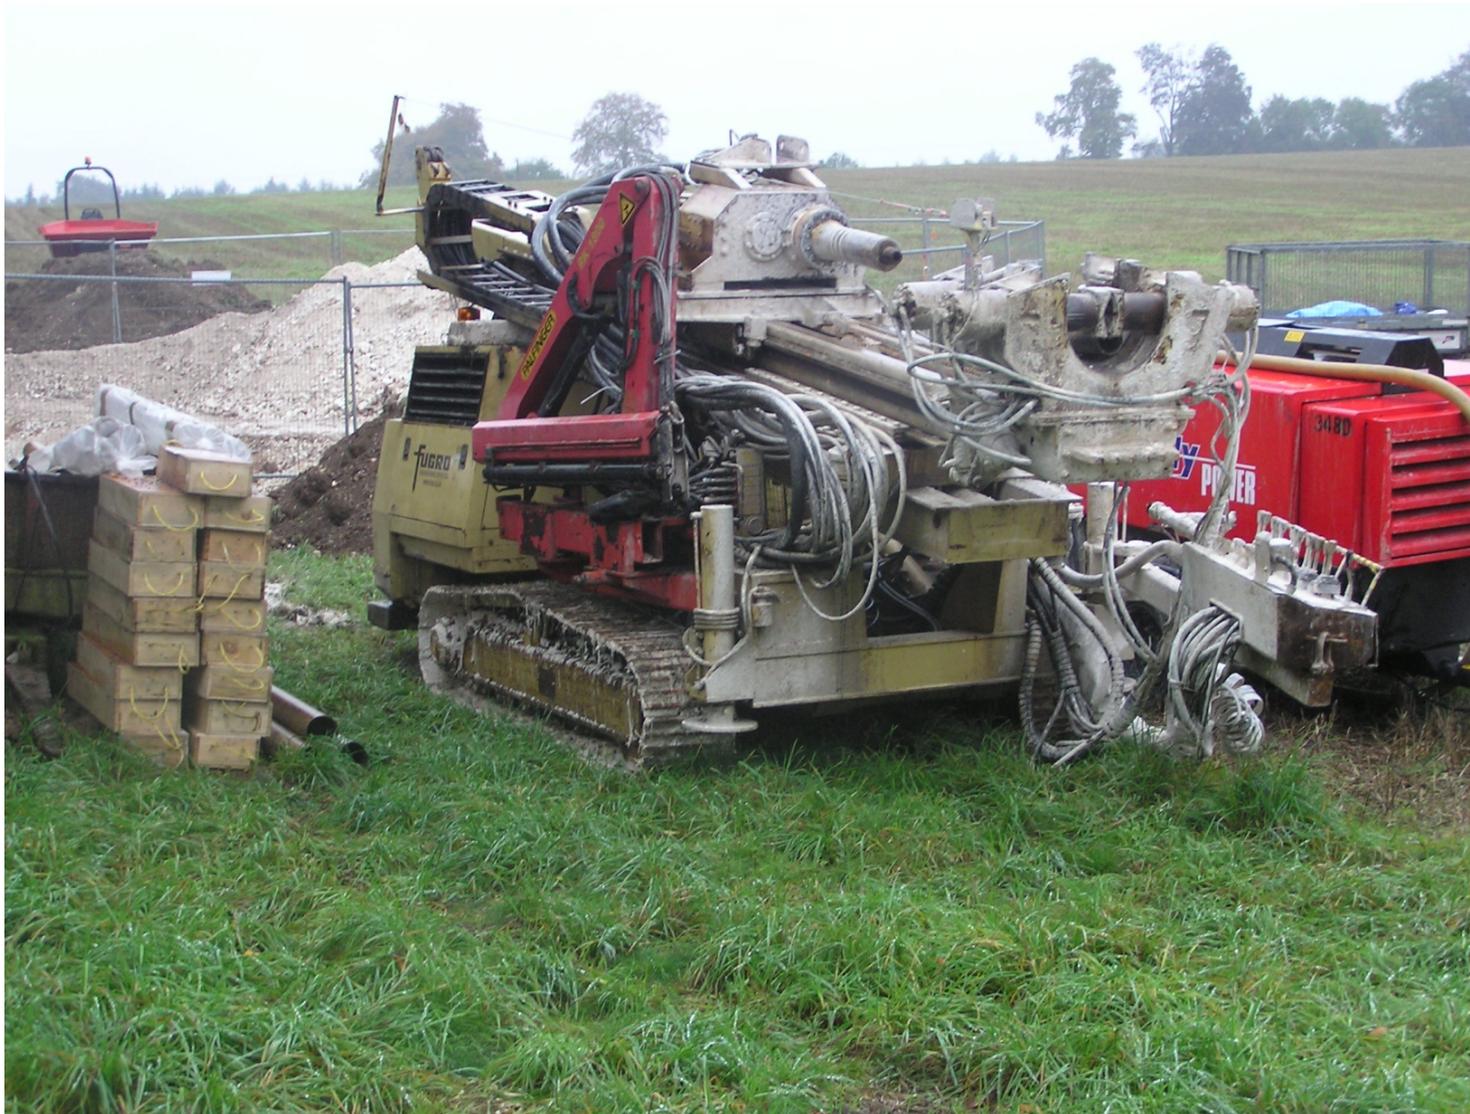
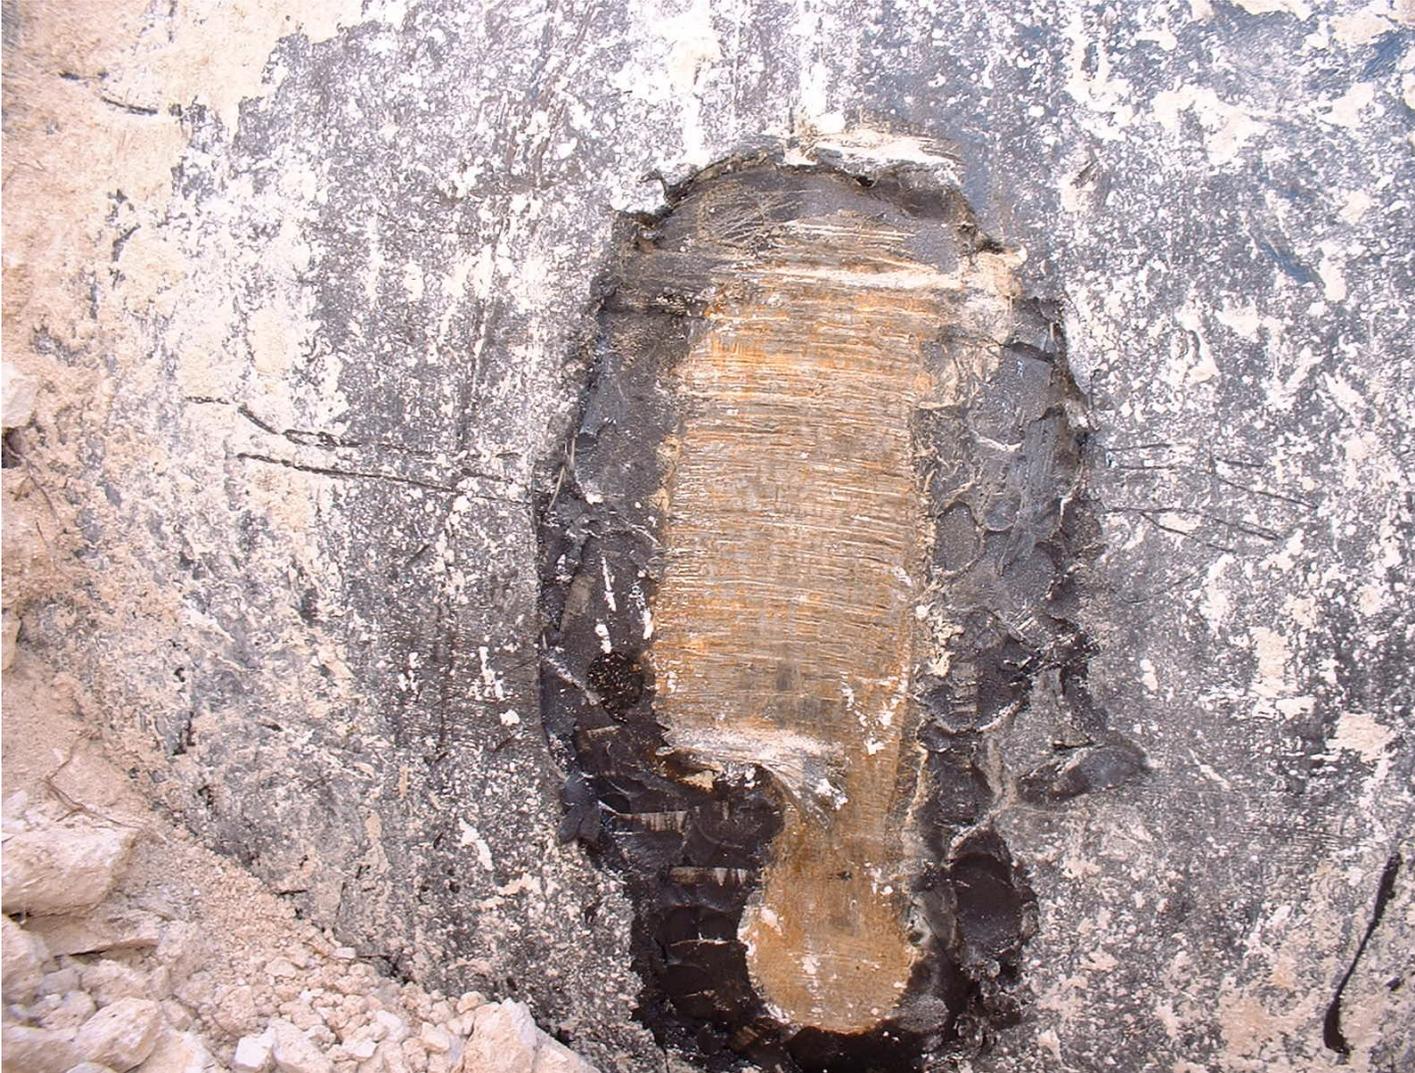
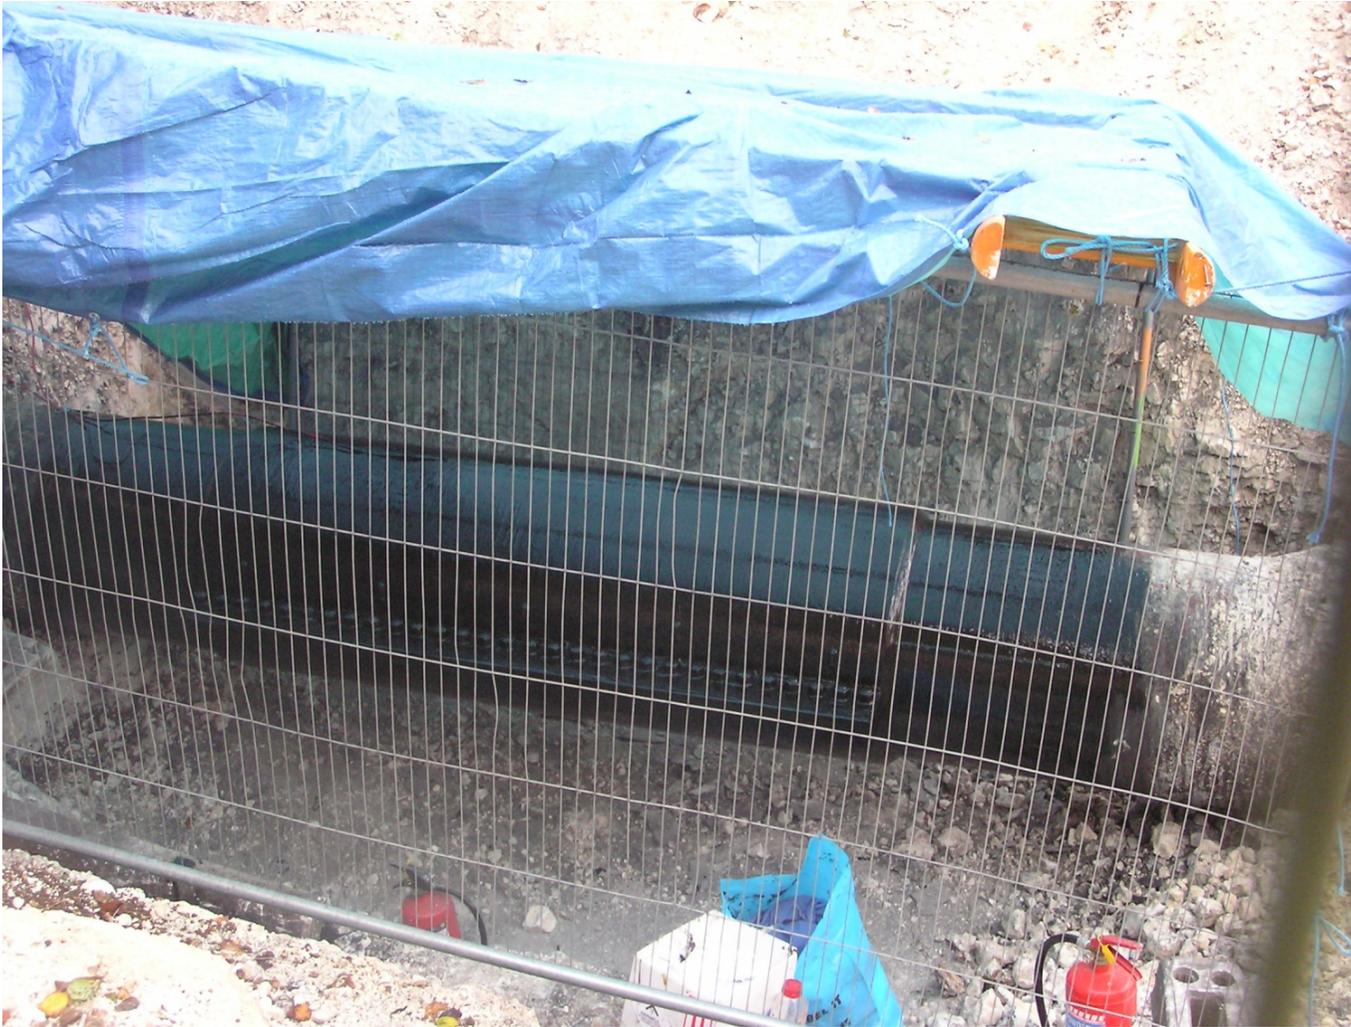
Causes – Human Errors

- Poor Communication
- Lack of Site Survey
- Lack of understanding of issues competence of Landfill site manager
- Lack of competence of Bore hole team
- Lack of pipeline identification

Actions Taken

- National Training Programme agreed with Landfill Operator
- Marker Post replacement scheme

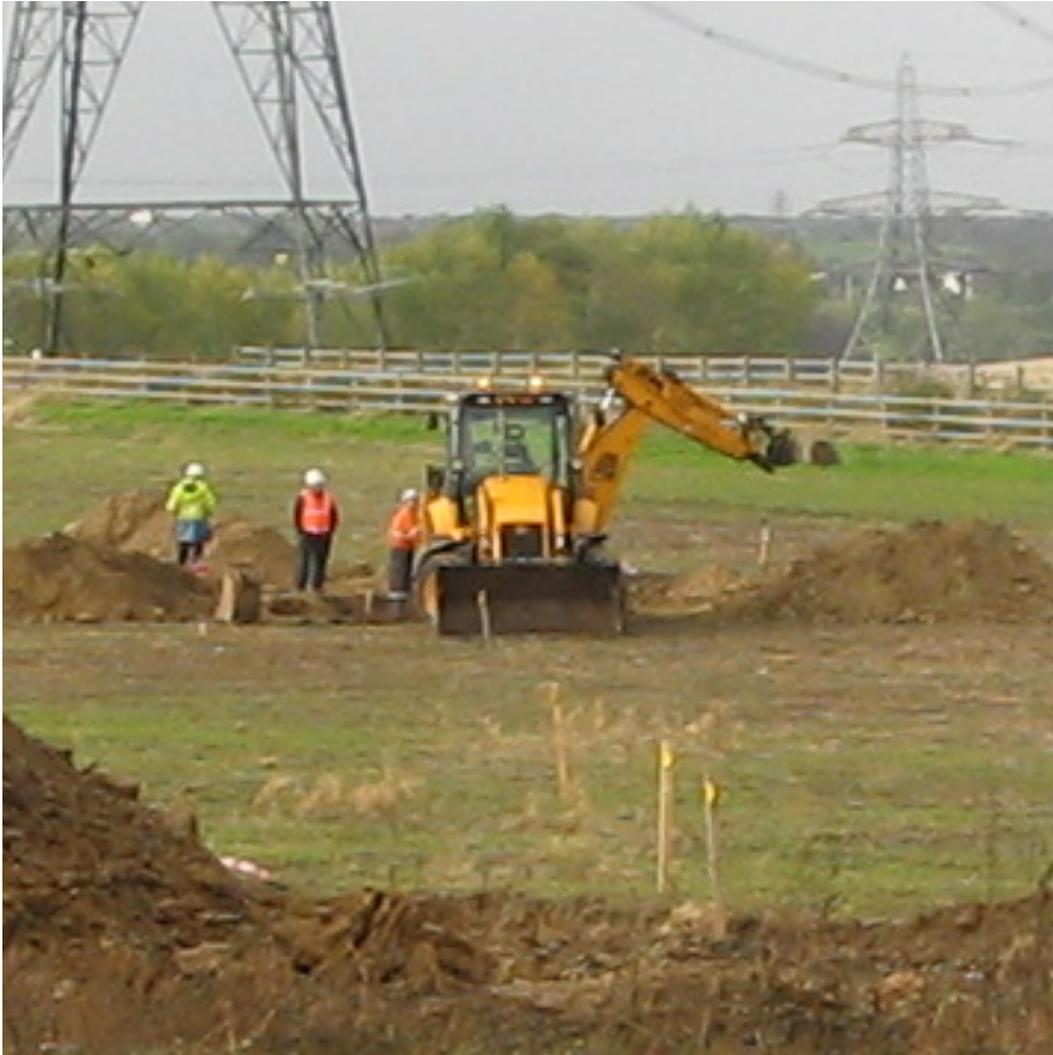
Trial holes to find
position of pipeline
monitored by
Pipeline Inspector

- Pipeline Details
- Diameter: 750mm
- MOP: 70 Bar
- NWT: 11.91mm
- Grade: X52

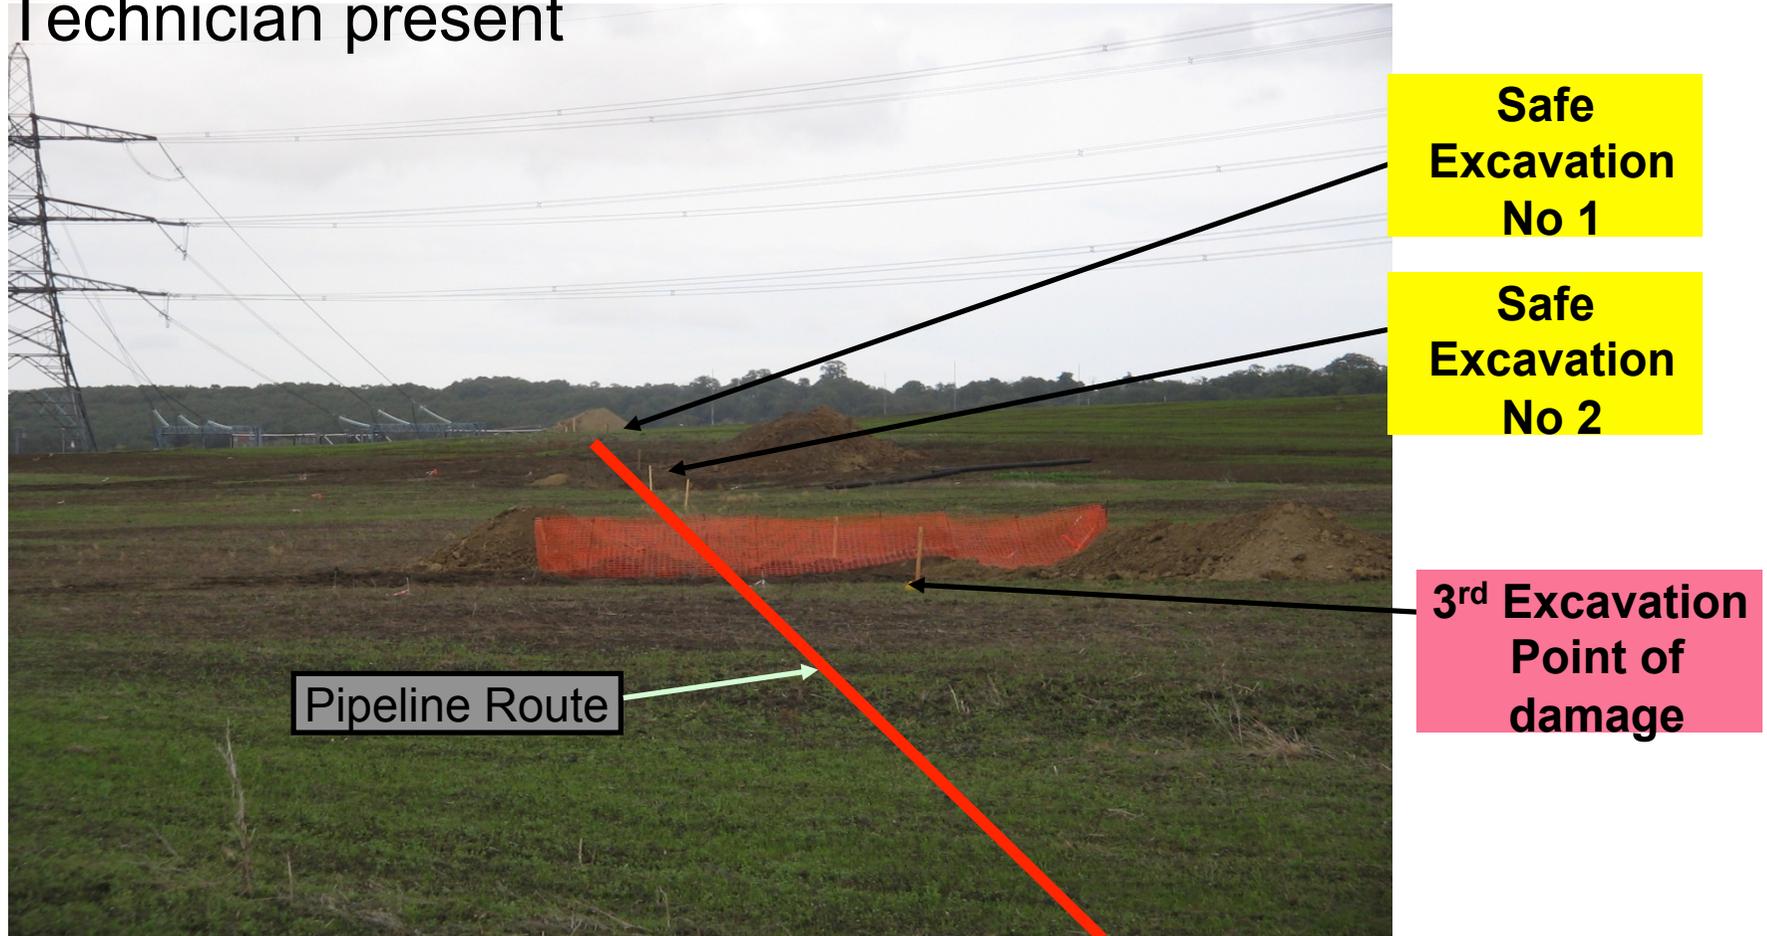
Pipeline damaged by mechanical excavator whilst Pipeline Technician present

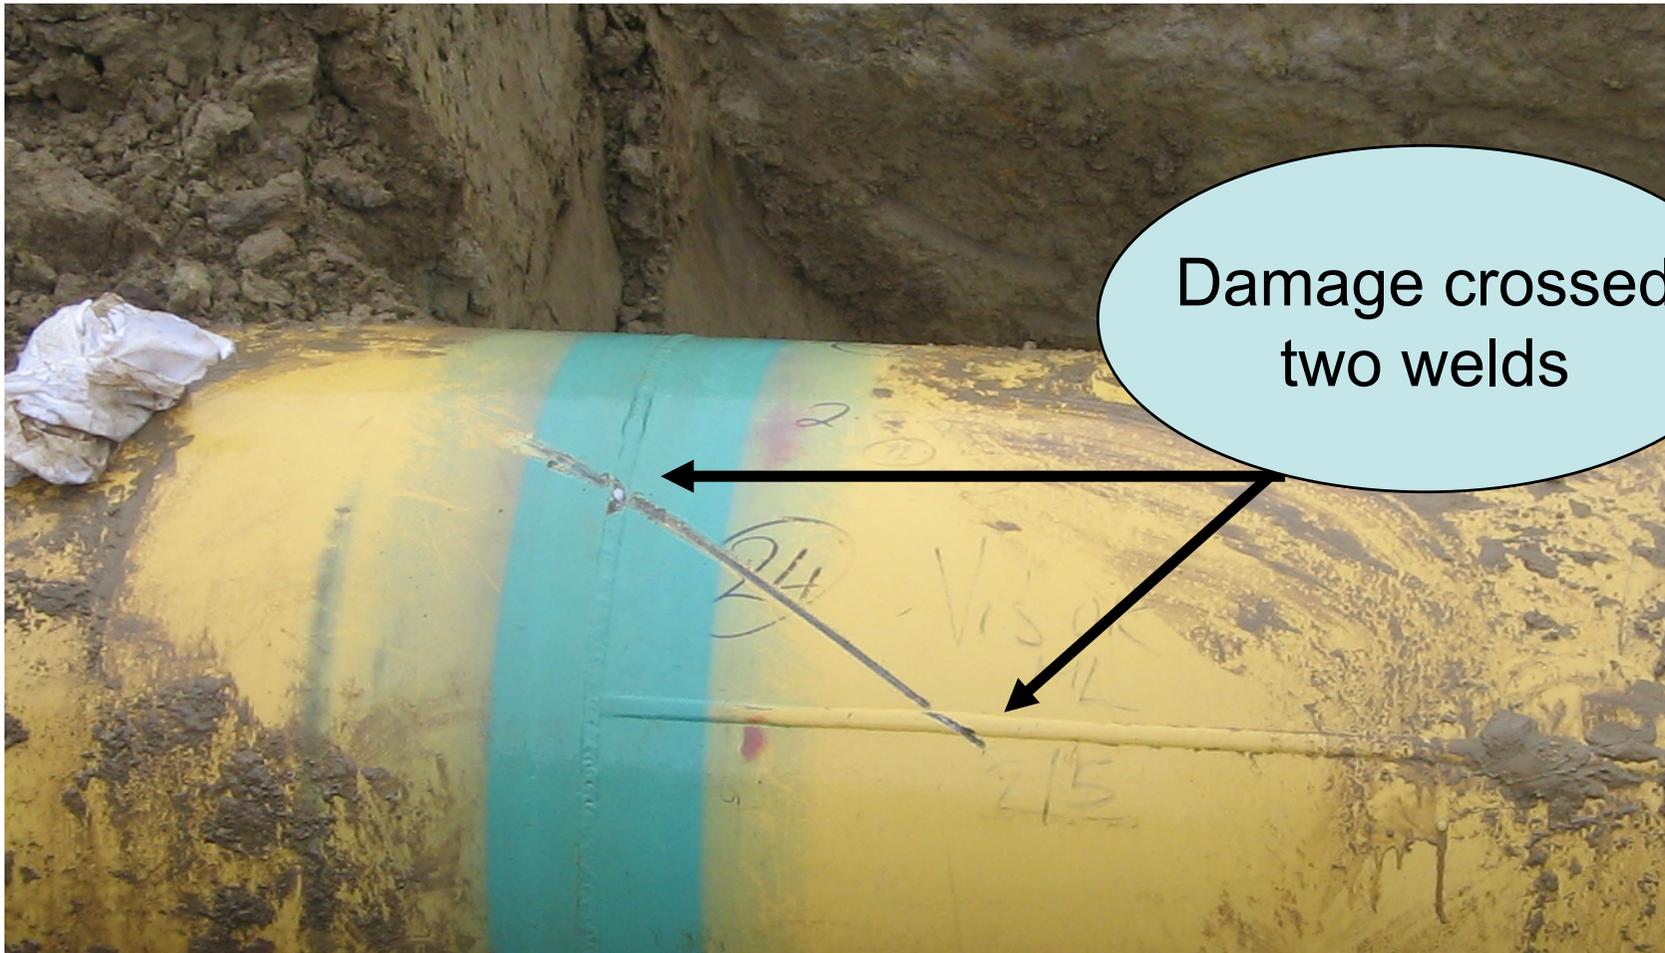
Damage crossed
two welds

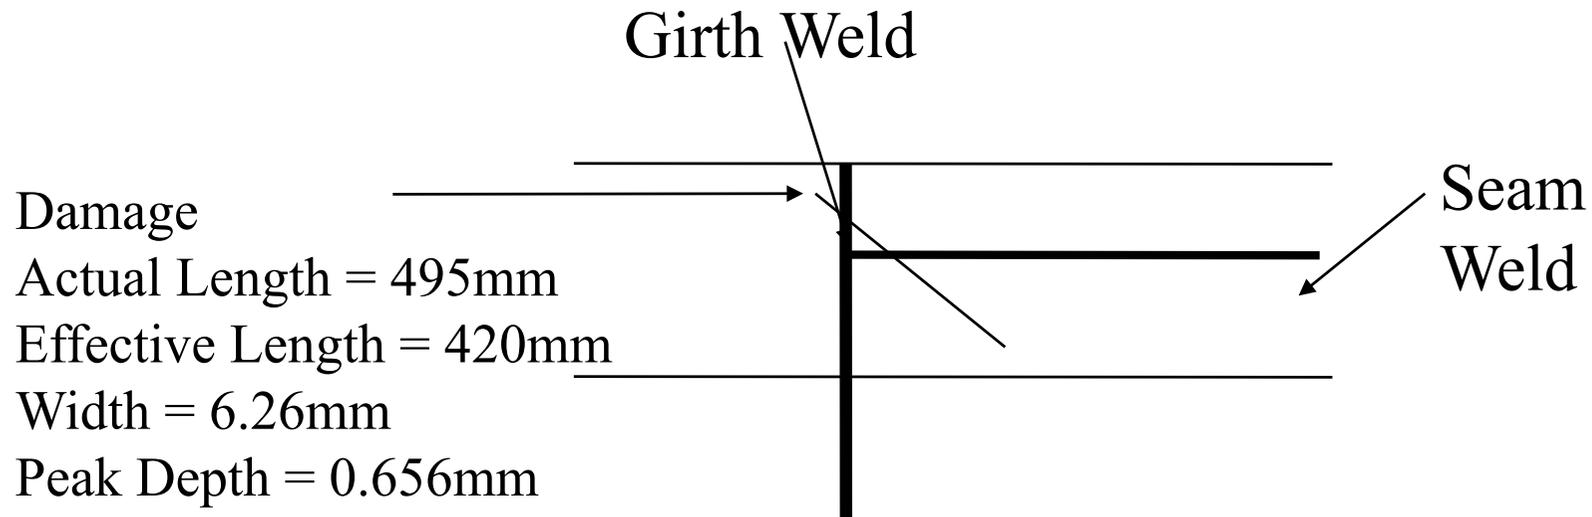
Damage is assessed using T/PM/P/11 table 8

- Referring to table 8 (gouge) the pipeline design factor is greater than 0.5 and less than 0.72

- The effective length of defect $x 0.2R = 420\text{mm} x 0.2R = 76\text{mm}$.

- Defect is categorised as 'Extreme Damage'

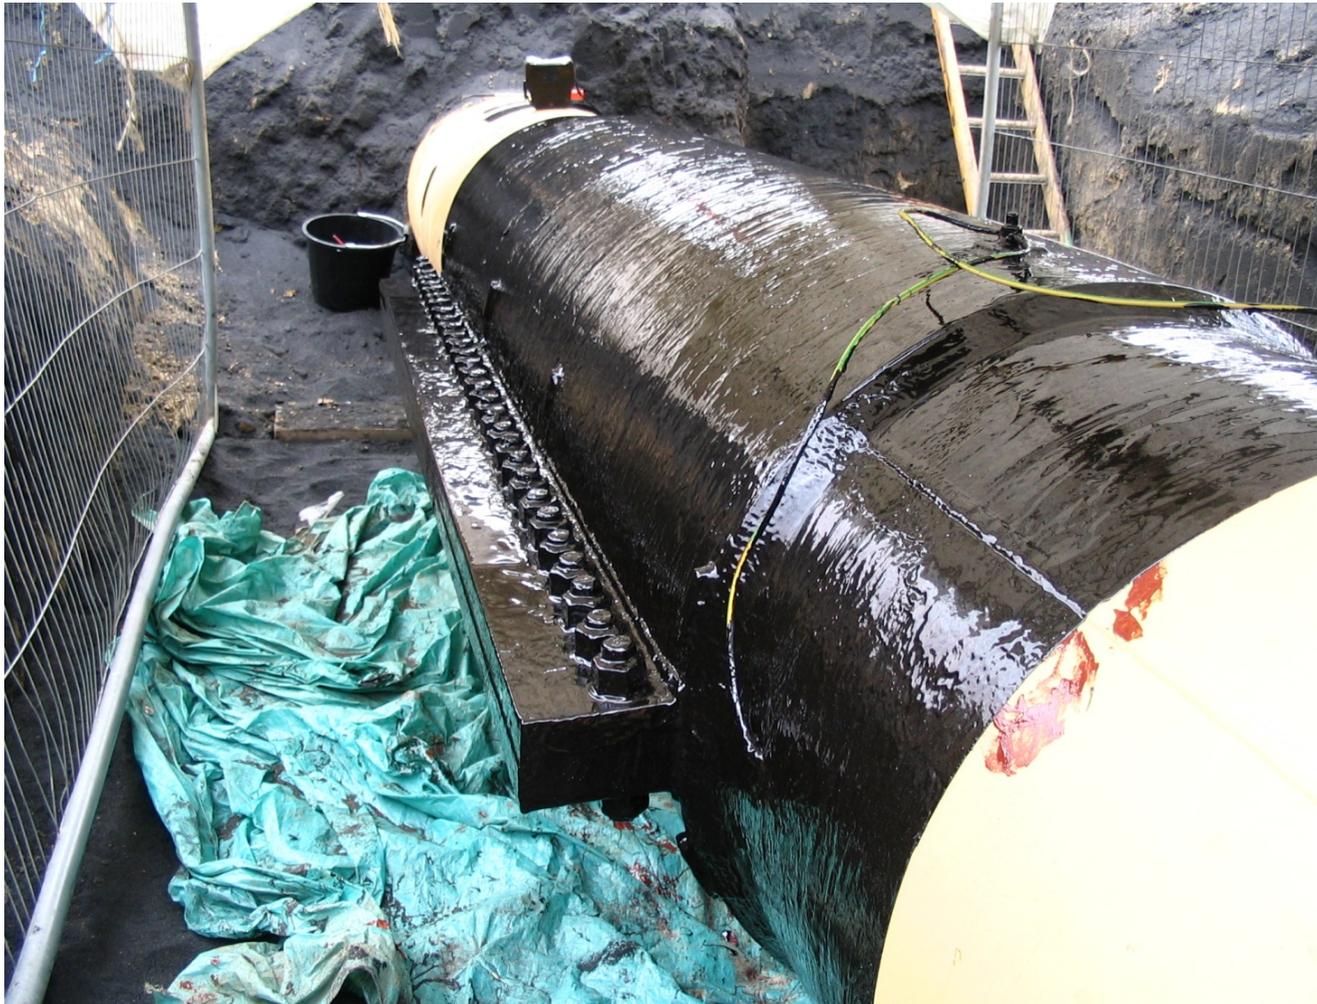
Immediate Causes – Human Factors

- Failure to follow Work Procedure Maint/5028
- Failure to follow Safe Operating Procedure SSW/22

Root Causes

- Inadequate training
- Shortfall in Competency Assessment
- No workplace monitoring carried out

Repair
Epoxy
Shell

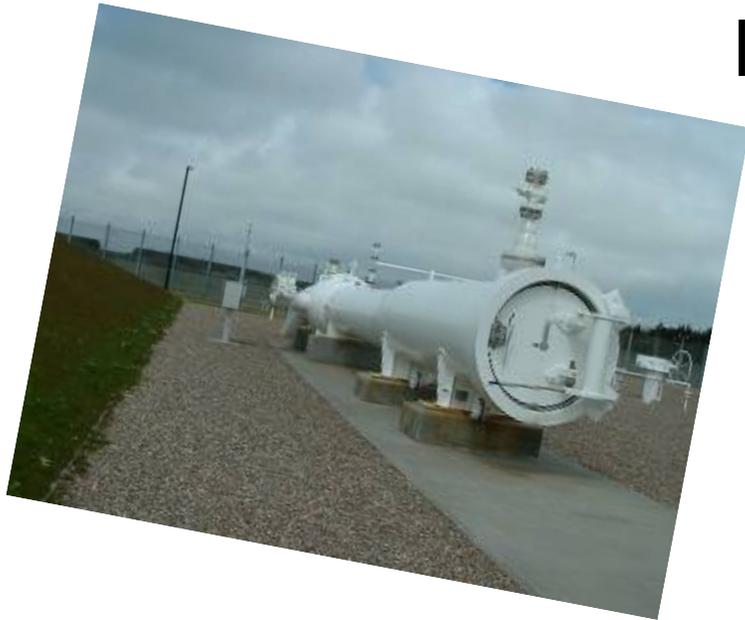
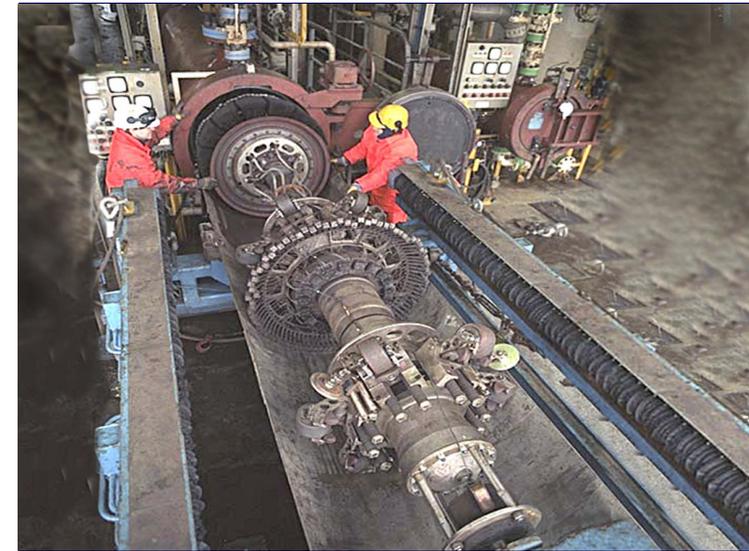
Corrosion defect identified by routine In Line Inspection

- Diameter: 900mm
- MOP: 70 Bar
- NWT: 12.70mm
- Grade X60

Peak Depth – 28%

Average Depth – 14%

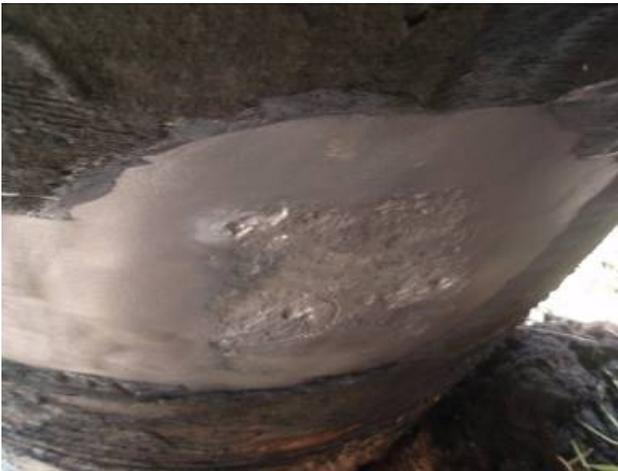
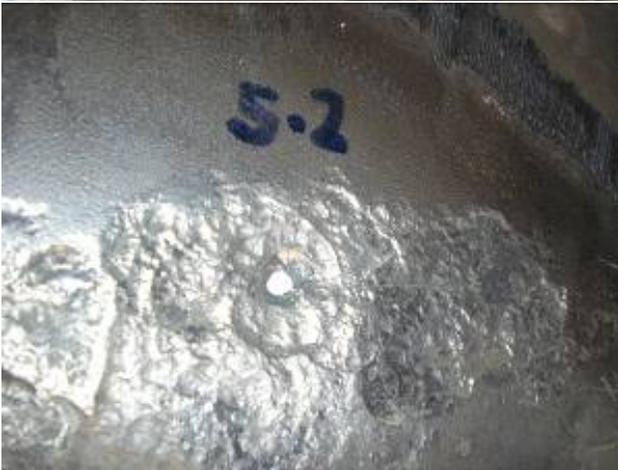
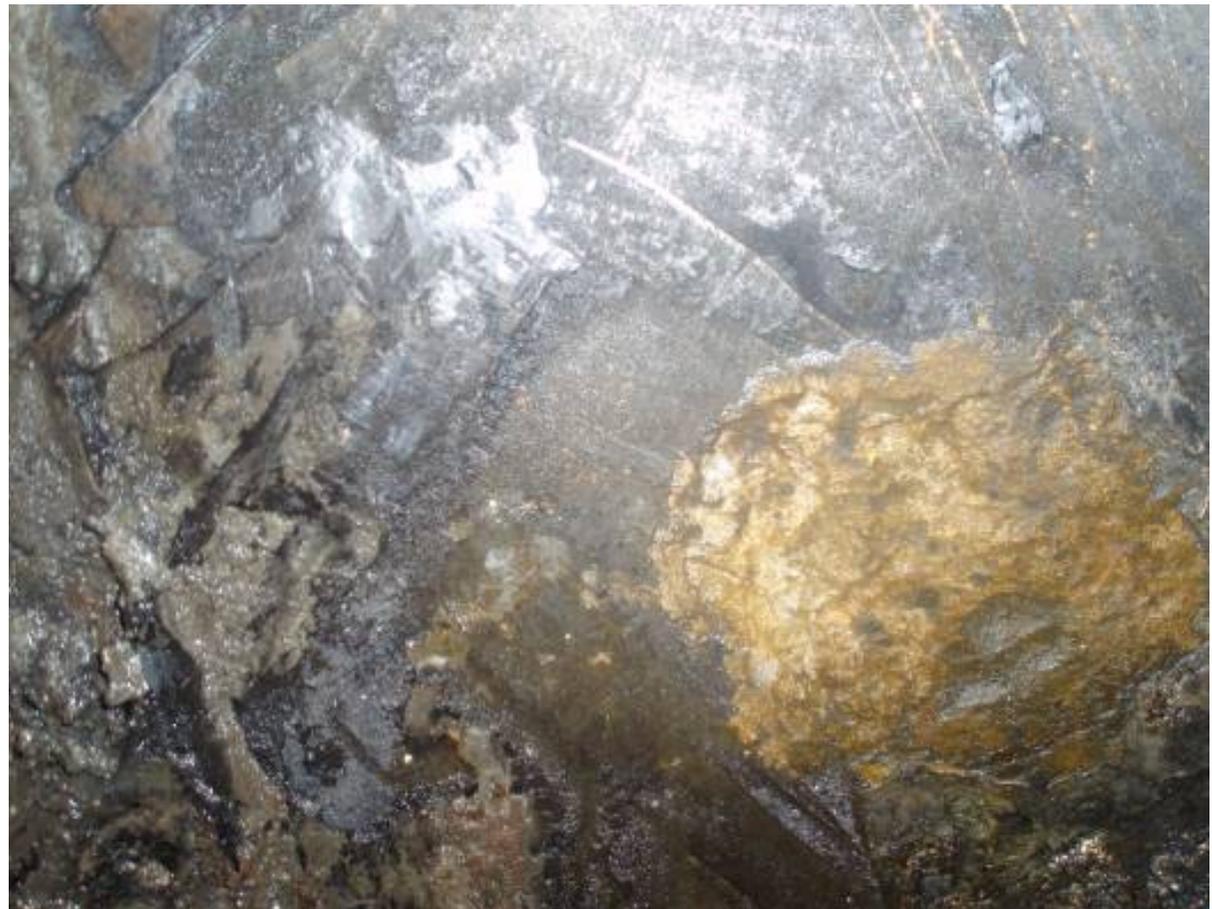
General corrosion

Extreme Damage

Actual Length = 110mm

Effective Length = 110mm

Width = 110mm max

Peak Depth = 5.2mm (39%)

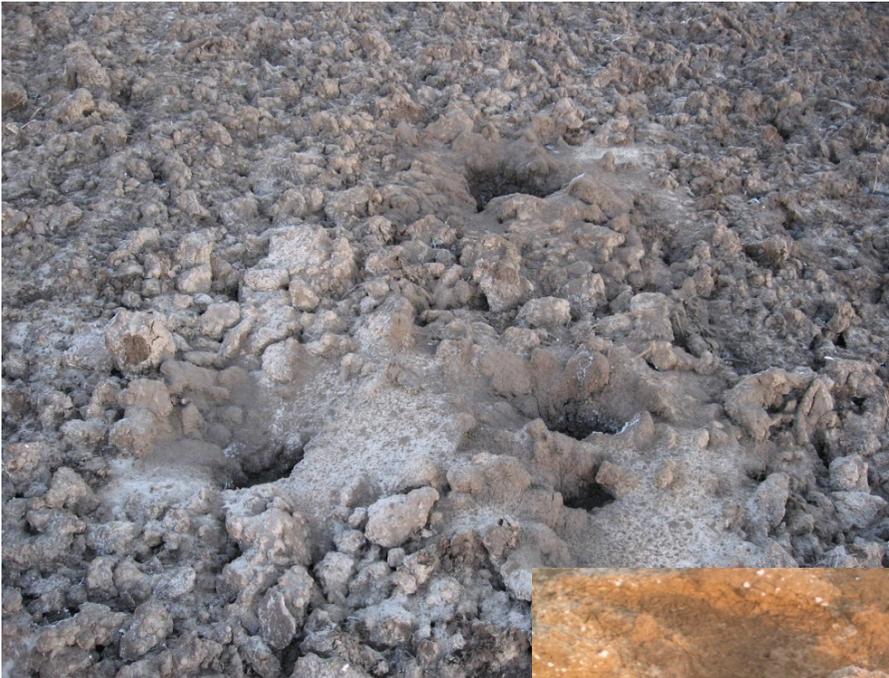
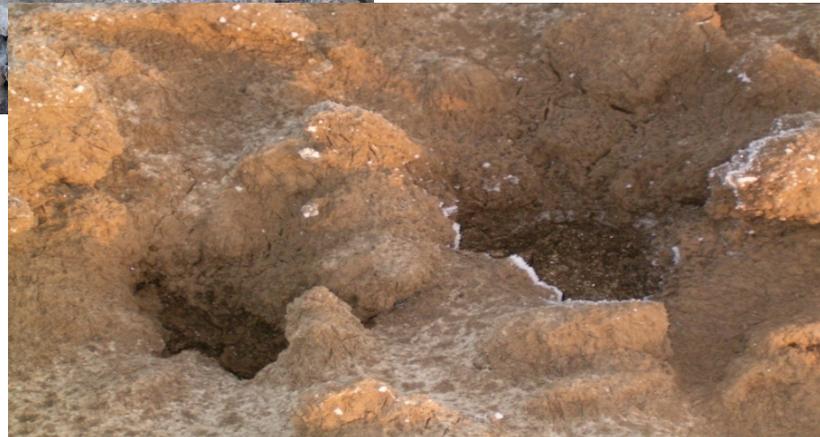
Incident in the Netherlands

Whilst carrying out routine inspection on the pipeline easement an employee found gas leaking from funnel like holes and bubbling

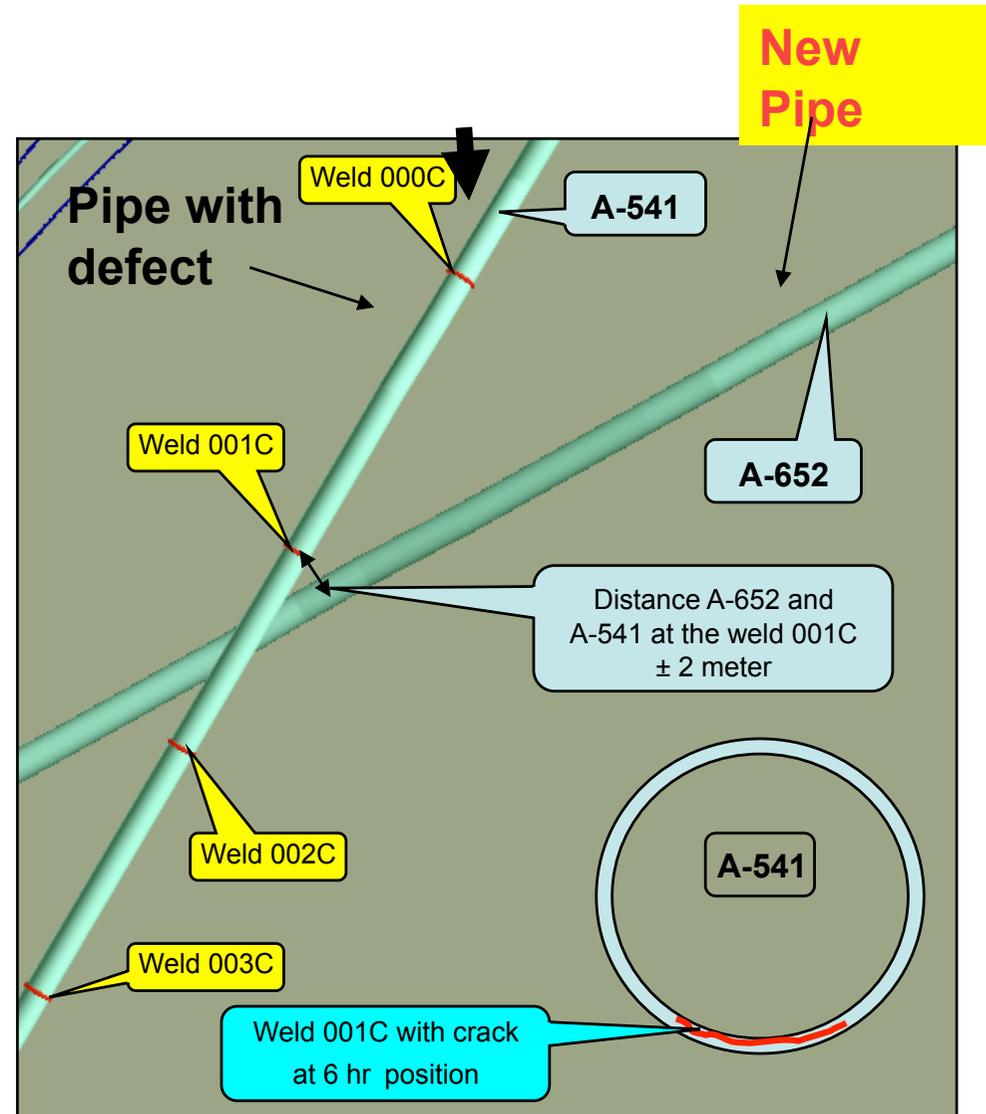
- New Pipeline laid 1m underneath existing 42" constructed in 1971
- Girth Weld failed 18 months after construction work
- No precaution taken to support pipe during construction of new pipe and the welds on old pipeline were not inspected

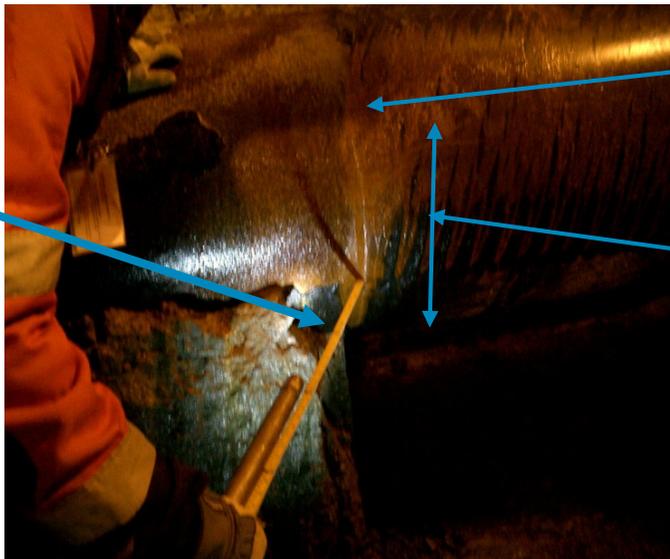
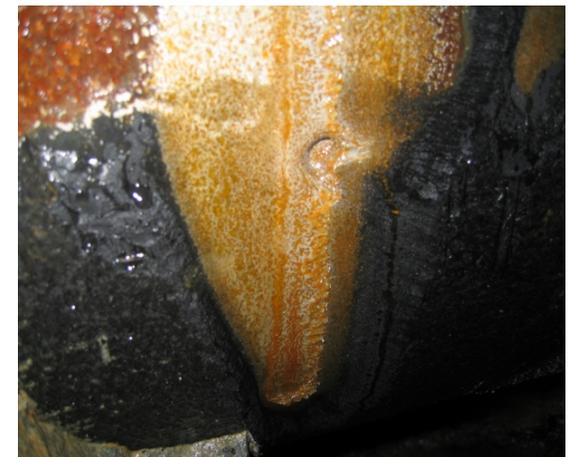
- Water jetting was used to remove asphalt coating on a 30" gas pipeline. *Norway on 6 October 2008*
- Water jet operating at *approx. 1000 bar and 180 l/min* failed resulting in the jet moving repeatedly along the same line for a duration of approximately 10-15 minutes.

Distance
from
nozzle to
pipeline
460mm

With: 26mm
Dept: 0,2-1,2mm

**Length;
460mm**

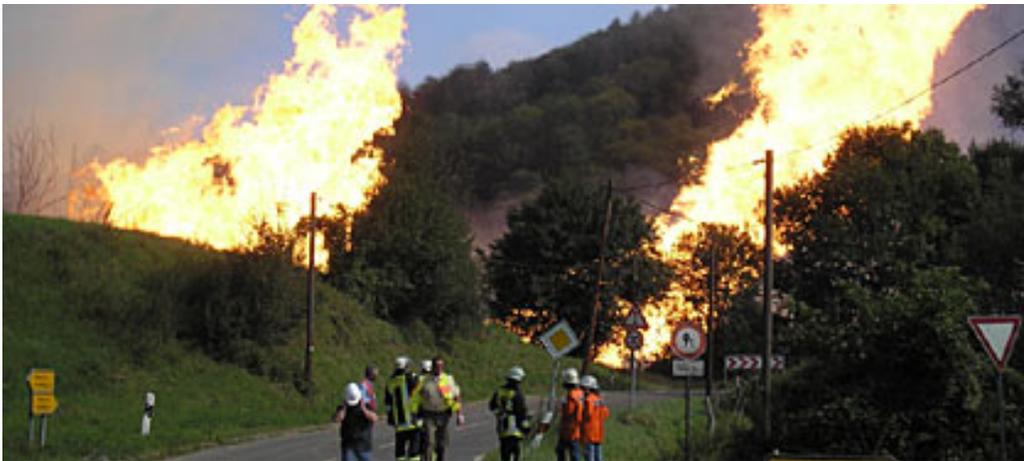
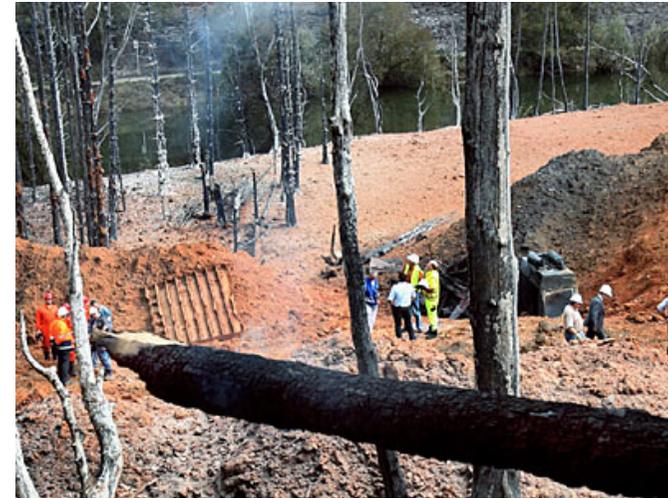
Gas Transmission Pipeline failure Lanhtal Germany

Pipe failed as a result of ground movement

Cause - new pipeline being constructed parallel to exist pipeline on side of hill

The trench for new pipe was below existing, excavated material placed on top of existing pipe, heavy rain, excavation for new pipe collapsed land slip caused pipeline to fail

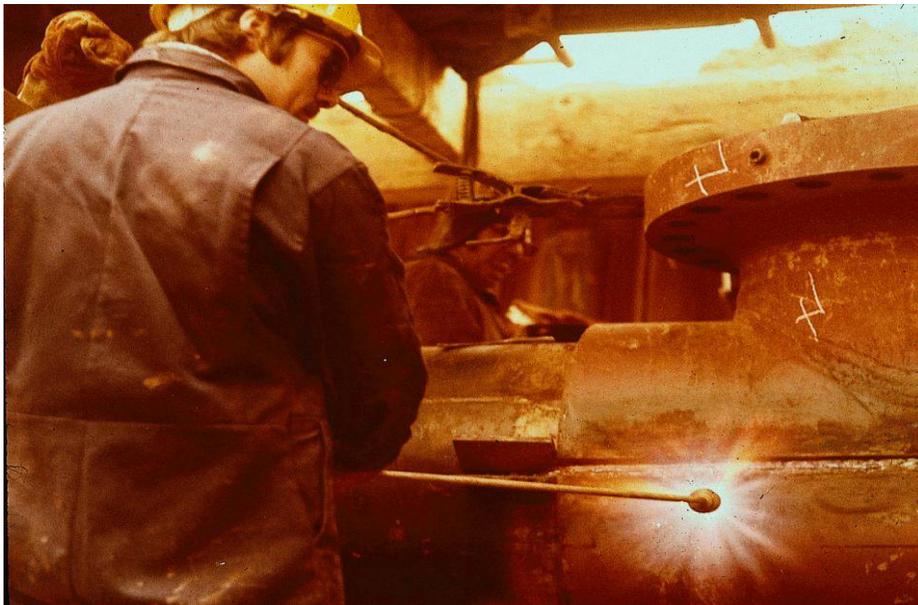
Damage caused to
pipeline

Pre heat torch left
against pipe
unattended

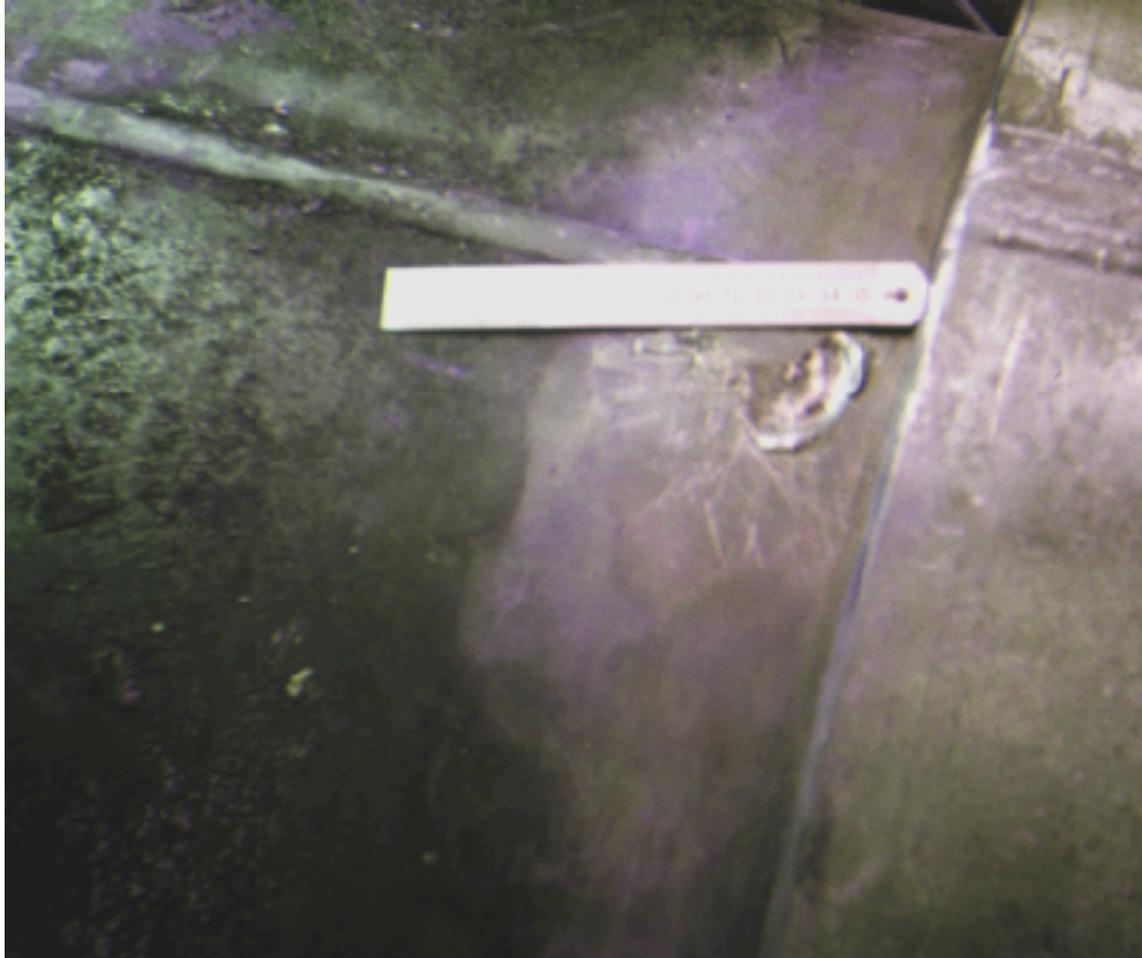
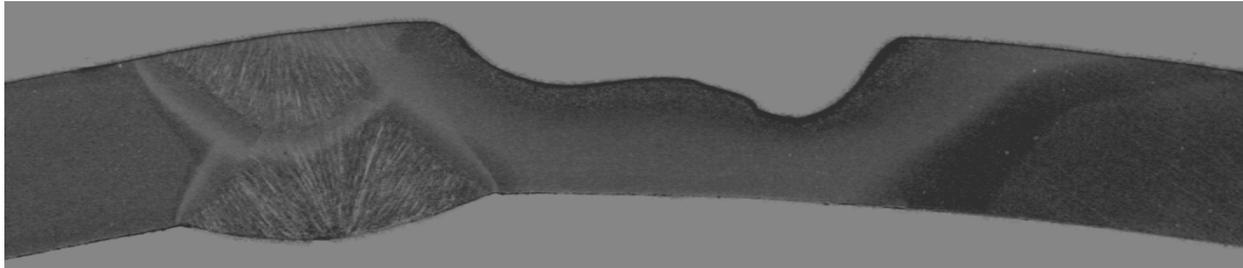
- ▶ **Metal loss equivalent to 46% of pipewall for an area 42mm x 37mm**

- Lack of Competency Management
- Lack of Understanding of risk
- Poor Site Management

Defect cut out and replaced by tee and new section of pipe

- New Heating torch introduced which reduced the risk of similar incident
- Prior to all hot tap operations the team carrying out the work undergo special briefing and training on risks carried out by specialist
- Improved competency management of welders mate
