# Line Walking

# Line Walking as a Risk Reduction Measure

# Recent SEARs/RIDDOR report

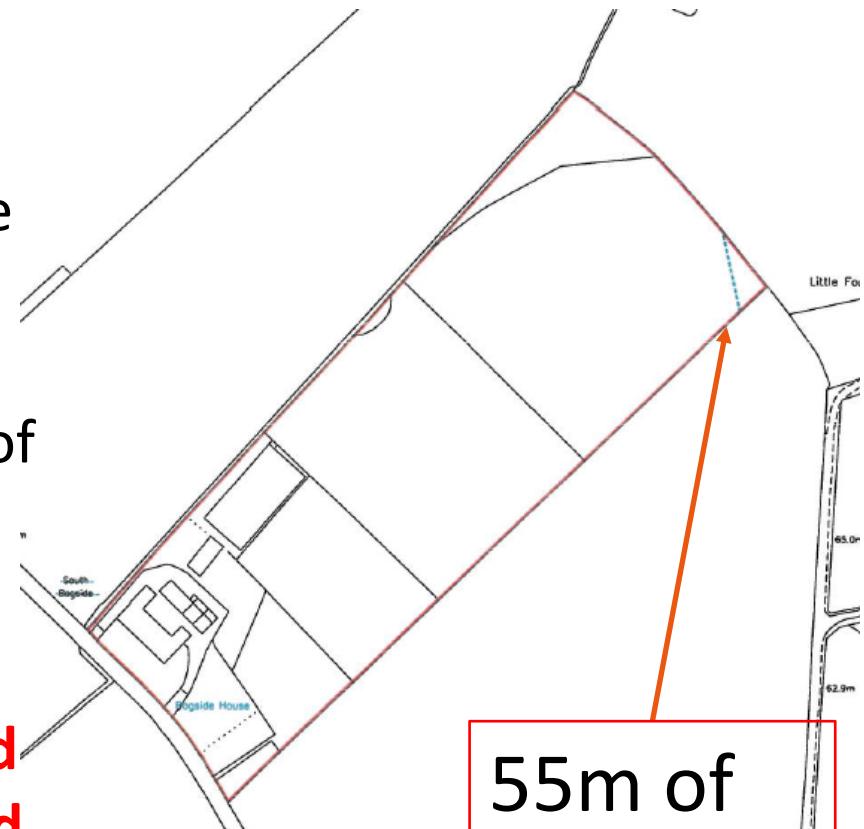
# Title Deed extract showing Pipeline

1. Land holding was part of a larger estate which became subdivided.
2. New land owner unaware of short section of pipeline.
3. Was on Title Deed but not highlighted by lawyer. **Deed of Servitude/Wayleave and land owner liaison not effective**

55m of  
pipeline

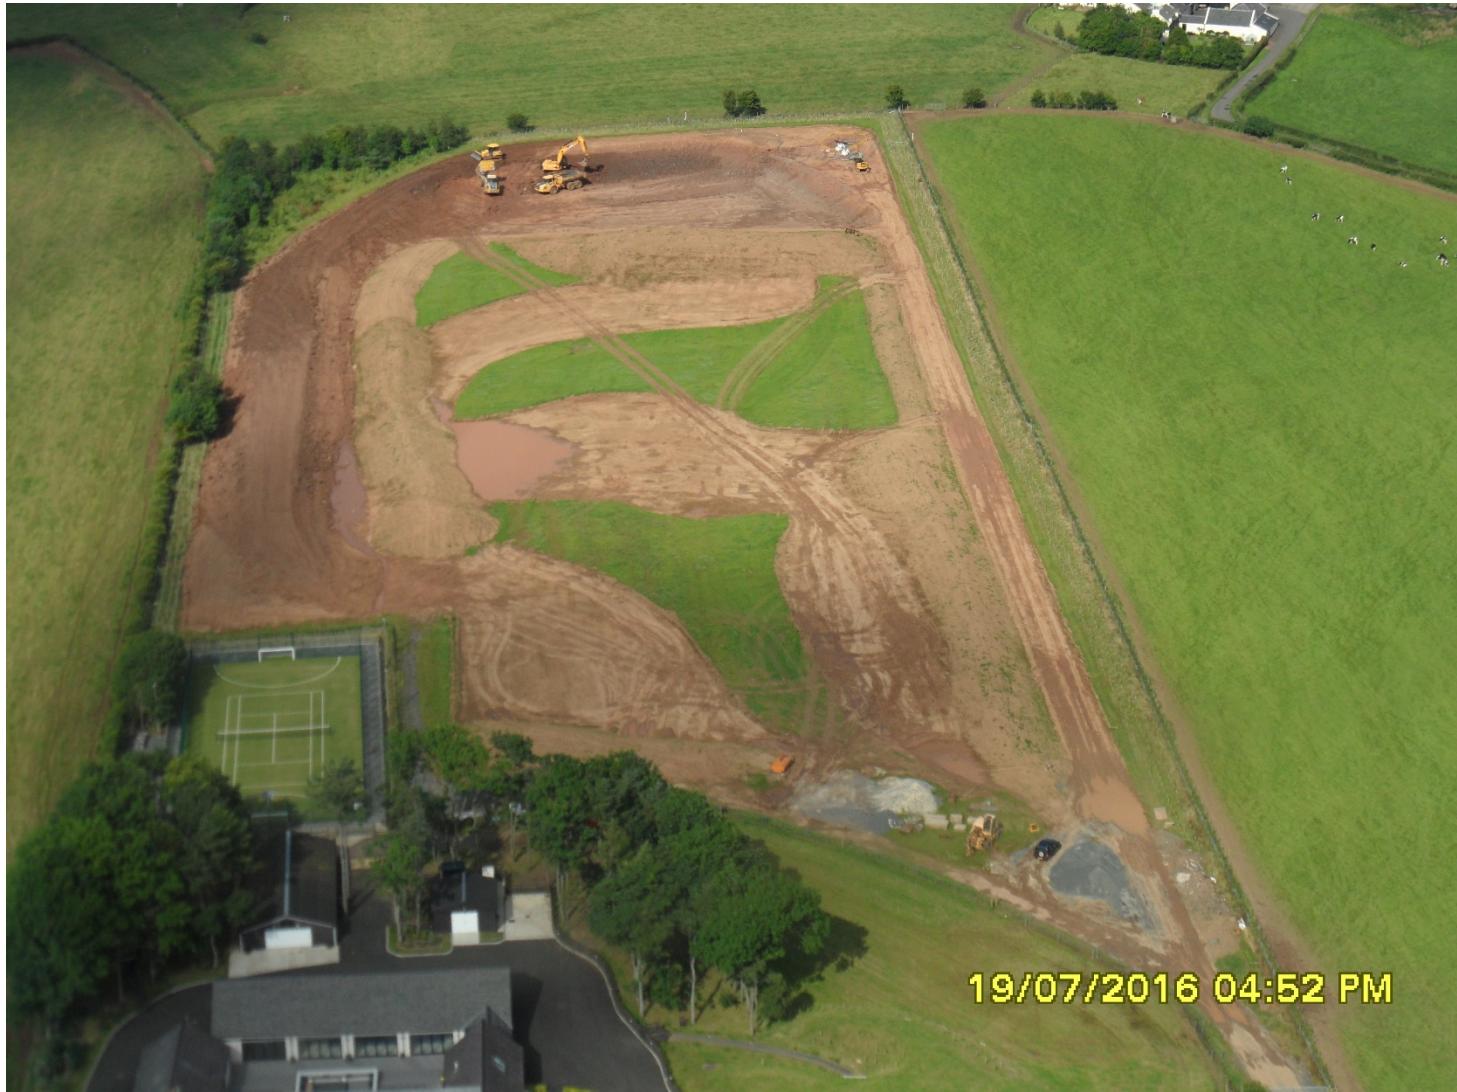
# Work on Golf Course

1. SGN Aerial Sighting on “Major Earth Moving Works In Progress” reported near the end of the working day.
2. Work had commenced only 10 days prior to damage
3. Pipeline damaged early the next morning.  
**(Within Aerial Survey Cycles)**
4. Major Works (not previously notified) underway to build 4 hole golf course in “private garden”  
**(No Land Use Planning)**

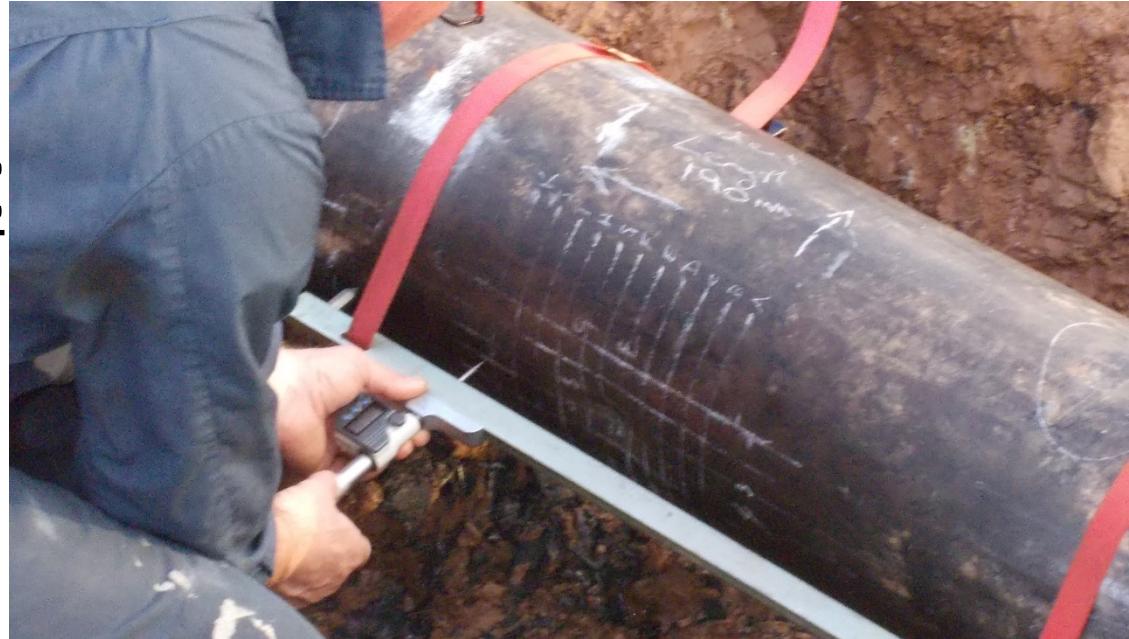
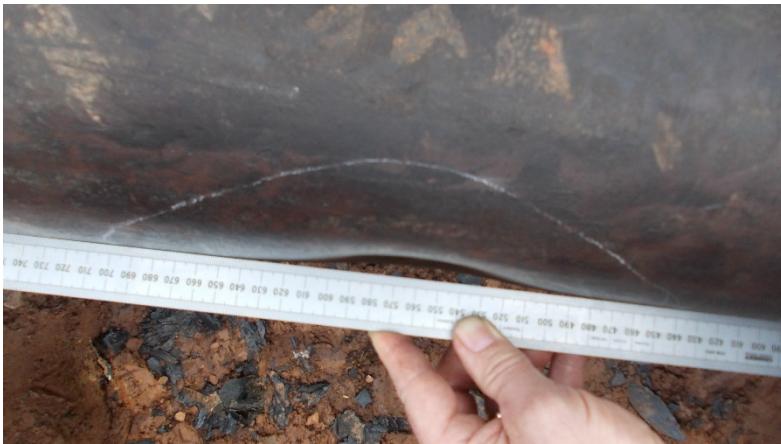
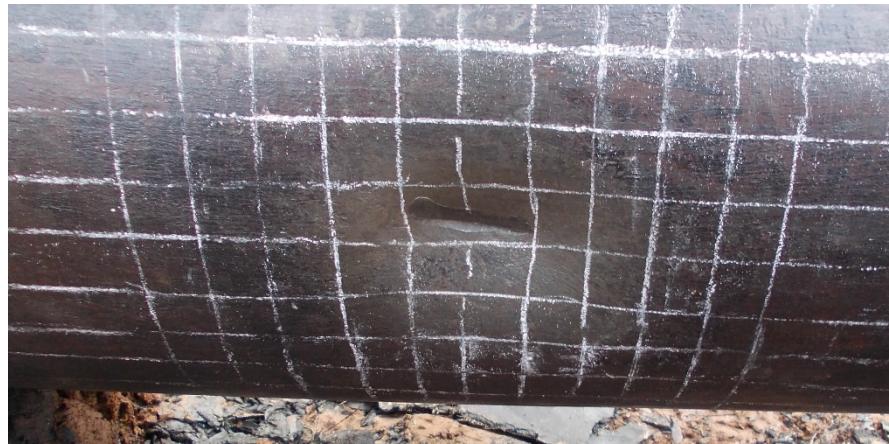
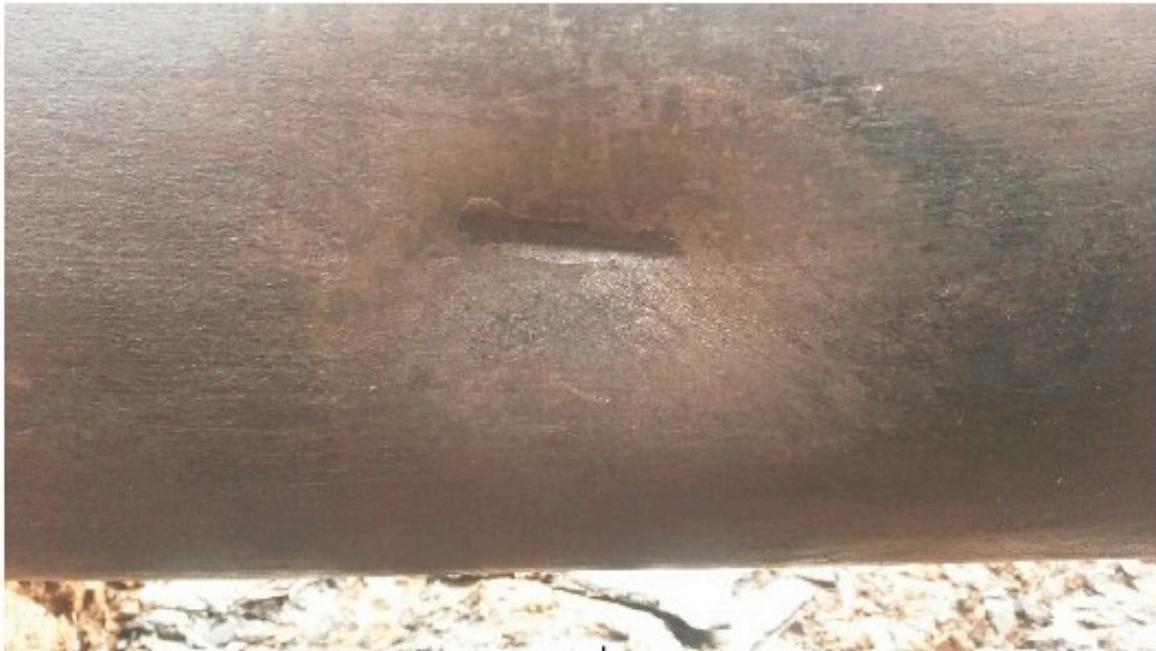
# P11 Measurement and Assessment

1. Pressure lowered 19 - 16bar.
2. P11 assessment on main damage including MPI (Initially categorized as Extreme Damage)
3. Further pressure reduction 16 -11bar and temporary repair shell fitted.
4. 14 further areas of damage (All superficial).
5. Further detailed assessment of main damage then categorised as severe

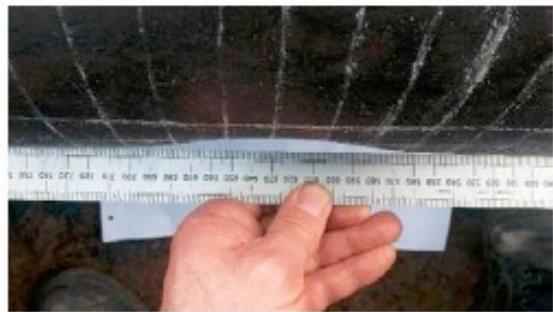
Dent:

Peak depth: 15.44mm

Damage located at 09:00 around pipe circumference, 12:00 is the top of the pipe

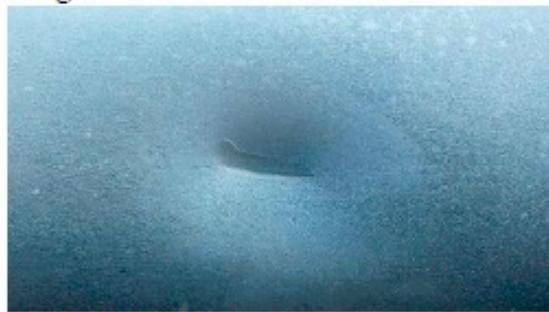
Gouge:

Peak depth: 1.5mm

Length: 48mm
