Pipeline Bending Strain Assessment using ILI Tools: Case Studies

Ian Murray CEng IMechE, Jane Dawson, Lautaro Ganim (PII Pipeline Solutions, UK)
Daniel Bieger (EGO, Switzerland) Daniel Vallejo, GVM Switzerland)

2. Case Study 1: Pipeline Rupture

3. Case Study 2: Coincident Features

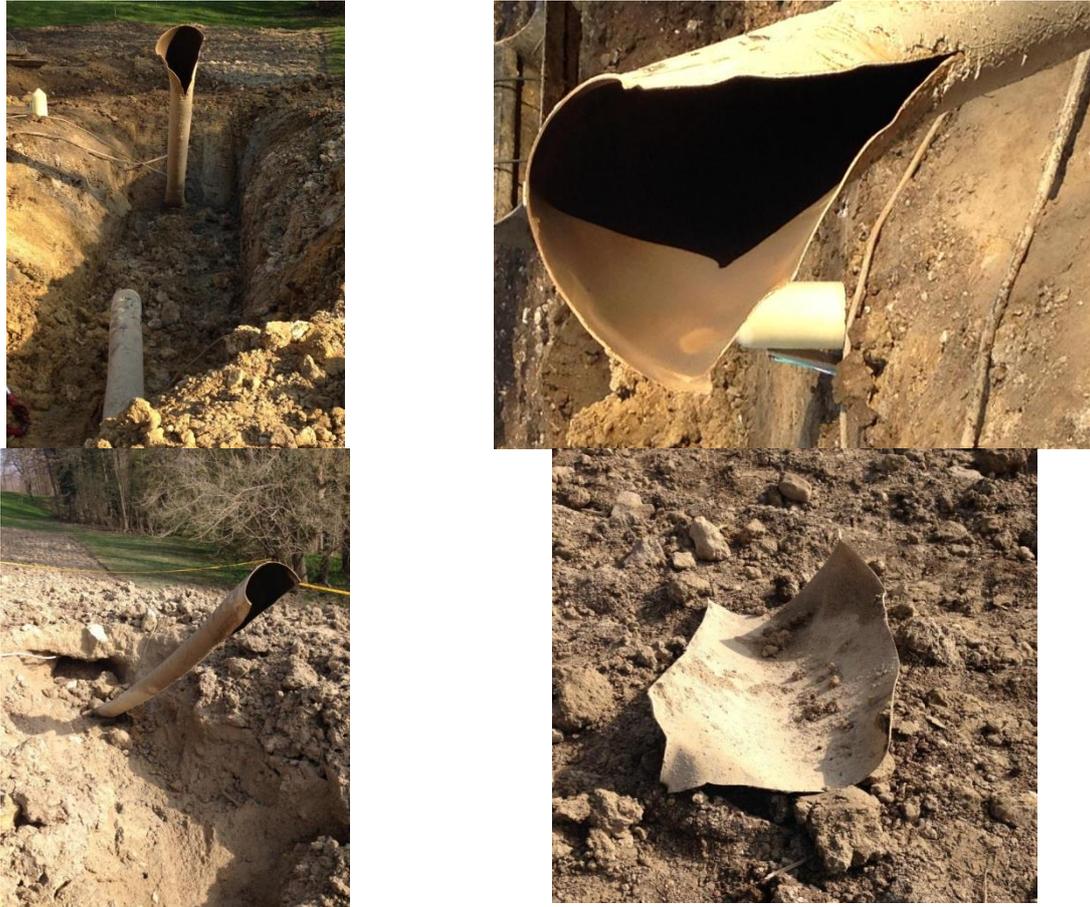
Figure 1 – Rupture Site Photographs

The failure site was investigated and it was found the rupture had resulted in a large crater exposing the previously buried pipeline. Photographs of the failure area are presented in Figure 1.

Historical data indicated the slope had been moving over time, with more recent records indicating an increase in these movements from 2013. It was concluded that this increase in movement lead to high shear forces which ultimately caused the failure.

Therefore it can be concluded that the rupture was caused solely by the catastrophic external loading on the pipeline resulting from the sudden landslide. Using an IMU unit to identify areas susceptible to ground instability can aid in mitigation of these catastrophic events.

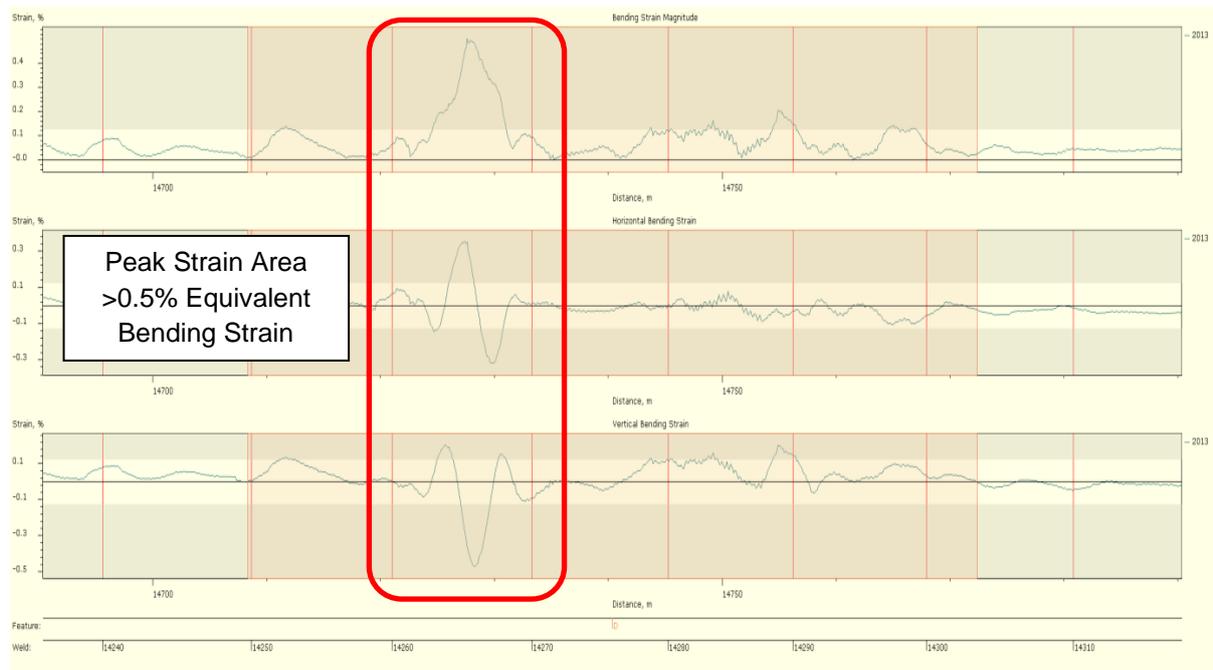
Figure 2 – Strain Data for Failure Area

It was determined that at the time of the 2013 ILI there was significant bending at the failure site; the equivalent bending strain was found to be $>0.5\%$ (see Figure 2 for the peak in strain evident at the failure location).

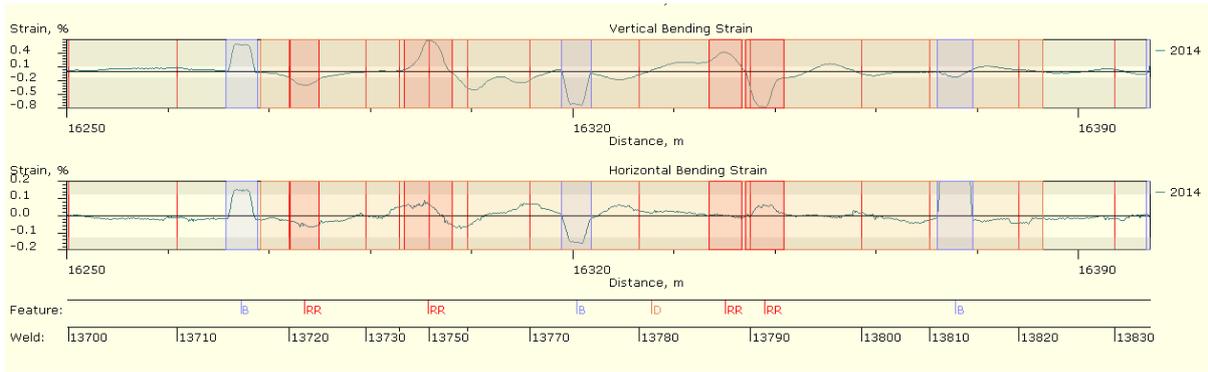
Figure 3 - Equivalent Bending Strain Investigation Findings

The investigation identified an area of high strain, coincident with a number of bends as well as a number of strain peaks. Several of these peaks showed some characteristics of bends however they were not typical of the signals seen on the rest of the line therefore in order to be conservative these peaks were included in the reported strain magnitude.

The data collected for this area is presented in Figure 3 below. This data shows the horizontal and vertical strain profiles. The strain peaks are highlighted in red, with the identified intentional bends highlighted in blue.

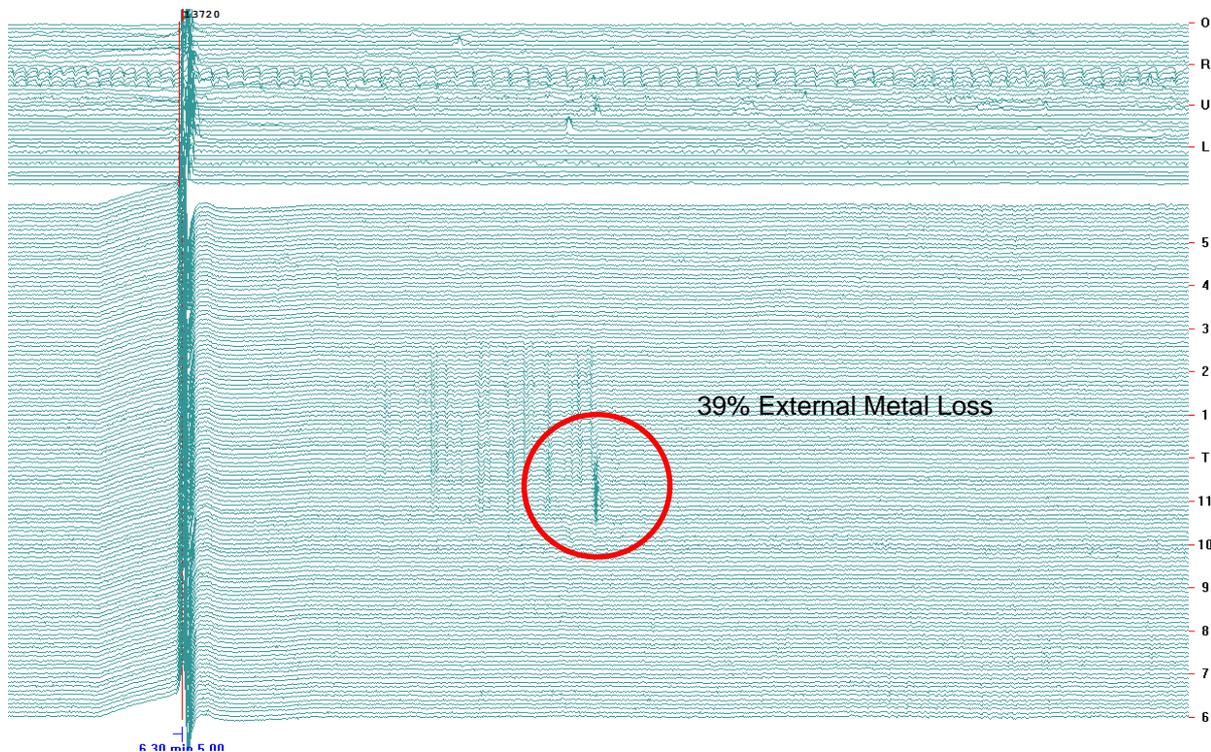
Figure 4 – Magnetic Flux Data showing Coincident Feature

As part of the investigation the coincident features reported from the MFL tool were reviewed. It was determined that, coincident with one of the strain peaks, a metal loss feature had been reported. This was identified as a 39% wall thickness in depth external metal loss feature, which was axially short and circumferentially wide (the ILI signal data for this feature is shown in Figure 4 below).

It was determined through interrogation of the data that this feature was located in the tensile zone of a peak in bending strain.

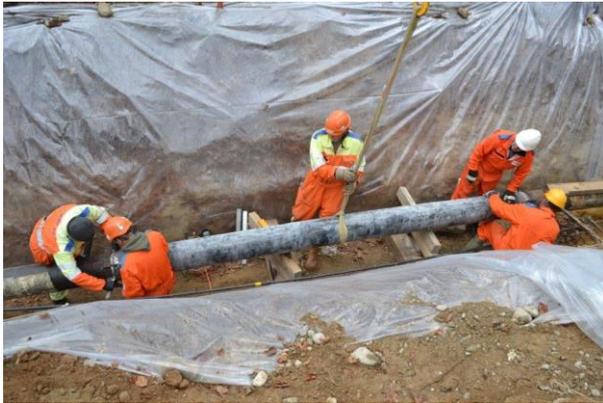
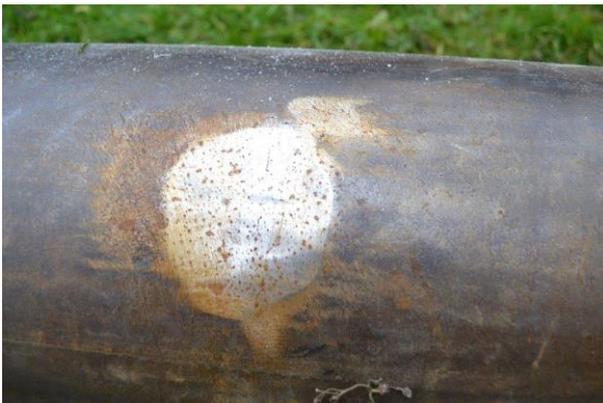
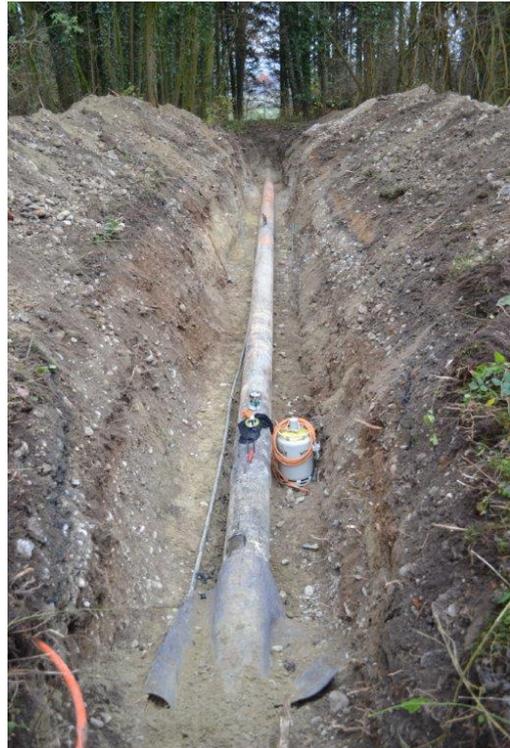
Figure 5 - In-Field Feature Investigation

EGO carried out in-field investigations to excavate and further investigate the origin of the identified strain and bending (Figure 5). At the location identified as metal loss in the ILI report no external metal loss was found. Following localised grinding at the location it became evident that the reported metal loss feature was in-fact a circumferential crack (Figure 6). The crack was located at the top of the pipe in a tensile strain zone.

It was determined that the crack was 40% wall thickness in depth with comparable circumferential length as reported by the MFL ILI tool. This feature was repaired as part of this investigation. In addition the bending loads were relieved from the line.

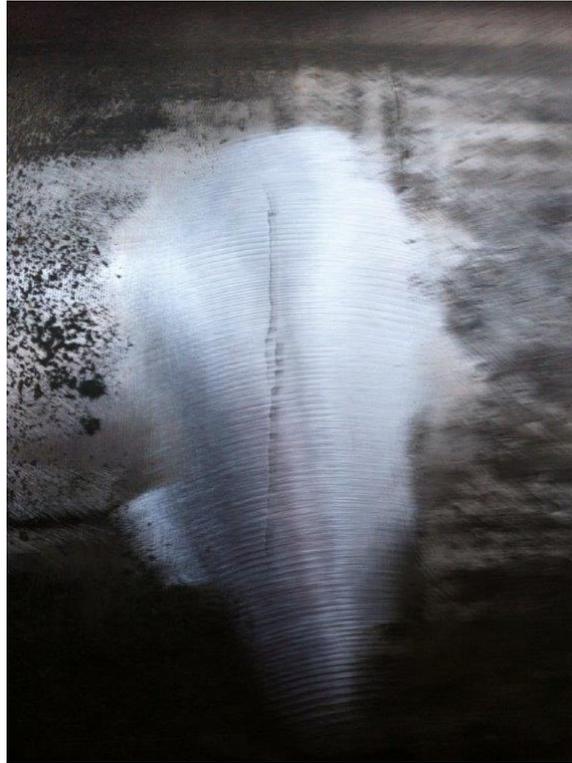
Figure 6 –Crack found from In-field investigation at location of reported External Metal Loss Feature
