THE PALACEKNOWE PIPELINE DIVERSION FAILURE

On Wednesday 22nd December 1993 a steel pipeline carrying natural gas at high pressure fractured at Palaceknowe near the village of Beattock in Dumfries and Galloway.

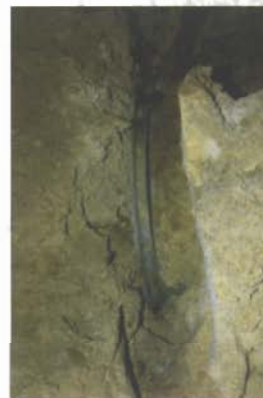
The failed pipe could clearly be seen at the bottom of the crater

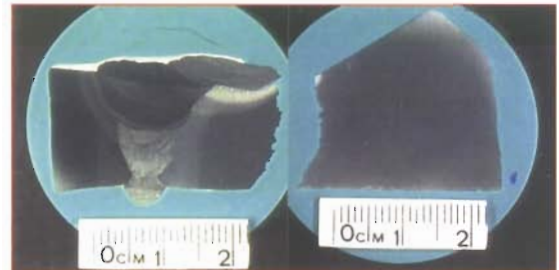
The new section of pipeline was connected to the original pipe at an existing steel construction joint. This special joint provided a seal to a casing around the thin walled pipe. The casing offers protection to the gas transmission pipeline where it crosses below the A74 trunk road. The pipeline failed in this component in the metal alongside the thick walled pipe connection weld.

Section through girth weld showing location of fracture

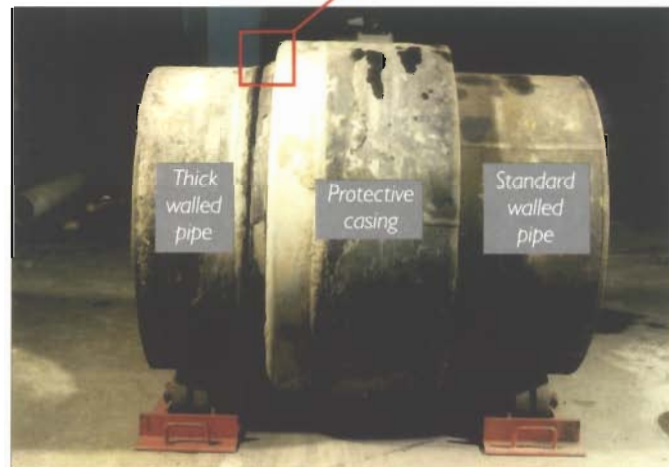
The diversion had involved a change in the vertical level of the pipeline and this had placed the new pipe on a layer of soil infill materials. One of these materials was subsequently found to be sensitive to compression under water saturation. This would have occurred at some time after pipeline construction and backfilling. The soils also exhibited compression under the action of the considerable depth of material above the pipeline. A concrete protective slab produced additional loading and compression to the soils below the pipeline. The combined loading from the concrete slab and overburden material produced a differential settlement along the pipeline which produced a very high bending load at the pipe to casing joint.

Cut out section of pipeline containing the fracture

Whilst the nature of the weld and pipe was not a contributory factor to the failure of the joint, it was found during the investigation that the strength of joints of this type could be improved by modifying the welding technique.
