Safety Alert Isolation of Plant for In Line Inspection

25th May 2011

ILI Inspection

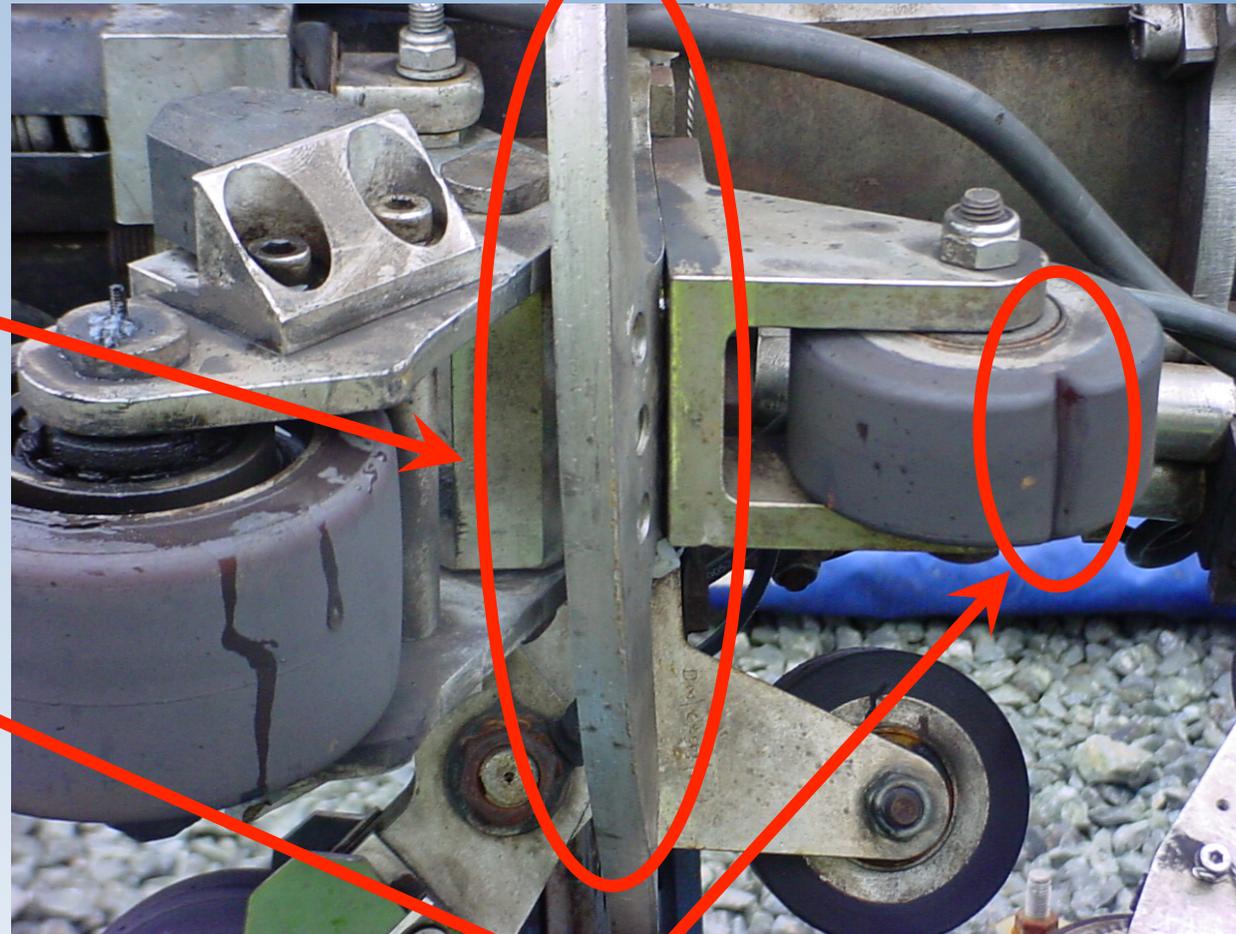
Tool Damage (2nd Module)

- Rear wheel support ring on module bent

- Wheel on this ring had pressure mark on tyre

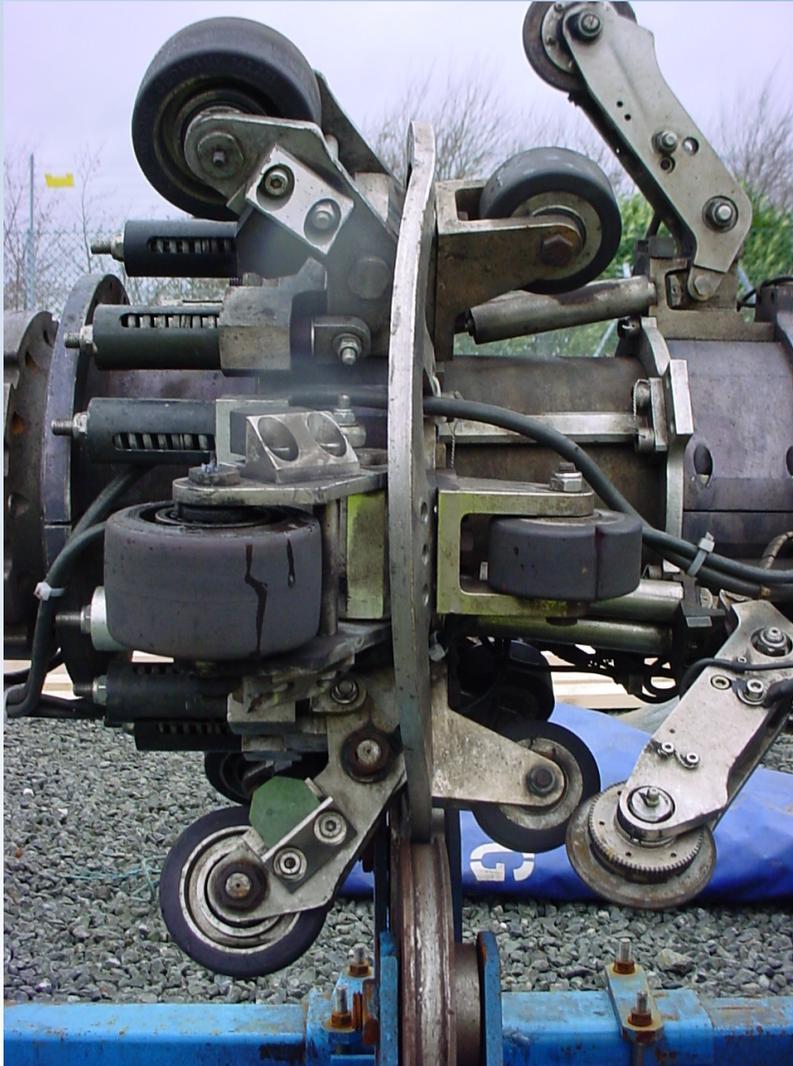
- **As a result of delay the tool battery ran out before end of run**
- **Damage not major but pipeline only partly inspected**
- **Inspection needs to be repeated for complete pipeline inspection data therefore financial impact**

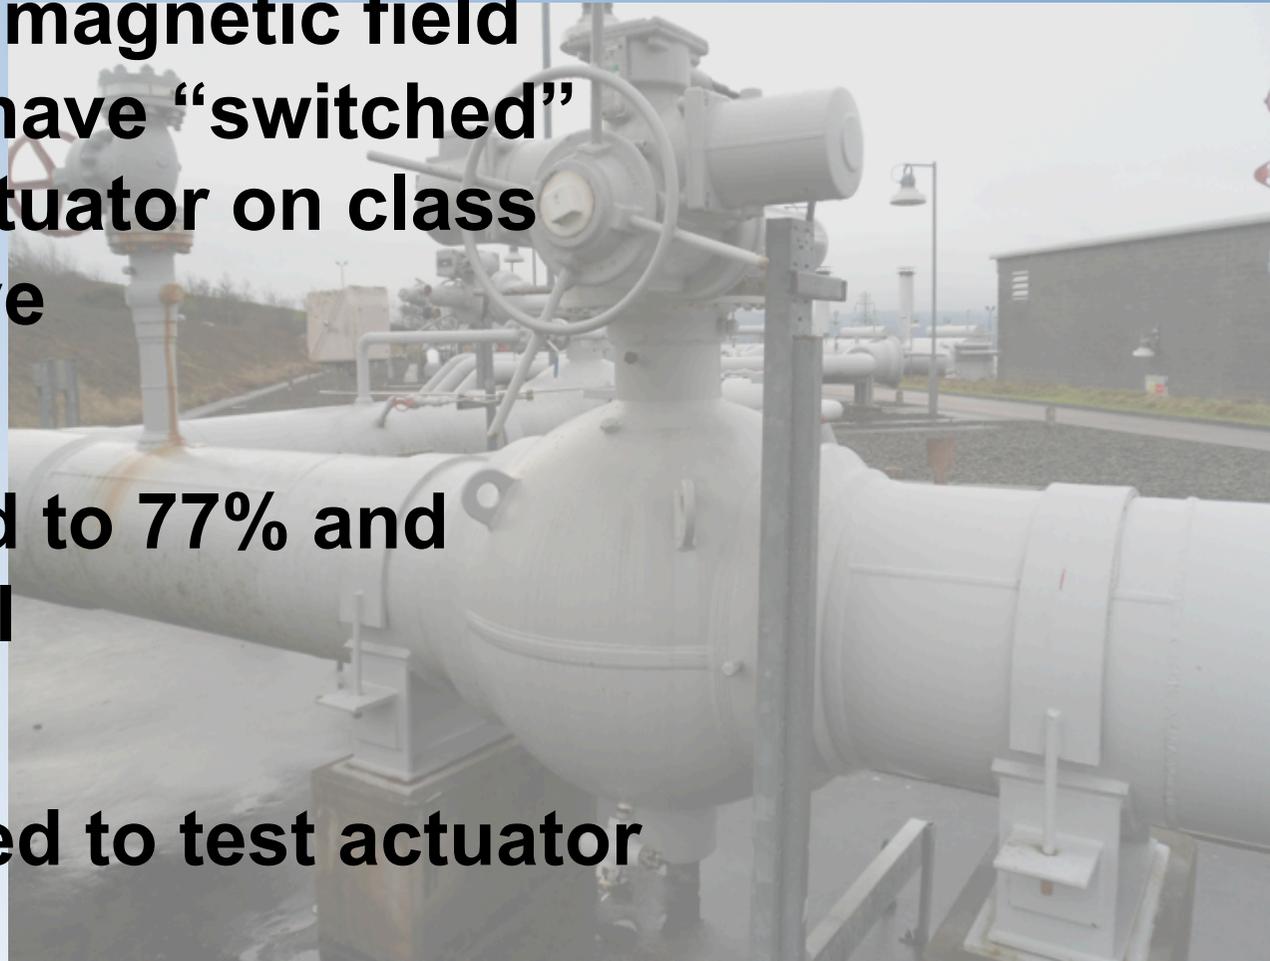
- **MFL ILI tool magnetic field believed to have “switched” electrical actuator on class 600 ball valve**
- **Valve moved to 77% and arrested tool**
- **Trial arranged to test actuator and valve**

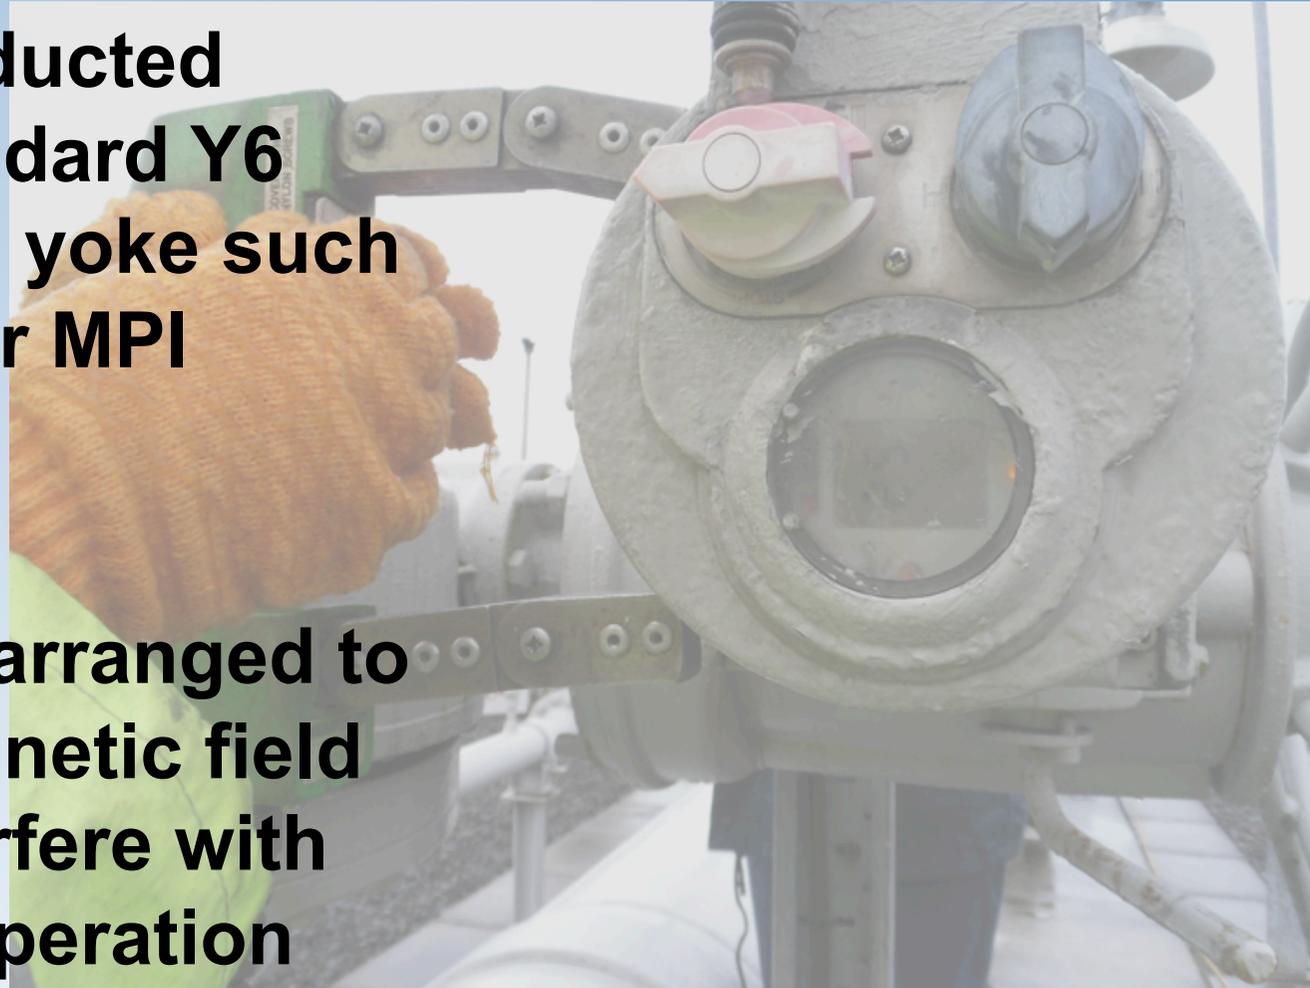
- **Tests conducted using standard Y6 inspection yoke such as used for MPI inspection**
- **Site trials arranged to test if magnetic field could interfere with actuator operation**

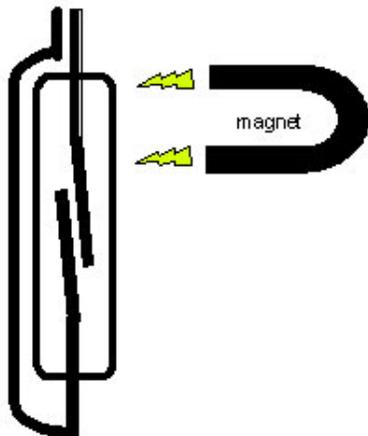
reed switch in "open" position

- Reed (Magnetic) switches in actuator switch gear
- When switch is rotated bar magnet in knob passes over switch situated behind casing
- Reed switch is closed by magnetic field and actuator energised

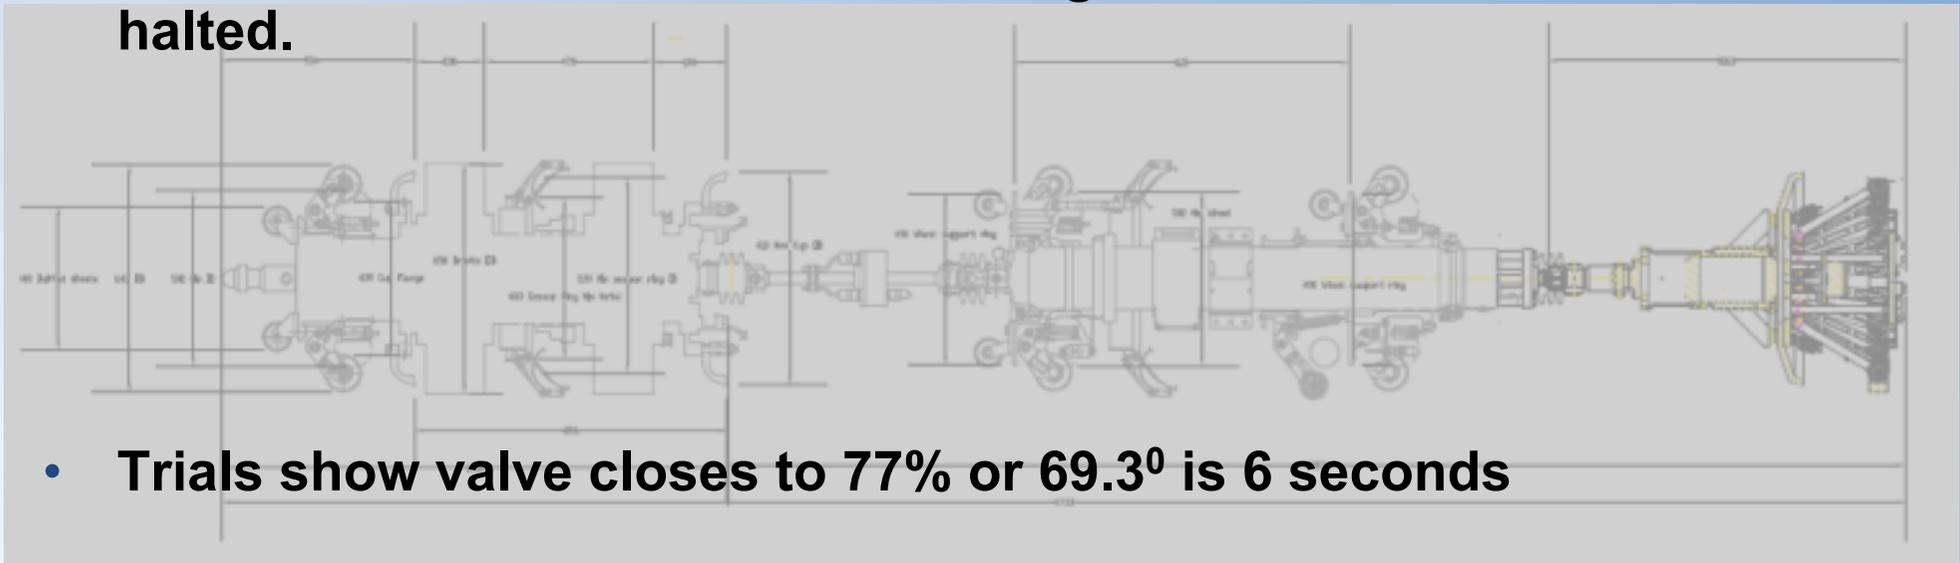
- The ILI tool had travelled 9.2 metres at a speed of 0.5 m/s
- Tool travelled about 2.5 metres though the ball valve then halted.

- Trials show valve closes to 77% or 69.3° in 6 seconds
- At 0.5 m/s tool would travel from a position where the magnets were in the valve to final position in 5 to 6 seconds
