Feeder 15

Feeder 15 Key Points

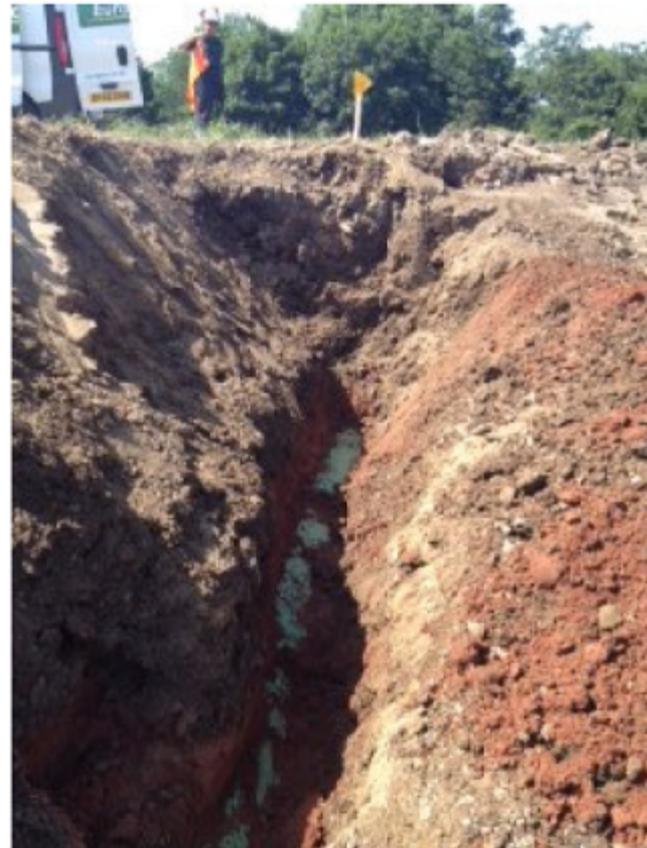
Fig 8 - Feeder 15 had not been damaged. There was 8 to 10" of red sand around the pipeline, therefore the excavator was extremely close. Note excavator bucket teeth marks in the ground directly above the pipeline

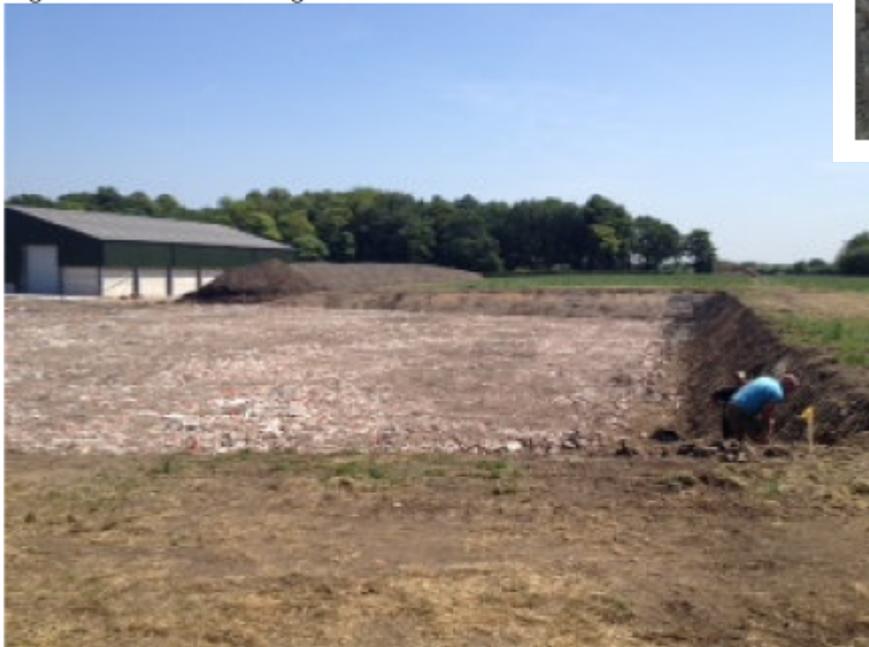
Fig 9 - Photograph of second excavation to supply water to the new building. The aerial marker post is clearly visible.
