FATIGUE ASSESSMENT OF HISTORIC WELD DEFECTS IN PIPELINES

Joe York-Fisher

MSc

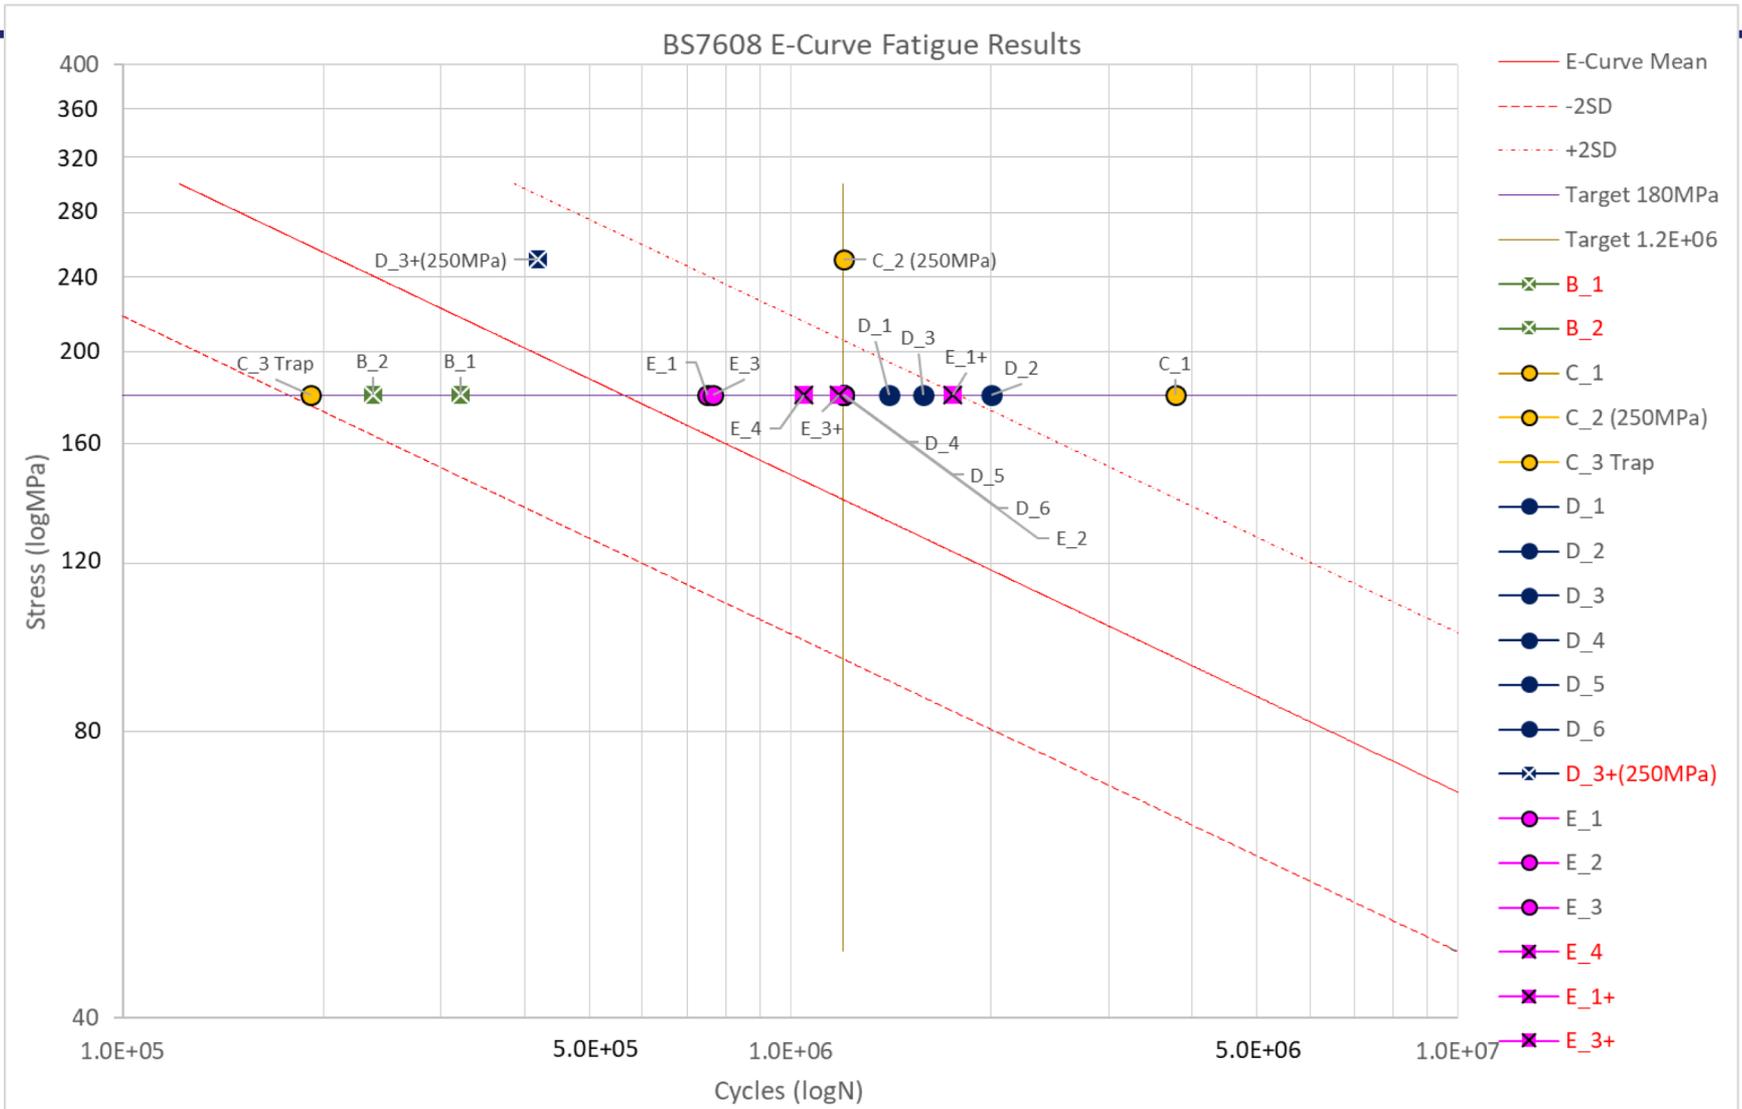
- All fatigue results above -2SD 'design' curve
- Only two results fractured below the mean curve; the order of fracture was surprising
- Main defects present in fractured specimens:
 - Misalignment
 - Lack of penetration
- Misalignment produced artificially high stress

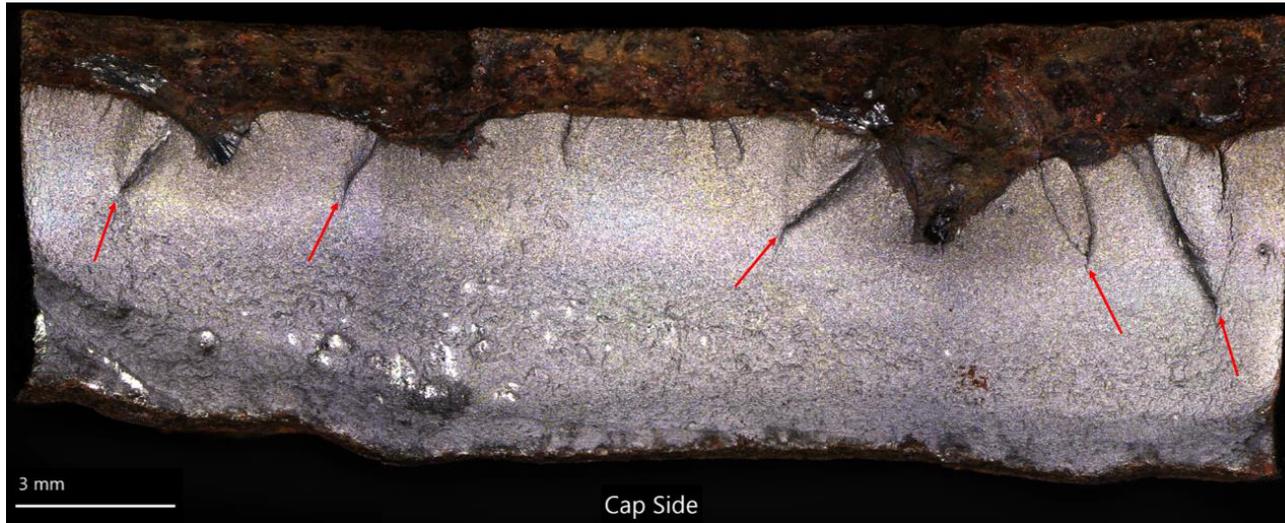
t) B_1 Fracture Ratchet-Mark Locations

- Ratchet marks indicated that none of the initiations occurred internally or artificially
- Internal defects contained expected elements
- Specimen which fractured above mean stress curve, had multiple pores on fracture surface
- The two below-mean fractures had no signs of internal defects on the crack propagation path

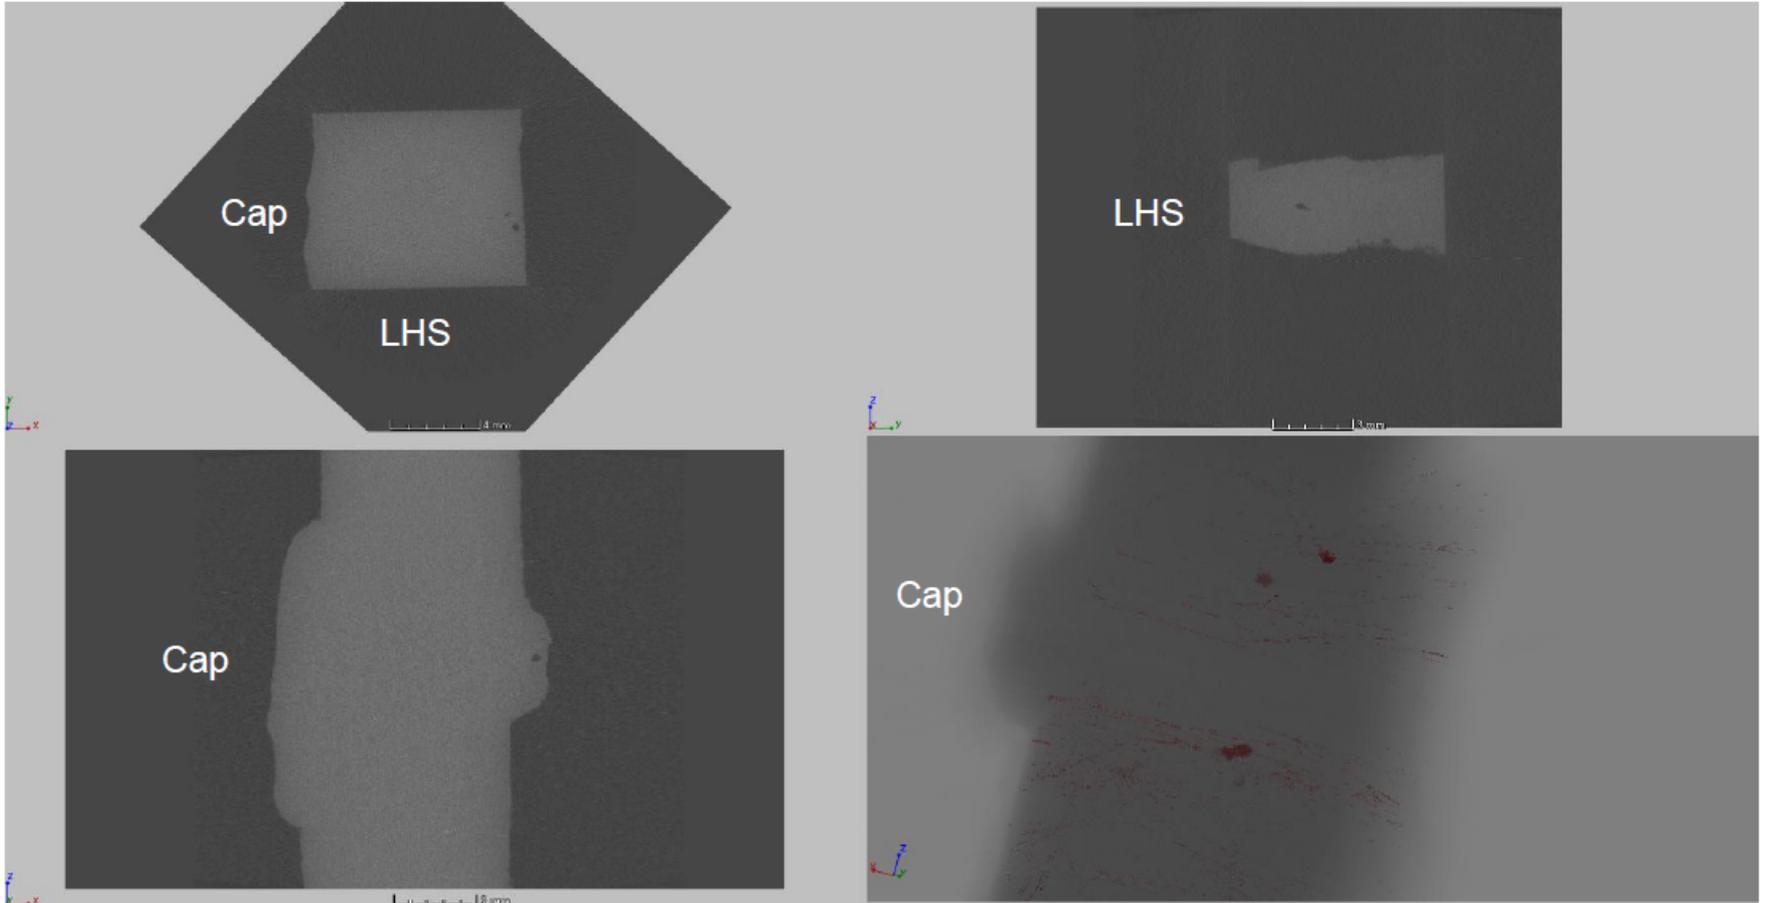
- Wormholes easily mistaken for pores

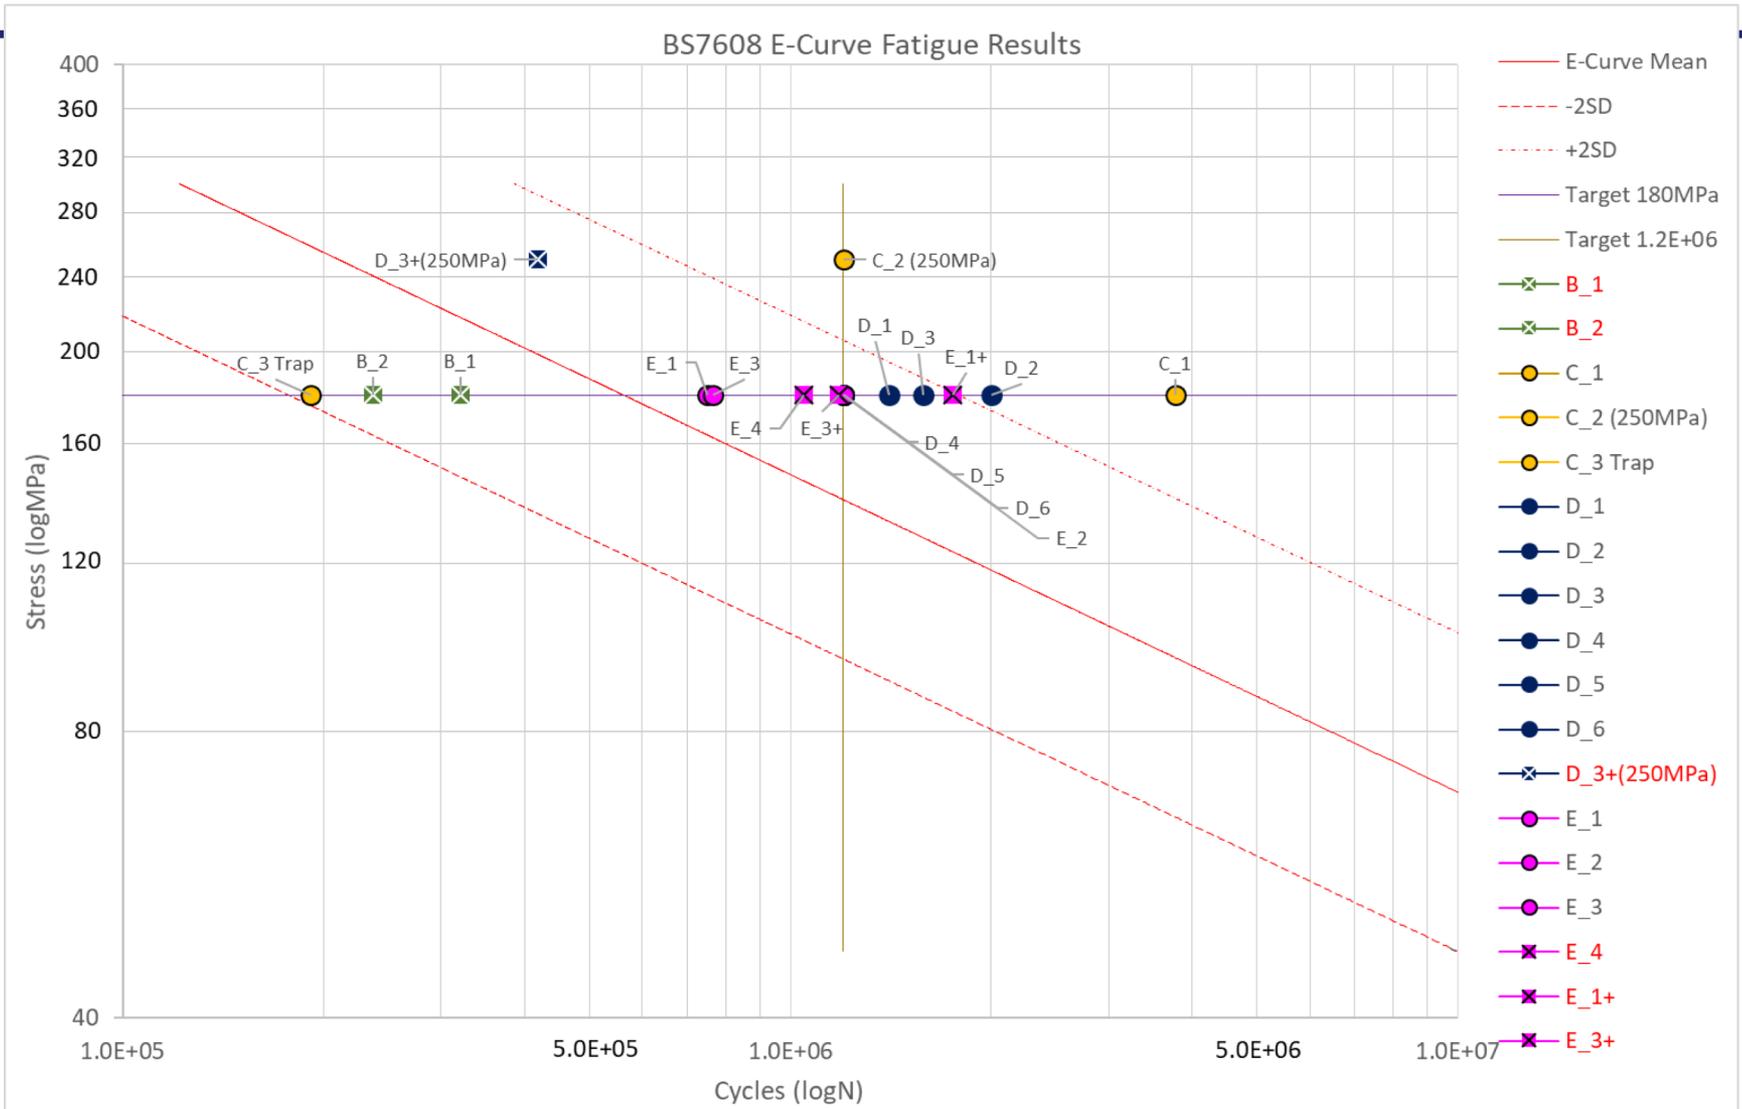
- Extra tests:
 - Two to explore milling variation
 - One to consider surge pressures
- All fractured above mean stress curve
- Surge test of approx. +40% stress, conducted on the most defected surviving specimen;
 - Surge fatigue life fractured above mean stress curve
 - Combined with previous tests puts result above +2SD
