What happened?

Findings and key learning points

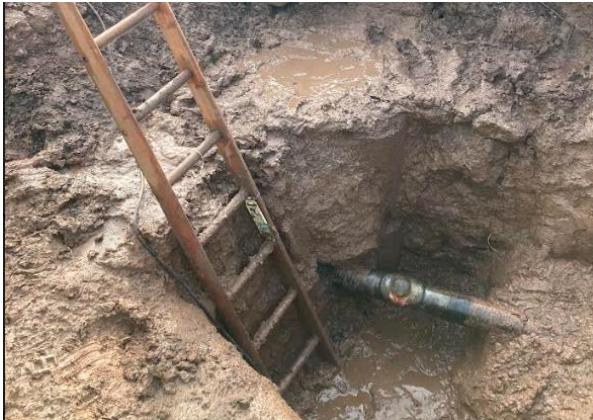
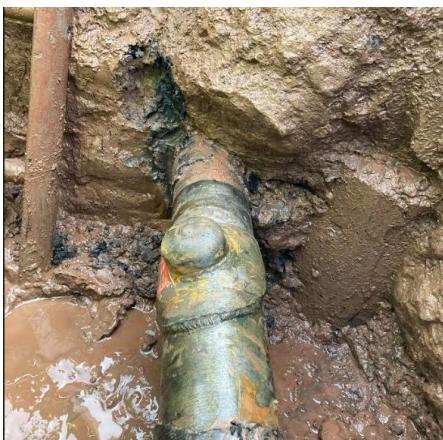
- A pipeline operator identified a leak from a 24 barg gas main
- Following excavation, a non-standard repair was uncovered
- Due to the proximity of a water main concrete valve chamber, diversion of the gas main was the only viable solution

- The operator carried out continued fitness-for-purpose reviews of their oldest gas pipelines following a leak in 2021 from a pipeline dating from 1965
- This resulted in annual leakage surveys of similar age pipelines being implemented
- As a result of a leakage survey a leak was detected in another 1967 pipeline
- On excavation, an unusual repair (see photos) was discovered. The domed cap is assumed to encapsulate a fitting. The operator had no records of the repair which is assumed to be of similar age to the pipeline
- A parallel water main runs within 3 metres of the gas main and the concrete walls of a valve chamber encase the gas main
- The water company would not give permission for the concrete to be removed to fit a repair clamp, so a diversion of the gas main was the only solution

- It is recommended that operators consider what steps may be appropriate to ensure the continued fitness-for-purpose of pipelines of similar vintage, include these in their management plan, and keep them under review
- Operators should be made aware that unrecorded non-standard repairs may have previously been carried out
