What happened?

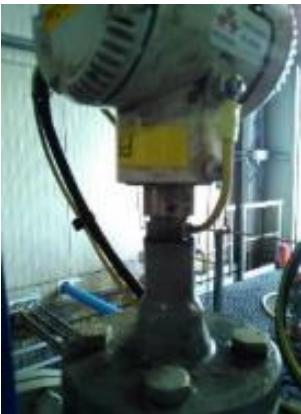
Original Installation

- The source of the leak was identified as a broken coupling located between a pipework flange and a pressure indicator (see upper photos)
- Prolonged vibrations from the pump had caused fatigue failure of the coupling
- The directly mounted pressure indicator was replaced with a capillary type of indicator. The flexible tube between the instrument and the connection point prevents transmission of vibrations (see lower photos)

- It is recommended that operators check for installations where transmission of vibration could lead to a fatigue failure and, where identified, re-design the installation
- Consideration should be given to using capillary connections for pressure indicators rather than fixed connections where vibration is present
