What happened?

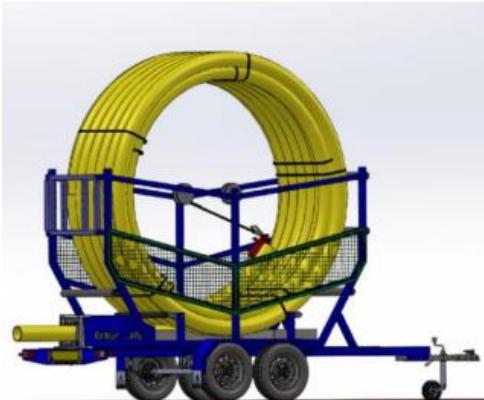
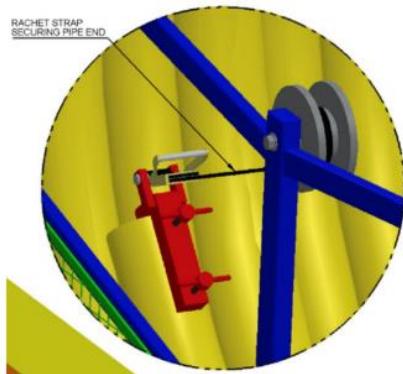
- 180 mm diameter coiled polyethylene pipe was being fed through a pre-drilled bore
- As the dispensing operation was nearing completion, the final section of pipe (tail-end) sprung from the coil pipe trailer. The stored energy was sufficient to strike and fatally injure an operative
- There is a known risk that coiled pipe greater than 125 mm in diameter has sufficient energy to cause a fatality
- Mitigations to minimise this risk are to secure the pipe to the trailer (lower photo) and to set up an exclusion zone
- Other Improvements identified are the fitting of an energy dissipation device and fitting sufficient guarding to coil pipe trailers

- Operators should be aware of the risks caused by stored energy in coiled pipe and ensure that Risk Assessment / Method Statement is appropriate and adhered to
