What happened?

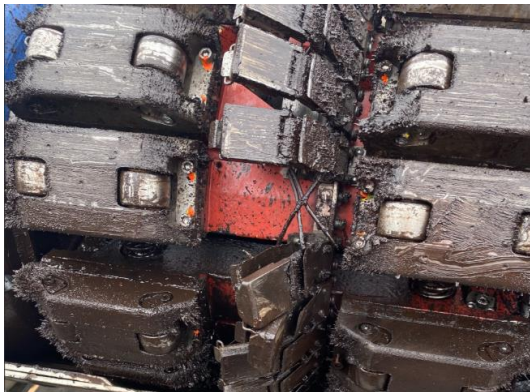
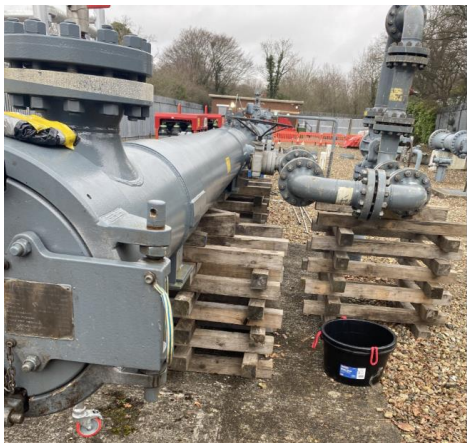
- An In-line Inspection (ILI) tool was damaged during the launch procedure
- Differential pressure across the ILI tool built up causing the tool to move backwards

- A Magnetic Flux Leakage (MFL) ILI tool was being used to inspect a 24" pipeline
- Three runs had already taken place (gauging and profiling)
- The ILI tool was loaded into the (temporarily fitted) pig trap but the pig trap door was not immediately closed (contrary to the Non-Routine Operation (NRO) instructions)

- Pressure built-up in front of the ILI tool due to an up-stream 2" balance line valve passing and a vent valve being closed (contrary to NRO instructions). Differential pressure across the tool caused the ILI tool to move backwards damaging the sensors

- The passing 2" valve had been greased and operated 36 times during the whole pigging operation. Pressure gauges were not fitted to check that the valve was holding

- Non-compliance with the NRO was found to be due to inexperience of the staff carrying out the operation and inappropriate hand-over of the NRO (e.g. no site visits)

- It is recommended that experienced staff are included in a pigging operation site team
- Non-Routine Operation instructions should be reviewed on-site, appropriately handed-over and adhered to
- Critical valves should be checked to ensure that they are holding pressure
