Investigation of RMA Valves - Weld Defects

UKOPA Members Meeting

February 2023

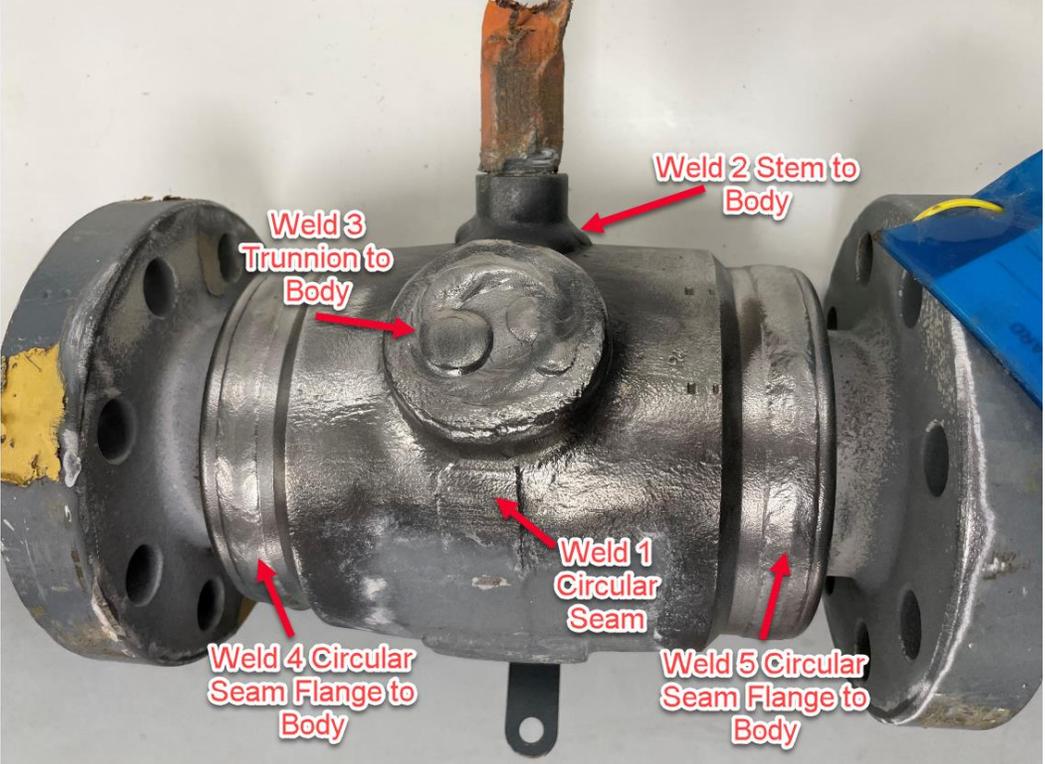
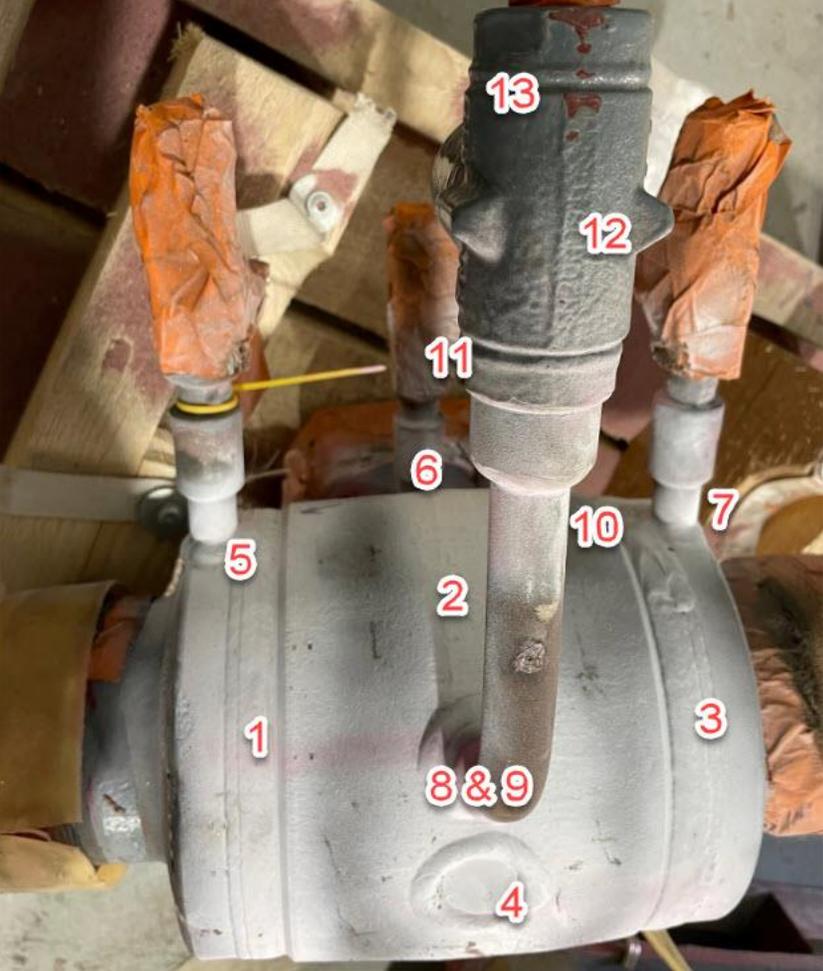
Weld Maps 2" & 4"

NDT Findings were sectioned and examined using metallographic techniques to gain information on the morphology and associated feature severity.

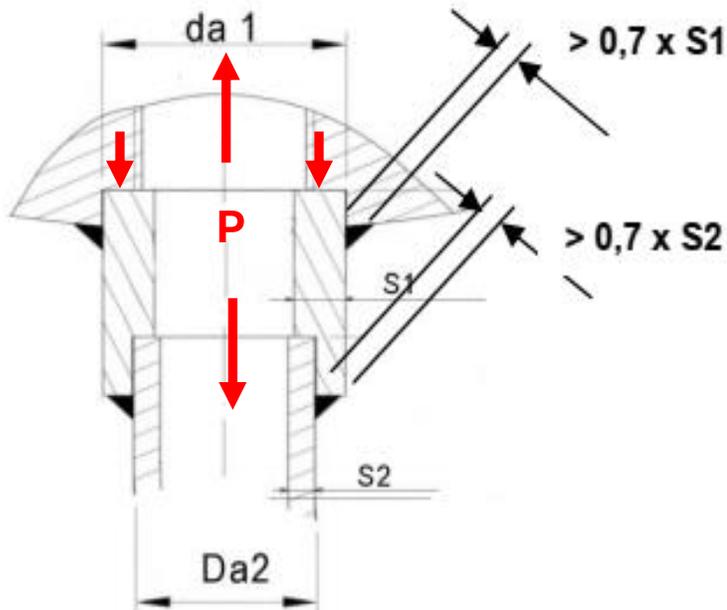
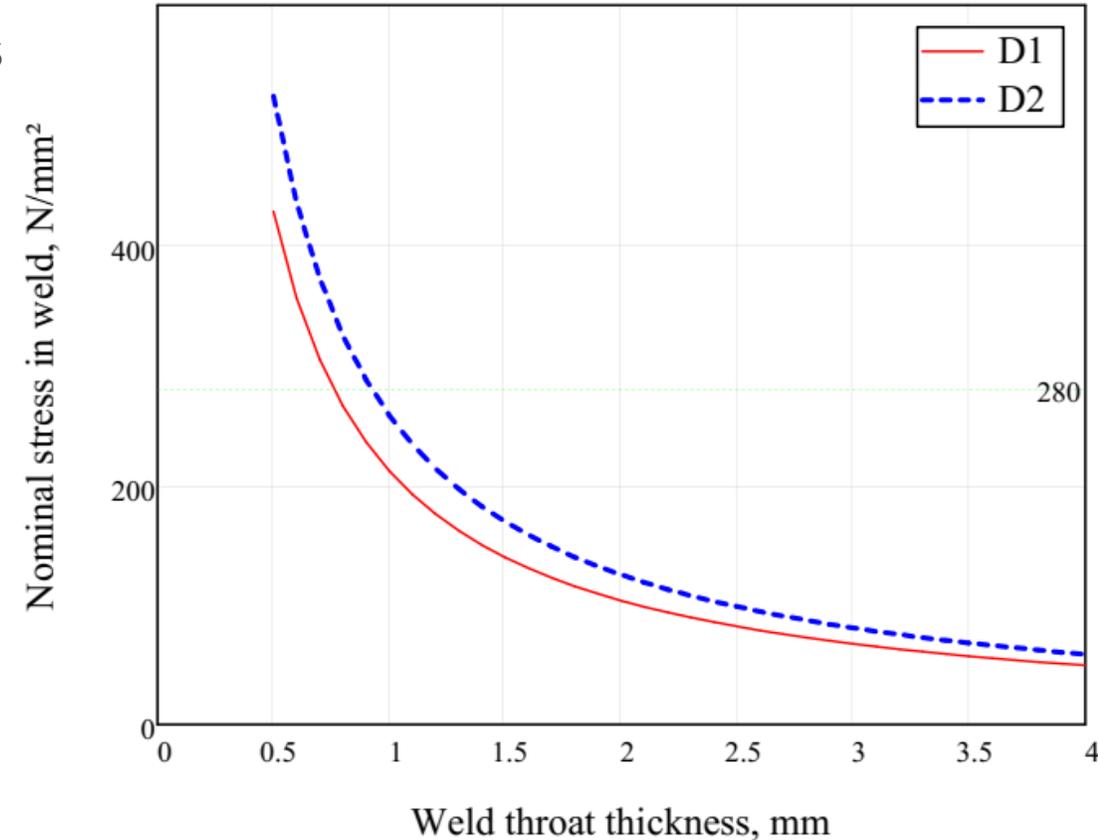
Engineering Analysis – Socket Weld Results

- Plot shows nominal stress in the weld as a function of the fillet weld throat thickness for two diameters
- At the allowable stress of 280 N/mm² the required thickness is about 1 mm
- Result is not sensitive to allowable stress or connection diameter
- Assumed that the weld throat thickness is constant around the circumference

A loss of pressure containment will not occur at the socket weld attachments even if these welds do not conform to the design dimensions or contain small imperfections

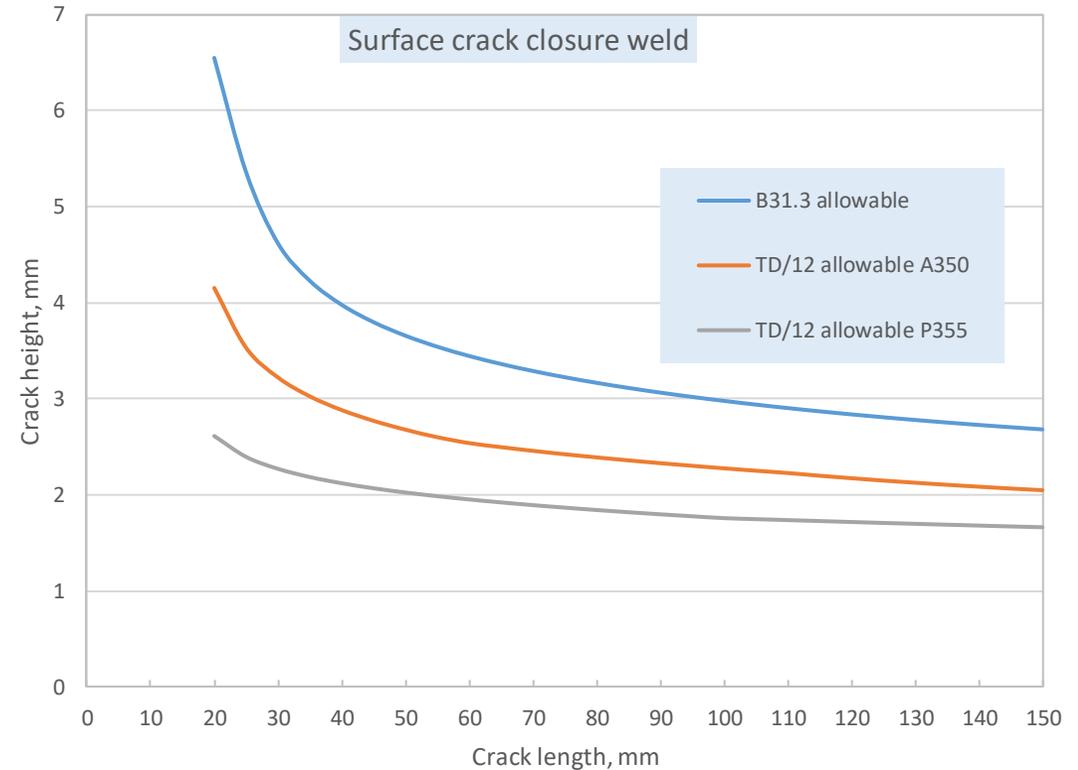
Engineering Analysis – Butt Weld Cracks Results

Results vary with the design code

- B31.3 has the lowest allowable stress, hence the largest tolerable crack sizes
- P355 materials are not listed in B31.3 but allowable stress would be virtually the same A350
- TD/12 allowable stress depends only on the yield strength, so results vary depending on the grade
- Smallest sizes are found for P355 due to the higher SMYS

The analyses cannot predict leakage from undetected small weld imperfections, only whether a failure of the pressure containment will occur from gross imperfections.

Leakage can only be prevented by a combination of quality control of welding, for example identifying undersize welds or stop-start defects, together with the factory pressure test.
