PSWG Update (inc. Learning Brief sharing)

Martin Cook (WWU)
PSWG Chair

Learning Briefs

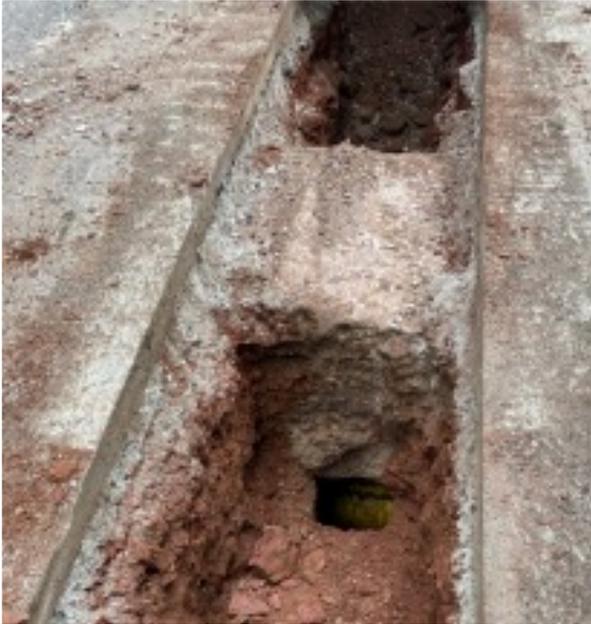
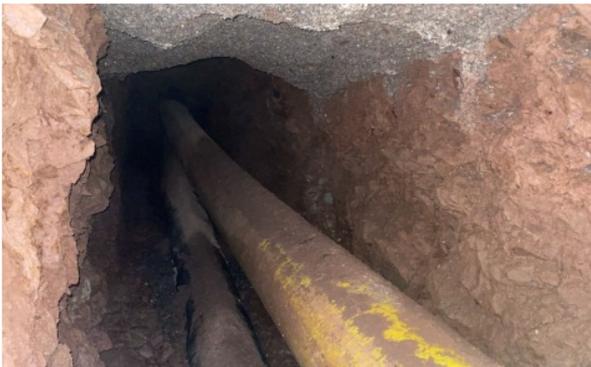
- A routine excavation was carried out to uncover a gas transmission pipeline in a road crossing.
- Following removal of the top cover a key-hole was opened and this revealed the pipeline to be within a void. The void was immediately filled with pea gravel to prevent trench collapse.
- Further investigation revealed the void to be approximately 7.5 x 1.0 x 0.8 m. Prior to reinstatement the void was filled with a lean cement/aggregate mix.
- A gas distribution pipeline was also found within the trench – this was unexpected as the records indicated this pipeline to be 3 metres away.

- The pipelines were originally surrounded by sand. This is not good practice.
- The transmission pipeline runs in a straight line down a hill for 800 metres prior to the road crossing. Drainage issues are evident in the fields. It is assumed that the pipeline trench has acted as a land drain resulting in the sand at the road crossing being washed-out.
- The operator is carrying out further investigation with Ground Penetrating Radar and selective digs to identify any further voids and determine where the washed-out sand has gone.
- An In-Line Inspection is planned to check for any damage to the pipeline.

- Operators are advised to identify any pipelines laid in such a way that the trench could act as a land drain and be aware of the possibility of sand washout.
- Operators should be aware that pipelines may not be laid exactly where records indicate.

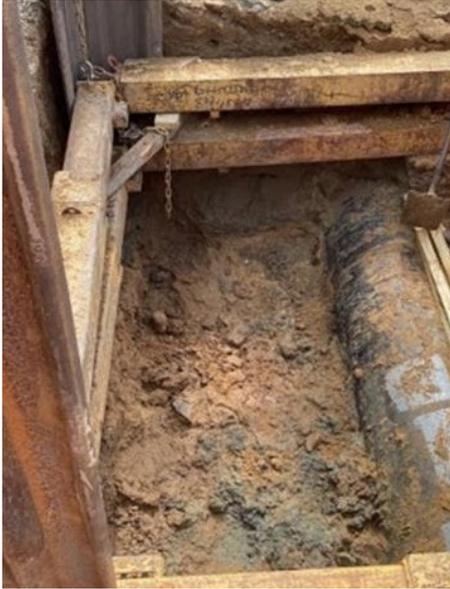
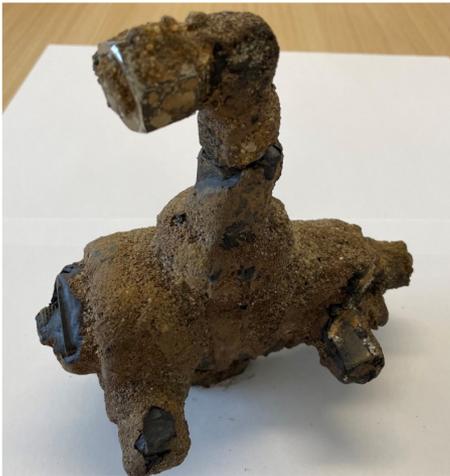
- A high-pressure gas transmission pipeline was being excavated. The restricted nature of the excavation required the use of sheet piles and hydraulic trench supports (top photo)
- Whilst re-positioning a support, it dropped in an uncontrolled manner and made contact with the very edge of a buried ½" screwed valve assembly (bottom photo) which was attached to the pipeline behind the trench support
- The impact partially tore the screwed nipple attaching the valve to the pipeline, causing a leak sufficient to blow out a considerable quantity of material in the vicinity of the valve

- As-built drawings (50+ years old) had been checked and the valve was shown. However, it was not located as indicated. The edge of the valve was much closer to the trench support than thought and was thus in 'the line-of-fire' of the dropped support
- The ½" assembly was attached to the pipeline with a screwed fitting. This legacy practice is no longer used. Current practice is that branches should be a minimum of 2" diameter and fully welded
- The contractor was not experienced in this type of work. The Method Statement was inadequate and not followed. The Risk Assessment did not consider the vulnerability of the small-bore assembly

- Operators are advised to be aware that buried pipelines may have vulnerable small-bore fittings attached to them and that records may not be accurate
- Contractors and Operators should take consider such fittings when preparing Method Statements and Risk Assessments

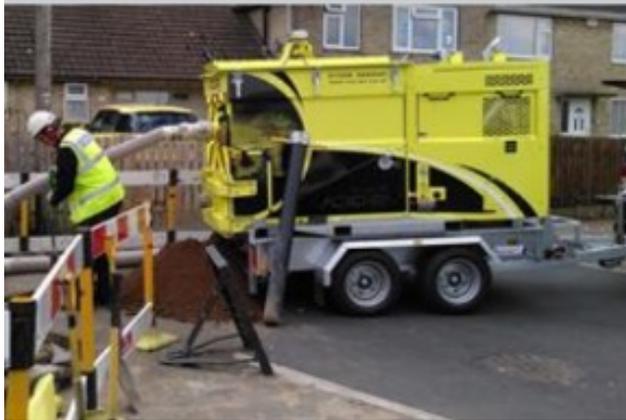
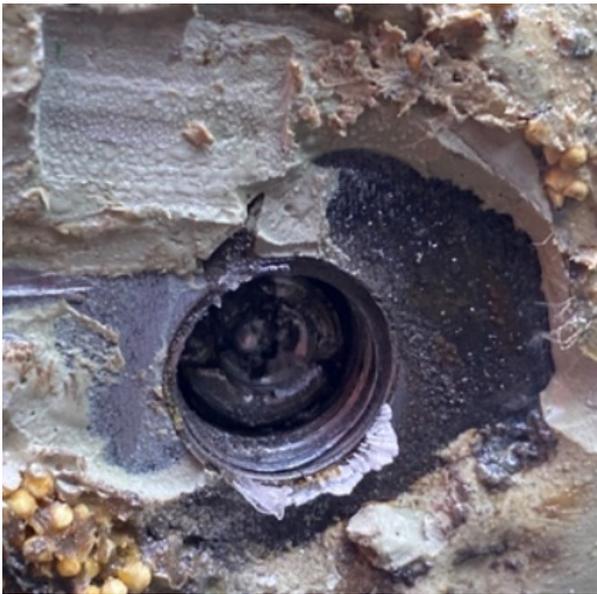
GAS LEAK DUE TO VALVE BEING DISLODGED BY VACUUM EXCAVATOR

- Excavation was taking place to allow the cutting and capping of a disused supply take-off from a buried gas pipeline requiring the construction valve to be excavated and used to isolate the connection
- The excavated material was being removed with a vacuum excavator truck
- The metal suction tube (see photo) on the vacuum excavator was being used to break up the soil
- A 1" sealant injection valve attached to the construction valve was sheared off resulting in a gas leak

- It is suspected that the small-bore valve was dislodged by the vacuum excavator suction tube
- Despite extensive searches including of the contents of the truck, the valve was not found
- The sealant valve was supplied with the line valve but had not been used as the construction valve was cocooned once the original installation had been completed
- The sealant valve was screwed into the body of the main valve
- The potential for the vacuum excavator to dislodge small bore attachments was not anticipated

- Operators and contractors are to be made aware of the potential damage that can be caused by vacuum excavators and recommend only using vacuum excavators to remove (rather than dislodge and remove) spoil when excavating

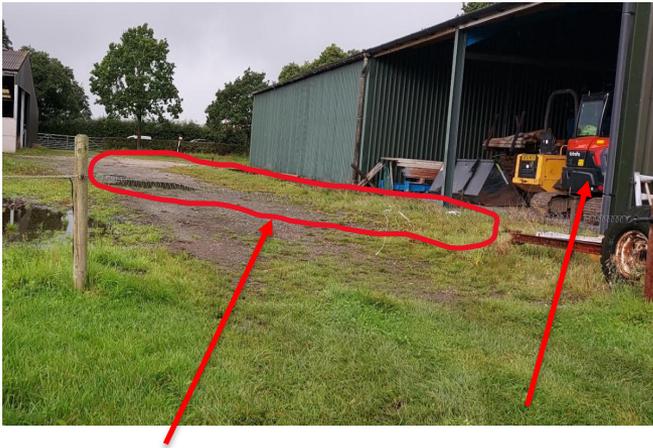
Electric wire gate

Plastic handle

- An operators survey team was working on farm-land.
- The presence of electric fences on the land (lower photo) was recognized.
- An electric coiled wire (acting as a gate) was in place across the farm-yard entrance. A plastic handle was in place to allow the 'gate' to be opened.
- When an operative touched the plastic handle, he received a near fatal electric shock and had to be taken to hospital. Recovery took several weeks during which time they were unable to work.

- On investigation, the electrical feed control to the gate was found to be defective. The energy delivered during the high voltage pulse was far more than the safe maximum of 20 joules. Death occurs at 200 joules.
- Despite pursuing with regulatory authorities, there was no easy way to take action against the farmer.

- Operators should assume that all electric fences are unsafe.
- Operatives should wear suitable dry gloves to protect against a high voltage pulse and ensure that all arms/hands/legs are covered.

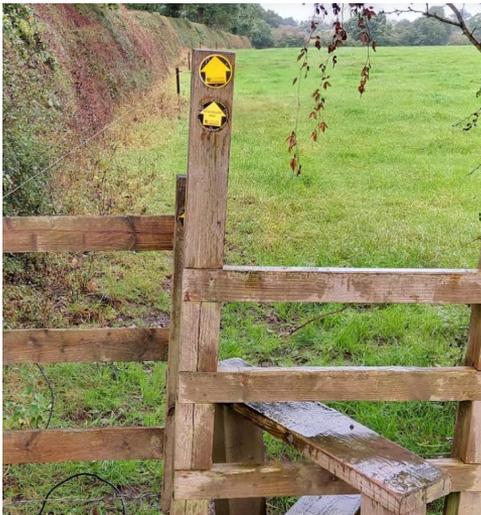
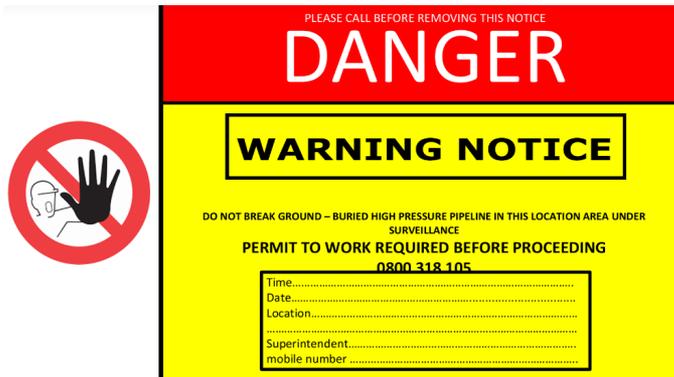
- A survey team observed an excavator within the operator's pipeline easement
- The excavation contractor had not contacted the operator, and no-one was present at the site
- The survey team left a hand-written note instructing the contractor to contact the operator

- On reviewing the incident, one outcome was to prepare a formal 'Warning Notice' form instructing contractors to contact the operator (upper picture)
- The operators' personnel now carry a supply of these forms in their vehicles
- When an un-notified excavation (or potential excavation) is observed, the 'Warning Notice' form is completed and attached to the excavator or barrier (lower photos) if no contractor is present.
- This has resulted in an increase in the number of contractors contacting the operator

- It is recommended that operators consider implementing a similar procedure
- The 'Warning Notice' template is available for other operators to use

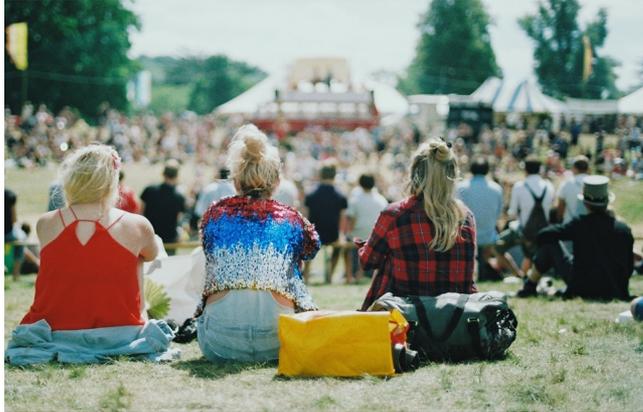
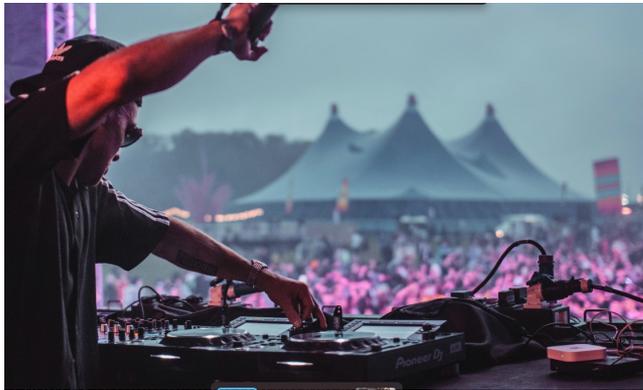
- A music festival organiser didn't consider the presence of pipelines
- The operator visited the site on a proactive basis
- Potential risks to the pipeline were from hammering in large marquee pegs and construction vehicle crossings
- The organiser cooperated with the operator to position marquees away from the pipelines and protecting the pipeline at vehicle crossing points

- Music festivals can pose a risk to pipelines
- Organisers may not be aware of pipelines or the need to check with [LineSearchbeforeUdig \(LSBUD\)](#)

- Operators are advised to check for potential music festivals in the vicinity of their pipelines and to contact the organisers to advise them of the procedures regarding protection of pipelines

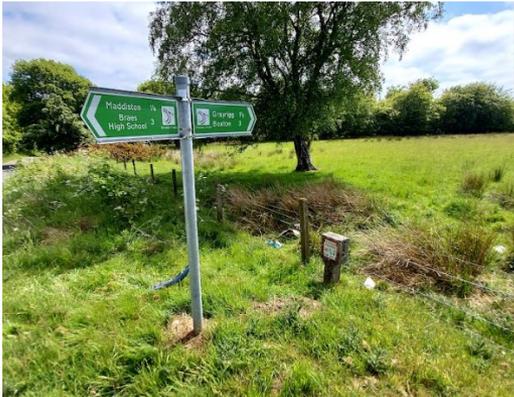
- During routine pipeline surveillance, it was noted that a signpost had been installed directly above a high-pressure ethylene pipeline.
- The sign-post installer was tracked down via the local council and found to be a local community group.
- When contacted, the community group offered no explanation other than that the ground was easiest to dig in that location. They admitted that they had seen the pipeline marker but had chosen not to contact the operator.
- The signpost was not buried sufficiently deep to contact the pipeline.

- The operator met with the community group to explain the serious nature of the incident, the potential hazard of striking a high-pressure ethylene pipeline and the correct procedure to follow in future, including the need to contact LinesearchbeforeUdig (LSBUD).
- The operator offered to relocate the signpost to a safe location.

- Operators should be aware that infringements can occur from 3rd Parties that are unlikely to be aware of LSBUD.
- Operatives should consider whether their marker posts are likely to convey the required message to those not routinely involved with buried pipelines or excavation.

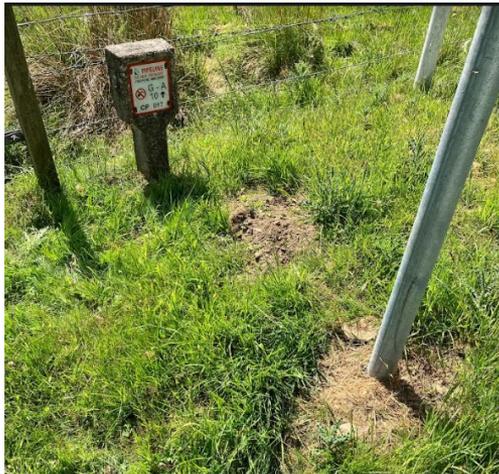
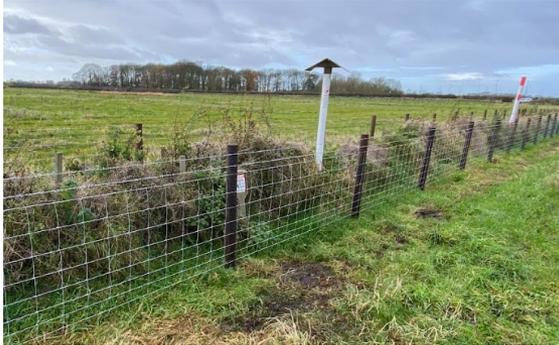
- During preparation for a CP survey, it was noted by the CP contractor that a fence had been installed directly above a high-pressure ethylene pipeline.
- The operator attended site and the fencing contractor that had erected the fence was located (working in an adjacent field). A discussion was held.
- Fortunately, the pipeline depth at this position is 2 metres – the fence posts were inserted to 0.6 metres.

- The fencing contractor (a small local company) advised that they had seen the pipeline marker but chose to ignore it because it referred to 'excavation'. They did not consider fencing work to be excavation.
- The land-owner was unaware of pipeline protocols.
- The operator explained to the contractor and the land-owner the serious nature of the incident, the potential hazard of striking a high-pressure ethylene pipeline and the correct procedure to follow in future, including the need to contact LinesearchbeforeUdig (LSBUD).
- Both the contractor and land-owner were receptive to the advice given.

- Operators should be aware that local small fencing contractors may not be aware of LSBUD and remain vigilant.
- Operatives should consider whether 'excavation' is the correct terminology to use on marker posts.

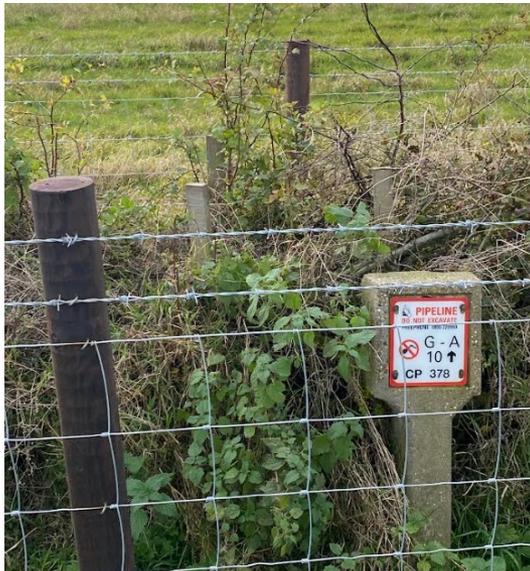
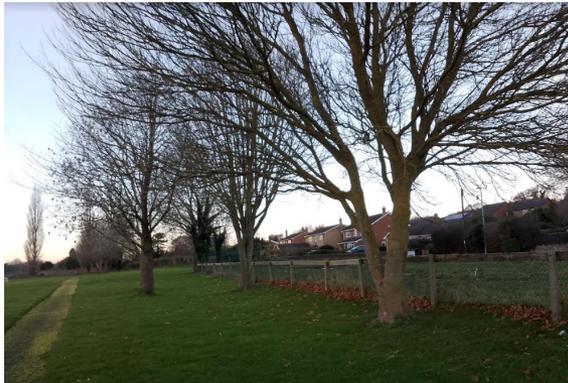
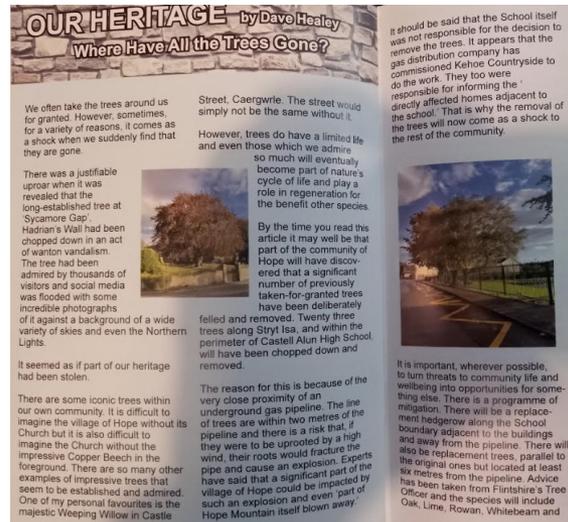
- An operator identified that 23 mature trees were close to a pipeline.
- The trees are along a school boundary within the school fence-line.
- Removal of the trees is a sensitive issue particularly with the recent 'Sycamore Gap' incident

- The operator engaged with the local community council regarding their plans to remove the trees.
- As a result of the engagement a balanced viewpoint was given in the local Parish Magazine (lower photo), setting out the reasons for removal of the trees and the action being taken by the operator to plant replacement trees.
- It is unclear why action had not been previously taken prior to the trees becoming large

- Operators should endeavour to remove trees from easements before they grow to a large size.
- Where removal of mature trees is likely to create public interest, operators should engage with local community councils prior to undertaking the work.
