PSWG Update (inc. Learning Brief sharing)

Martin Cook (WWU)
PSWG Chair

PSWG 2024 Work Plan

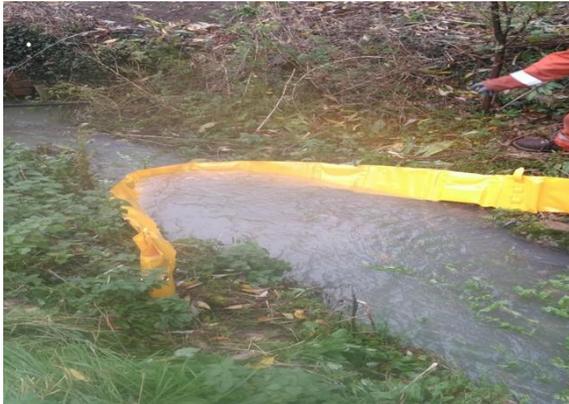
- An emergency response exercise was set up to test the response to a reported hydro-carbon leak into a water-course
- The exercise was carried out successfully and found to be very worthwhile

- A simulated call was made to the Emergency Control Centre from a 'farmer' reporting a suspected liquid hydro-carbon 'leak'
- The response team was mobilised and attended site
- The location of the 'leak' and run-off into a stream was identified and accessed
- A spill containment boom was set-up across the stream
- The team informed various simulated 'authorities' and responded to 'queries'
- The exercise provided excellent training for staff
- Specific learnings related to maps, familiarisation with access routes and providing permanent fixing points for the containment boom

- It is recommended that operators carry out exercises as a means of training staff and to identify learnings
- Liquid pipeline operators should review their spill containment equipment inventory

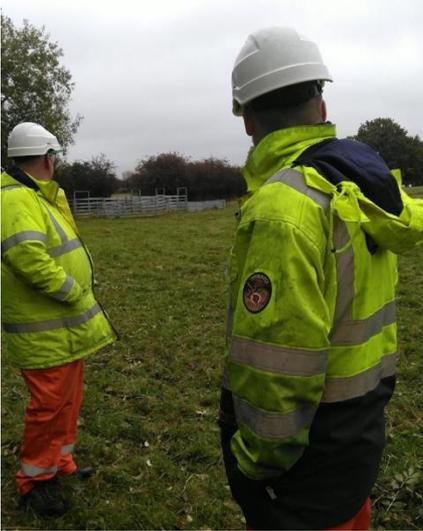
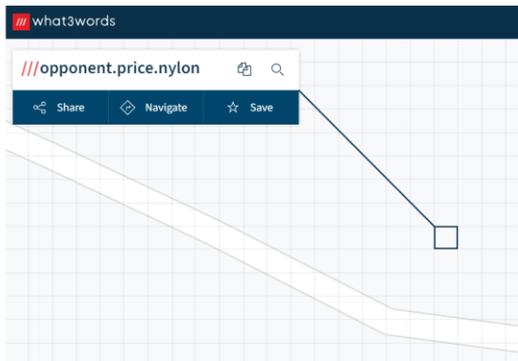
- An emergency response exercise was set up to test the response to a lone worker not responding to a colleague's phone call
- The exercise was carried out successfully and found to be very worthwhile

- The lone worker made an initial phone call to their base to give their location
- The procedure for lone working is that the lone worker then makes regular calls to a buddy to confirm there are no issues. This is referred to as a 'check' call.
- A pre-arranged 'check' call was not received by their buddy when expected
- The buddy tried to contact the lone worker several times using different mobile phones
- The buddy mobilised another worker and they proceeded to the last known location of the lone worker
- The lone worker was found safely carrying out work. They had lost track of time and hadn't heard their phone
- The use of 'what3words' to specify the location removed any ambiguity
- The main learning was to consider why the 'check' call was not responded to

- It is recommended that operators carry out lone-worker exercises to identify learnings
- Consider using 'what3words' in addition to other methods to identify a location simply and without ambiguity

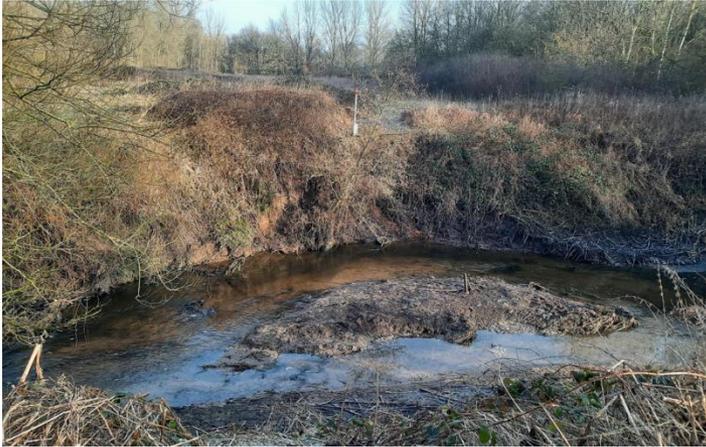
- During a routine line-walk, a section of riverbank was found to have been eroded exposing a section of underground pipeline
- Remediation works were carried out with full consultation from local agencies

- Following discovery, planning immediately commenced to remediate the issue
- Involved parties were the Local Authorities, the Environment Agency, local waterways representatives, specialist diving contractors and expert pipeline repair specialists
- The riverbank had to be rebuilt using environmentally approved materials
- The pipeline was inspected and re-supported from underneath before any backfill took place
- Remediation works were successfully completed
- The project took 9 months from initial planning to completion

- It is recommended that operators carry out routine inspections of pipeline river crossings. Publicly available LiDAR data can be used to map/monitor bank movement and spot signs of erosion
- Any remediation work will first require consultation with local government, environment and waterways agencies so that appropriate materials and methods are used

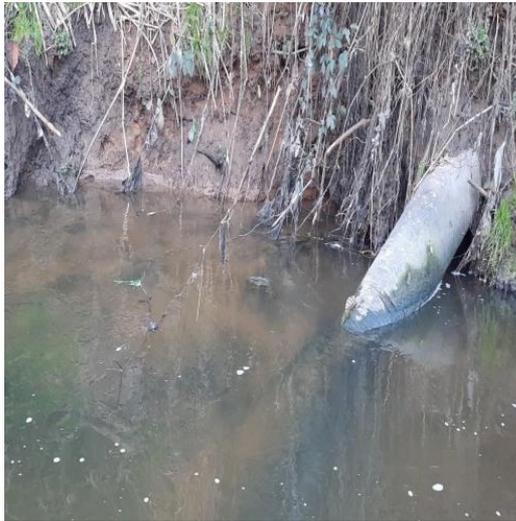
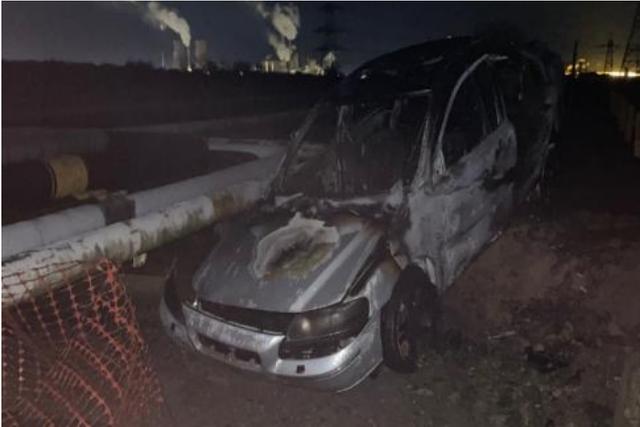
- A pipeline operator received a call from the local Fire and Rescue Service to advise that a vehicle had left the road, hit an overground pipeline and caught fire
- A PERO was dispatched and established that the pipeline involved was a water pipeline. The operator's underground pipeline, which was nearby, (purple line on the plan) was unaffected

- The pipeline operator's PERO received a call from the operator's control centre at 04:00 am
- The local Fire and Rescue Service had made contact to inform the operator that a vehicle had left the road in an area near to their pipeline, the vehicle was on fire, and that they were attending the scene
- The FR&S requested that the operator dispatch a representative to the scene
- The PERO first checked whether any leak detection alarms had been activated before travelling to the scene
- The PERO established that the operator's pipeline was unaffected

- It is recommended that operators consider the consequence of vehicles leaving a road in the vicinity of their pipelines
- Operators should make their PERO's aware of this incident

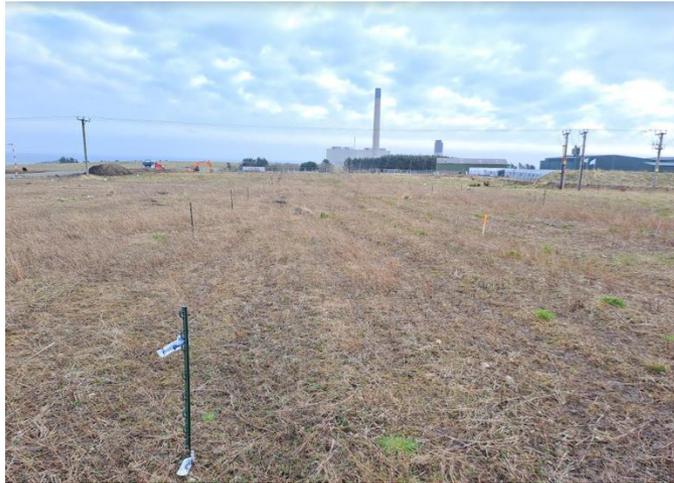
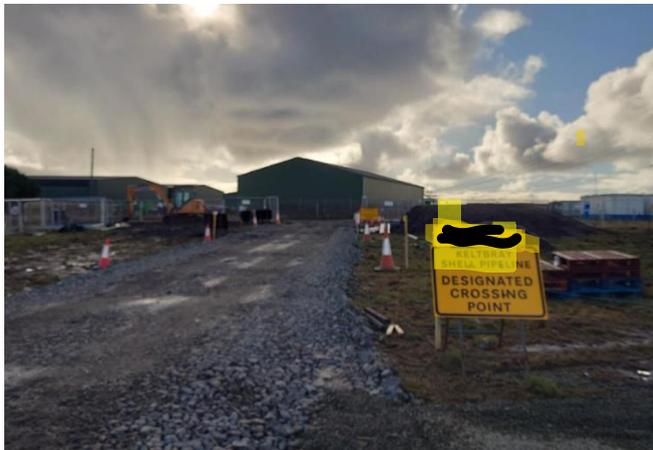
- A utility company installed a temporary road over a gas pipeline without the pipeline operator's authorisation or supervision
- The location of the pipeline was known to the utility company as were the procedures that they were required to follow

- A utility company required to install a power cable duct under several pipelines
- The utility company were in possession of all pipeline information and had prepared an approved design for the duct and both temporary and permanent road crossings. They were also aware of the pipeline operators required procedures
- However, the utility company's principal contractor proceeded to strip 250 – 300 mm of top-soil from above the pipelines without permission
- The utility company held an internal investigation resulting in several actions: removal of certain personnel, daily tool-box talks & safety meetings, tightening of the blanket no-dig zone, clearly designated crossing points

- Operators should be aware that despite contractors having all the necessary information and procedures, rules may not be adhered to
- Operators may need to consider increasing their representation at work sites

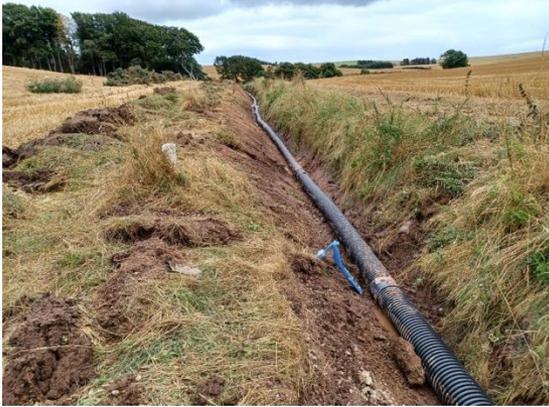
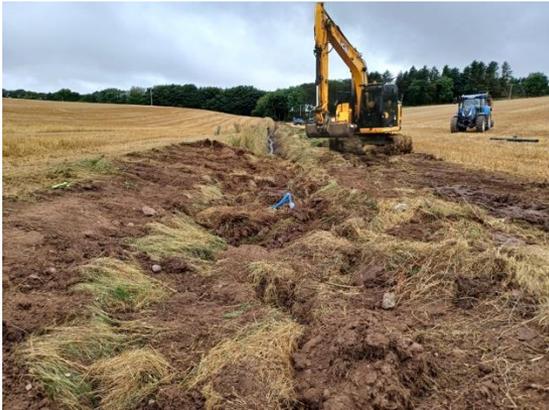
- A landowner instructed their employees to clear a ditch to allow installation of a new drain
- Excavation was carried out by mechanical excavator and crossed a high-pressure pipeline
- The pipeline was not damaged

- A landowner instructed their employees to carry out excavation works but did not advise them of the presence of the pipeline.
- The operatives noted the pipeline marker posts but did not consider the work to be significant enough to warrant contacting the pipeline operator
- The pipeline was not damaged as the excavated ditch was shallower than the pipeline depth of cover (1 m)
- The operator held discussions with the landowner, highlighting the safety consequences of pipeline damage/release of content. The operator also went through the required procedures for works within 50m of their pipeline
- A formal letter was issued to the landowner recording the event and highlighting the relevant responsibilities under PSR (Pipeline Safety Regulations)

- Operators should be aware that infringements can occur from 3rd parties who have ignored pipeline markers
- Operators should consider whether their marker posts are likely to convey the required message regarding excavation

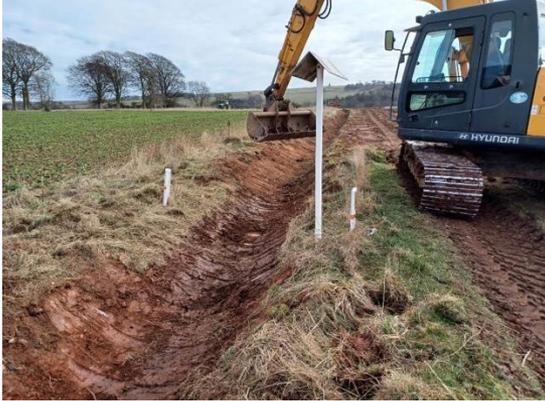
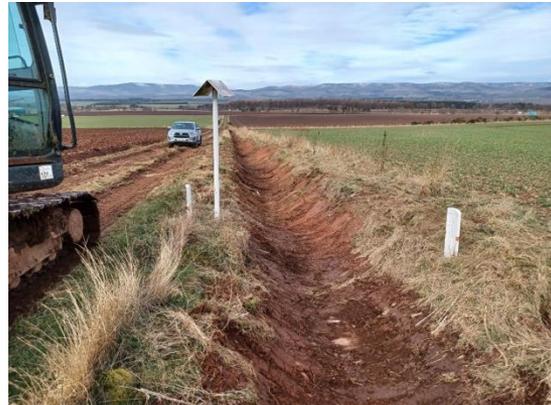
- A landowner instructed their employees to clean a ditch without notifying the pipeline operator
- The cleaning was carried out by mechanical excavator and crossed a high-pressure pipeline
- The pipeline was not damaged

- A landowner instructed their employees to carry out cleaning works via WhatsApp message
- The landowner did not advise them of the presence of the pipeline or provide any controls
- The operatives noted the pipeline marker posts but assumed the landowner had notified the pipeline operator
- The pipeline was not damaged as minimal material was removed from the base of the ditch and the concrete protection slabs were unaffected
- The operator held discussions with the landowner, highlighting the safety consequences of pipeline damage/release of content. The operator also went through the required procedures for works within 50m of their pipeline
- The operator provided additional pipeline route maps with 50m corridor highlighted. These were laminated to allow outdoor use and storage in machine cabs

- Operators should be aware that infringements can occur from operatives who have assumed that the landowner has carried out the necessary pipeline checks
