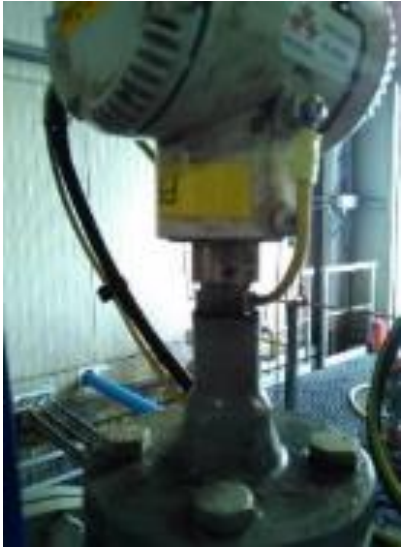
Original Installation

- The source of the leak was identified as a broken coupling located between a pipework flange and a pressure indicator (see upper photos)
- Prolonged vibrations from the pump had caused fatigue failure of the coupling
- The directly mounted pressure indicator was replaced with a capillary type of indicator. The flexible tube between the instrument and the connection point prevents transmission of vibrations (see lower photos)

- It is recommended that operators check for installations where transmission of vibration could lead to a fatigue failure and, where identified, re-design the installation
- Consideration should be given to using capillary connections for pressure indicators rather than fixed connections where vibration is present

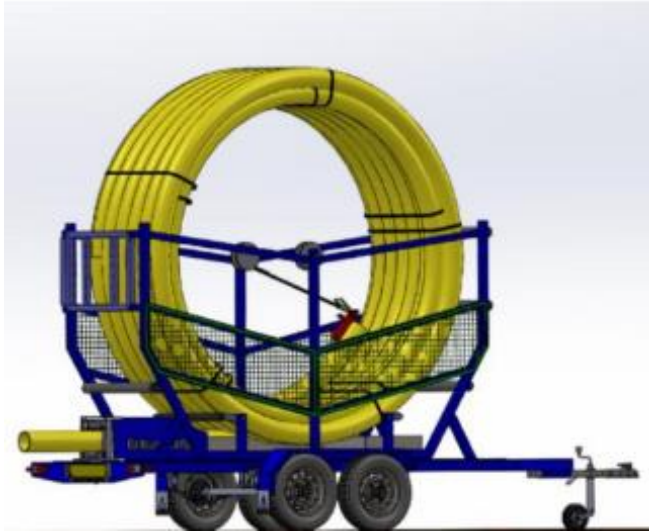
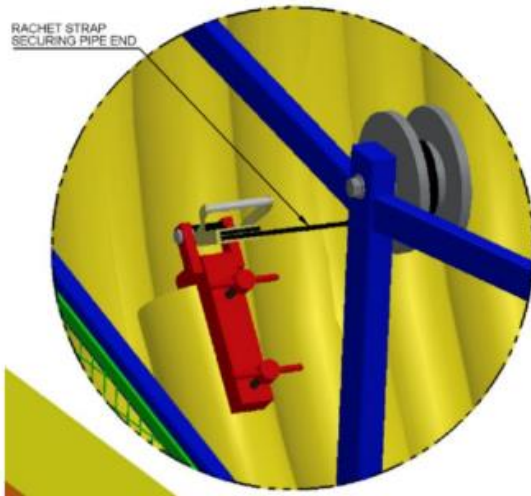
- A fatality occurred during a directional drilling and coiled pipe installation operation
- The tail end of the coiled pipe sprung from a coil pipe trailer with sufficient force to fatally injure an operative

- 180 mm diameter coiled polyethylene pipe was being fed through a pre-drilled bore
- As the dispensing operation was nearing completion, the final section of pipe (tail-end) sprung from the coil pipe trailer. The stored energy was sufficient to strike and fatally injure an operative
- There is a known risk that coiled pipe greater than 125 mm in diameter has sufficient energy to cause a fatality
- Mitigations to minimise this risk are to secure the pipe to the trailer (lower photo) and to set up an exclusion zone
- Other Improvements identified are the fitting of an energy dissipation device and fitting sufficient guarding to coil pipe trailers

- Operators should be aware of the risks caused by stored energy in coiled pipe and ensure that Risk Assessment / Method Statement is appropriate and adhered to

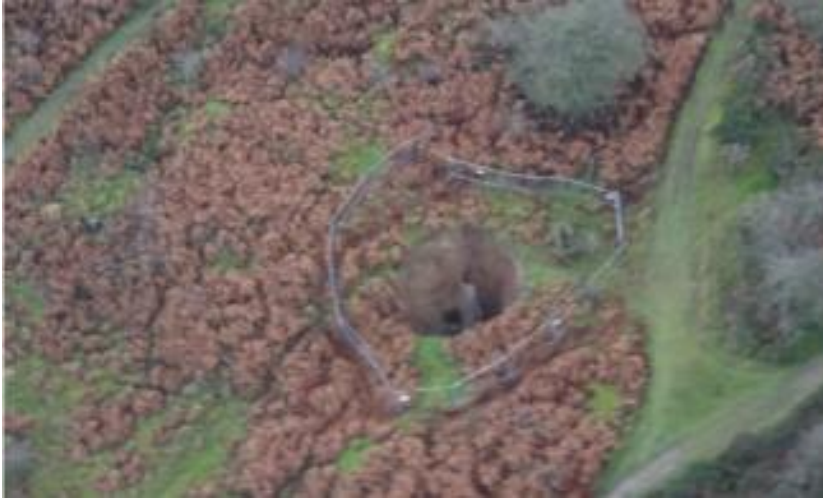
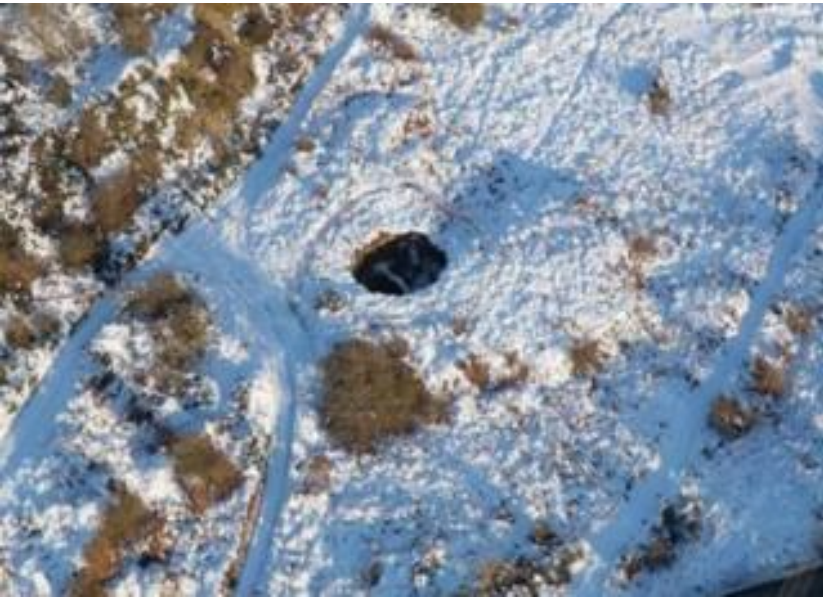
- During a weekly vantage point survey, a sinkhole was noted
- The sinkhole was formed due to an abandoned mine shaft re-opening
- An adjacent gas pipeline was unaffected

- A pipeline operative noted the appearance of a sinkhole during a routine weekly vantage point survey
- The pipeline operator carried out investigations and established that a capped disused mine shaft had collapsed and re-opened. The appropriate agencies and landowner were informed. A fence was erected around the hole.
- An aerial survey was undertaken to confirm the exact location. An adjacent gas pipeline 33 metres away was unaffected.
- The presence of the mineshaft was known when the pipeline was constructed so the route was selected accordingly
- The operator carried out a geophysical survey of the pipeline to ensure that there had been no subsidence or settlement caused by ground movement or underground water

- Operators should be aware that capped abandoned mine shafts may re-open and should consider including these on surveillance lists

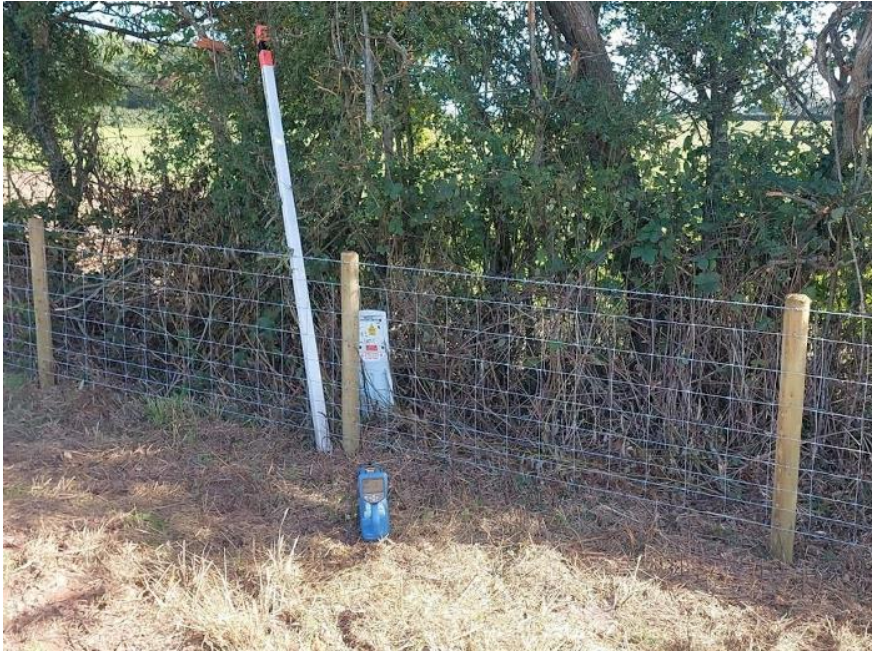
- A fencing contractor erected a fence in a pipeline easement without permission
- One post was inserted directly above the pipeline to a depth of 500 mm
- The pipeline wasn't damaged

- A pipeline operator was contacted by a landowner regarding drainage works
- On arrival at site, the operator's representative noted that a fence had been installed above the pipeline. This had not been authorised.
- The landowner had forgotten to inform the fencing contractor about the pipeline
- One post was directly above the pipeline and although the fencing contractor claimed that the posts were only driven-in to a shallow depth, it was found to be inserted to 500 mm
- The fence-post was adjacent to a pipeline marker post
- The operator explained to the contractor and the land-owner the serious nature of the incident, the potential hazard of striking a pipeline and the correct procedure to follow in future, including the need to contact LinesearchbeforeUdig (LSBUD)
- The post was removed

- Operators to reinforce the message to landowners that it is:
 - a) their responsibility to inform contractors and
 - b) that they need to contact the operator prior to any works near pipelines

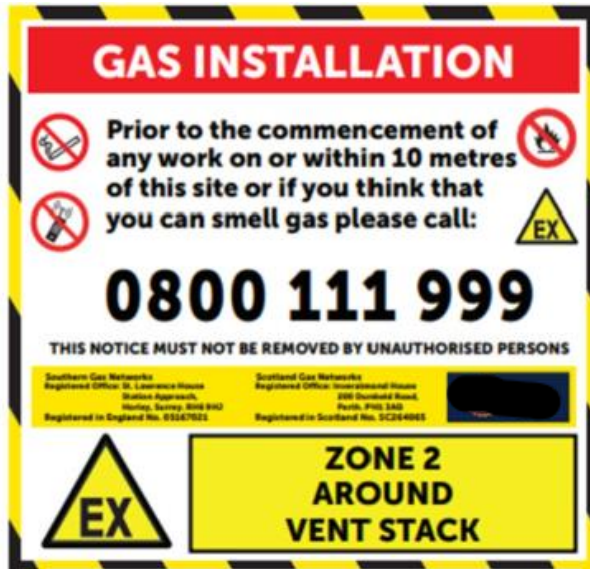
Example of warning sign

- Action has been taken to replace existing faded, worn, damaged or missing signs with improved operator standardised signs (see lower photo for an example)

- The new signs are prominently located, are highly visible, give clear instructions, use standardised symbols and colours and are made of long-lasting durable material

- Operators should review their unmanned installations and if necessary, install replacement warning signs

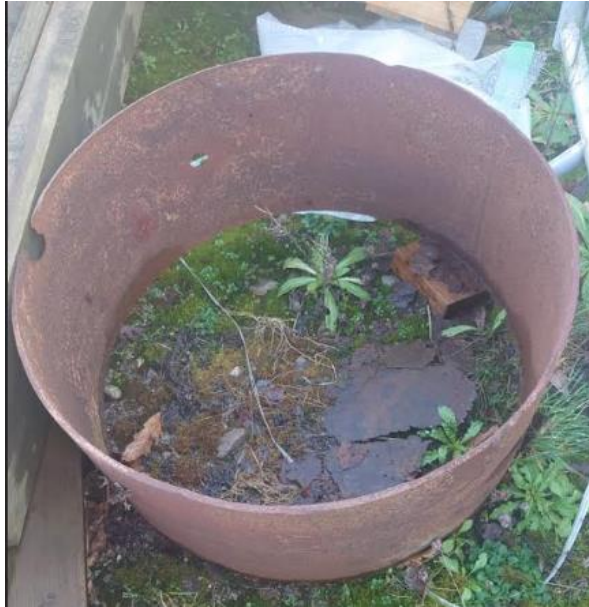
- A corrosion defect was detected in a 28" oil pipeline by In Line Inspection (ILI)
- On excavating, a section of off-cut pipe was found buried next to the pipeline adjacent to the defect
- It is unlikely that the pipe caused the corrosion, but it is an indication of poor construction practice

- A routine ILI (magnetic flux leakage) run was carried out on a 28" oil pipeline
- An external corrosion defect was detected on the side of the pipeline
- The location was excavated. An off-cut section of 28" pipe was found buried in the trench adjacent to the defect. It is assumed that the pipe was put in the trench during construction
- The coating of the pipeline was visually in good condition but upon removal, minor external corrosion was identified. The coating was removed and the defect addressed
- Although it is unlikely that the section of pipe had caused or influenced the corrosion defect, it is an indication of poor construction practice and may have caused coating damage
- It is likely that the section of pipe had affected previous MFL readings and delayed the identification of the defect. Improvements in MFL technology enabled the defect to be identified.

- Operators are to be made aware that detection of metallic objects adjacent to pipelines may be an indication of poor construction practices and should be investigated accordingly

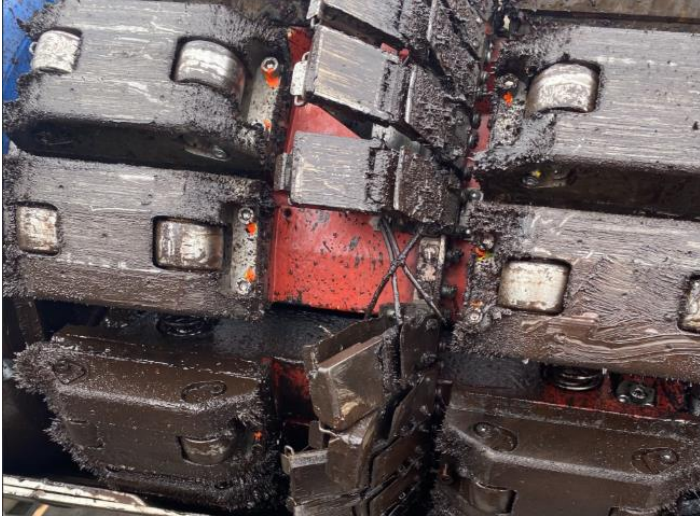
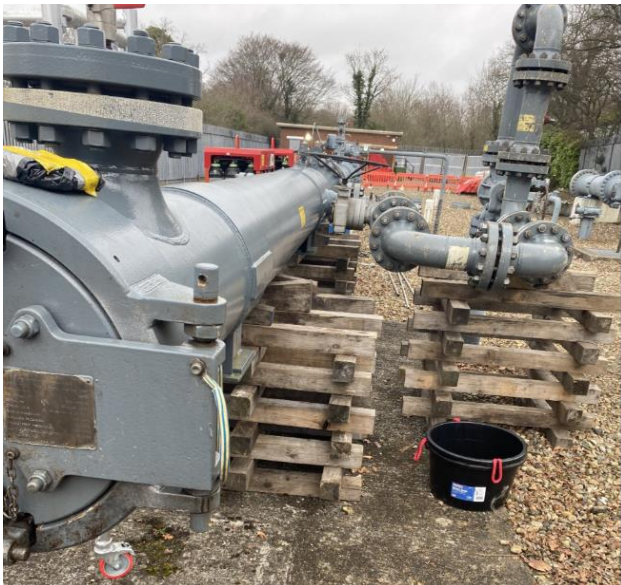
- An In-line Inspection (ILI) tool was damaged during the launch procedure
- Differential pressure across the ILI tool built up causing the tool to move backwards

- A Magnetic Flux Leakage (MFL) ILI tool was being used to inspect a 24" pipeline
- Three runs had already taken place (gauging and profiling)
- The ILI tool was loaded into the (temporarily fitted) pig trap but the pig trap door was not immediately closed (contrary to the Non-Routine Operation (NRO) instructions)

- Pressure built-up in front of the ILI tool due to an up-stream 2" balance line valve passing and a vent valve being closed (contrary to NRO instructions). Differential pressure across the tool caused the ILI tool to move backwards damaging the sensors

- The passing 2" valve had been greased and operated 36 times during the whole pigging operation. Pressure gauges were not fitted to check that the valve was holding

- Non-compliance with the NRO was found to be due to inexperience of the staff carrying out the operation and inappropriate hand-over of the NRO (e.g. no site visits)

- It is recommended that experienced staff are included in a pigging operation site team
- Non-Routine Operation instructions should be reviewed on-site, appropriately handed-over and adhered to
- Critical valves should be checked to ensure that they are holding pressure
