SHES Bulletin 173

Lighting Column Corrosion

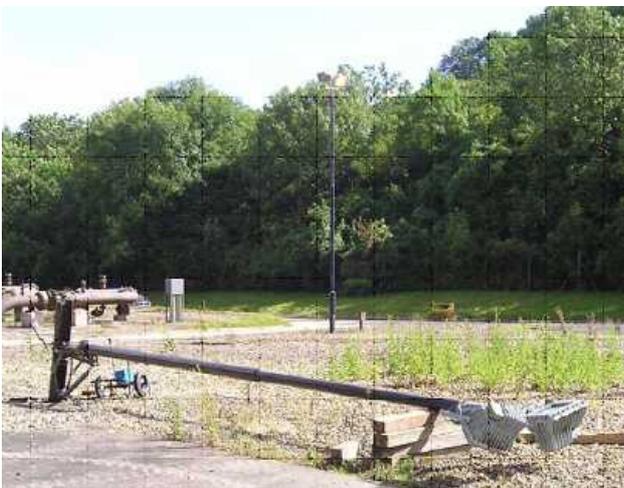
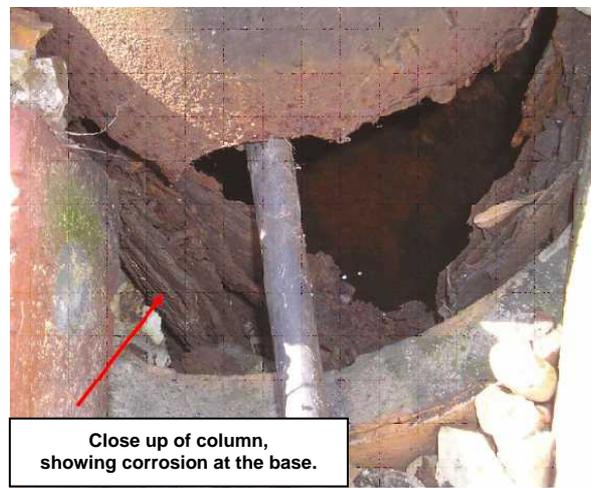
Close up of column, showing corrosion at the base.

During routine maintenance checks by Scotia Gas on the site lighting at Tatsfield AGI a lighting column collapsed whilst in the down position. On further investigation it was found that the base of the column had corroded internally. This type of column was installed some 25 -30 years ago and is not mounted on a concrete base but in a buried vertical shaft/sleeve. Water had gathered in the shaft and the post had corroded below ground level. On checking other columns on the site it was apparent that some of the other lighting columns were in a similar condition. This could have had serious safety implications had the column snapped in the process of being lowered.

The condition of lighting columns should be assessed before any work is carried out on a lighting column or before a column is lowered.

Should the condition of the column indicate that there is a risk of failure, maintenance on the lighting column should be postponed until either the necessary remedial work has been completed or a detailed survey has confirmed that the column is safe.

Even if there are no obvious signs that corrosion has taken place, increased care should be taken when lowering lighting columns as any internal corrosion may be difficult to detect when the column is upright. After the lowering jack has been attached, care should be taken to stand away from the direction in which the column is being lowered. Once the lighting column has been lowered re-inspect the column.
