Incident Investigation Summary

Responsible Managers I. Sarson / A. Jackson
Incident Reference No: Compass 22271/08/NG
Person Responsible for National Implementation: Paul Williams

South West Reinforcement Project - Gas leak following Pipeline Commissioning

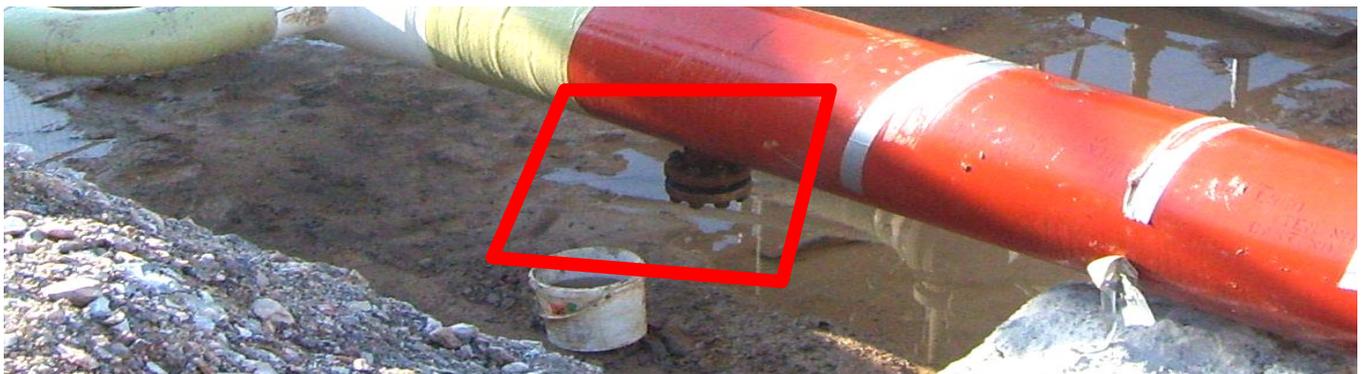
A gas leak was detected from a 50mm NB hydrostatic test drain point on new pipe work. The pressurised pipe had to be isolated and depressurised under an emergency Non Routine Operation Procedure to repair the leak. The drain point consisted of a weldo-flange fitting attached to the underside of the main carrier pipe and a bolted blank flange that had been re-sealed following the hydrostatic test and pipe drying operations.

- The blank flange attached to the drain point had not been tightened sufficiently to contain gas at pressures above 0.5 barg.
- The project Inspection & Test plan and Hydrostatic test method statement did not clearly designate specific responsibility to ensure that all joints re-made after the hydrostatic test and drying operations were of the correct tightness.

1. A tagging and check list system, to ensure all re-made joints are inspected and signed off as acceptable prior to commissioning with gas.
2. The preparation and tightening of such joints shall be witnessed by a Pipeline Inspector to confirm that the correct bolt tensioning torque setting has been applied and a new gasket/ ring has been installed.
3. Ensure the bolting procedure for low alloy steel stud bolts is specified in T/SP/E/55 is followed. Bolted joints should be prepared and tightened to the recommended sequence and torque settings given in Section C.
4. Work Method statements must clearly identify and define individual role responsibilities to ensure that all flanges that are broken or re-made following the hydrostatic test and pipe drying operations are tightened correctly as per T/SP/E/55.
