SAFETY Alert ;
- Pipeline damage during water jetting

Country: *Norway*

Date: *6 October 2008*

Type of activity: *Water jetting – approx. 1000 bar and 180 l/min*

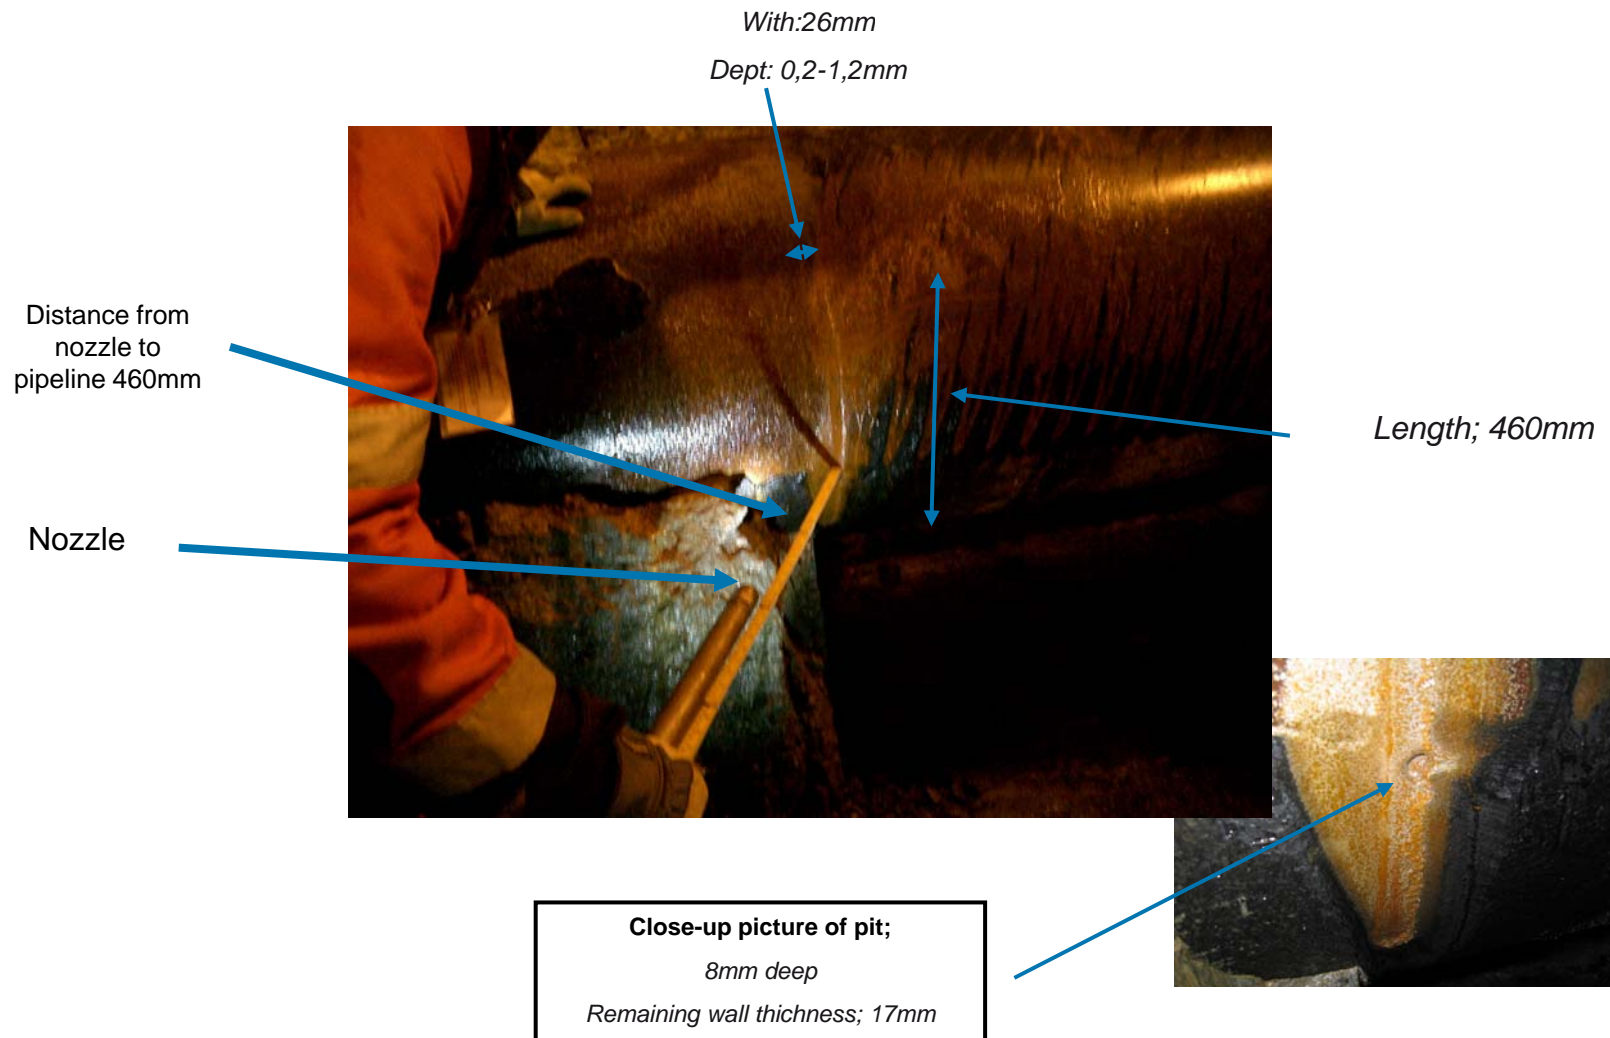
Type of damage: *Damage to pipeline*

- During removal of asphalt coating on a 30" gas pipeline, a water jetting method was used.
- During this operation the jetting equipment failed – resulting in the jet moving repeatedly along the same line for a duration of approximately 10-15 minutes.
- The distance from the jet nozzle to the pipeline was approximately 46 cm
- The operation caused a mark as seen from the picture:
 - Length ; 460mm
 - Width; 15mm up to 26mm
 - Depth; 0,2mm to 1,2mm at the ends
- The nozzle then got stuck in one position for approx. another 10-15 minutes and made a pit of 8mm dept - remaining pipeline wall thickness; 17mm
- The incident did not impact pipeline integrity.
- The incident is currently investigated by StatoilHydro and Gassco
