## U.K.O.P.A SAFETY ALERT

Shell North West Ethylene pipeline at Rainford Golf Course.

## UKOPA/SA/09/0024

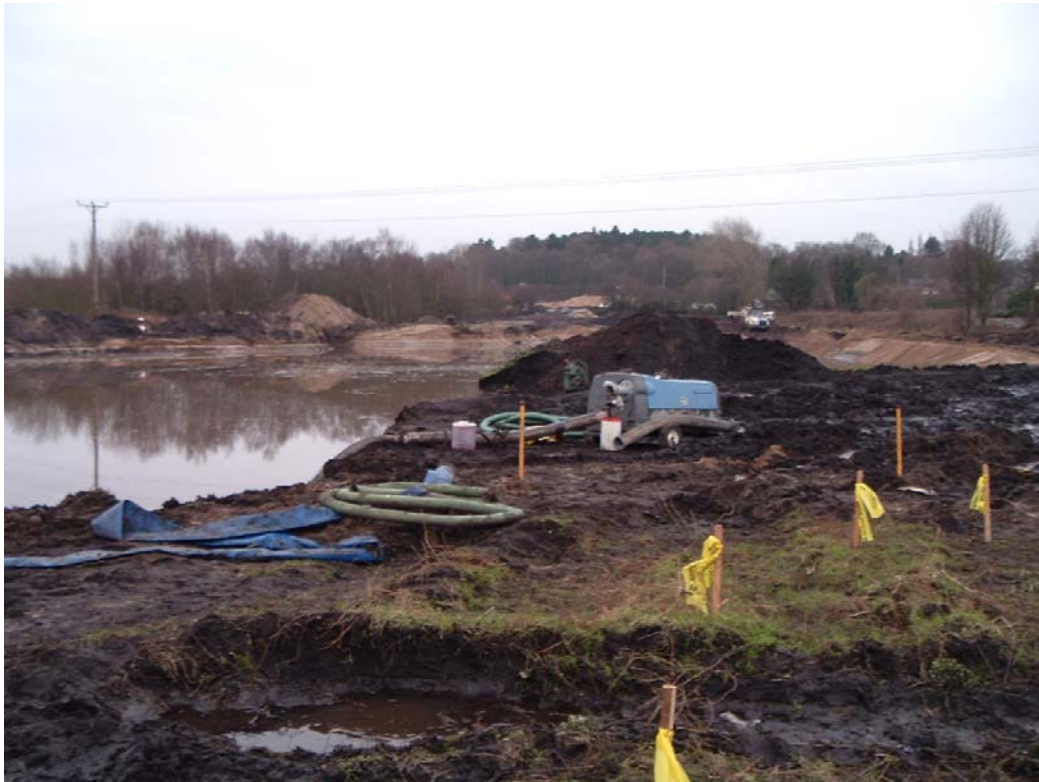
Construction of a new golf course at Rainford was a known activity and subject to regular surveillance by road patrol and by air as part of the risk management process. On 8<sup>th</sup> December, 2008 it was discovered that an excavation for a pond had extended to within 6.0 metres from the Shell pipeline. (The original construction plans submitted as part of the Planning application indicated the pond to be 60 m from the Shell pipeline).

The position of the Shell ethylene pipeline was clearly marked by pegs in the ground.

The pipeline is 4.5m deep at this location as it crosses under Rainford brook and below the depth of the pond excavation.

Material had been removed from the pipeline easement.

The excavation had also breached Rainford brook, a natural waterway. This was not indicated on any construction plans.

Excavation was stopped at the request of Shell and the bank stabilised. The contravention was raised with the site subcontractor and the site developer. Initial communication was hampered by the fact the excavator driver was Polish and had limited understanding of English.

1. Rainford Golf course developer agreed to protection measures (physical barrier) to be put in place to prevent further risk to the pipeline at this location.

2. Ensure that all site workers understand the exact location and dangers involved when working in proximity of a high pressure gas pipeline.
3. St Helens planning department contacted to ensure if the drawing issued to Shell was the latest revision of the Planning Application and to ensure Shell are issued with any agreed changes to plans after planning permission has been granted.

4. The Environment Agency was contacted to inspect the stability of the bank at Rainford Brook.
5. Surveillance coordination was reviewed between the aerial and road patrols to ensure that for significant developments of this nature there is a common understanding of the work that is planned to take place.
