SHES Bulletin 203

Elster / Instromet (formerly NFC) High Pressure Slam Shut re set shaft bush failure.

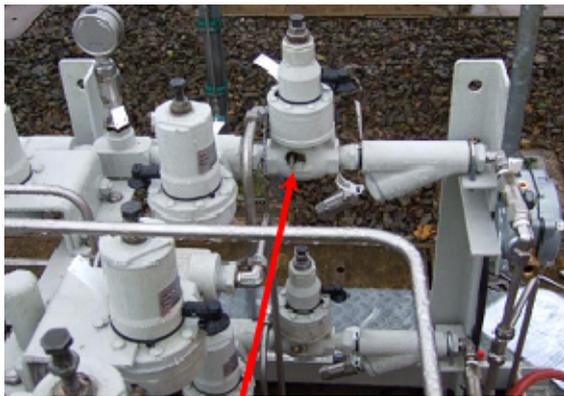
During pressurisation of a recently refurbished flow control valve control system pressure reduction skid, the brass bush / seal on the re set latch shaft failed causing the failed part to blow out. This resulted in a potential for injury and a small release of gas, see photo below.

An incident investigation involving the OEM is underway, until the outcome of that is known care should be taken to avoid over tightening of this arrangement.

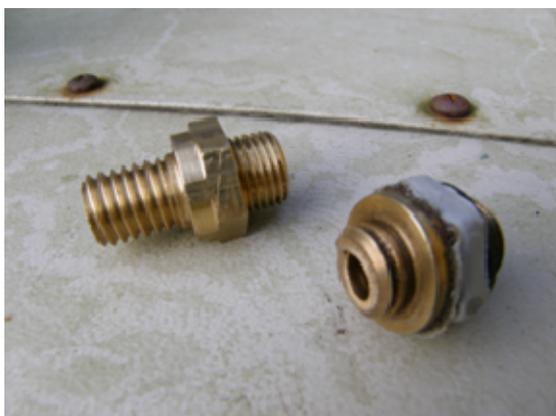
The photo shows the failed component (right) and a replacement for comparison.
