LEARNING FROM INCIDENTS AWARENESS ALERT

Near miss during a piling activity – how well do you manage HSE risks in offsite assets?

GP/AW/2008/04

Gas & Power

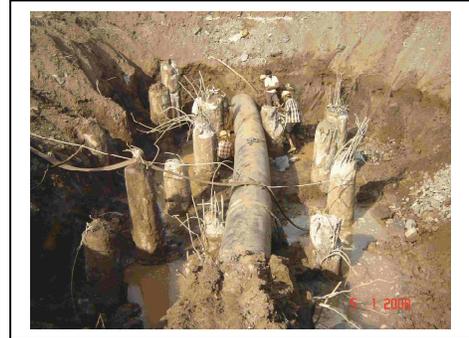
On the 3rd January 2008 an underground pipeline transporting regasified LNG from a JV Regas terminal to customers was hit as a result of a piling activity conducted on a third party premises during heavy construction work. The piling contractor stopped piling after he observed that the pile was not going through. Visual inspection of the pipeline revealed that only the coating of the pipeline was scratched, but that the pipeline itself was not damaged. Following investigation it was noted that 28 piles were driven in close vicinity of the pipeline (see picture). At 4 locations the coating was found slightly damaged and 3 piles were found touching the pipeline. Immediate measures after the incident included evacuation of the area and suspension of all construction activities in the vicinity of the pipeline corridor.

- Removal of several pipeline markers on the construction site, which eventually resulted in incorrect mark-up of the pipeline on the construction drawings used by the piling contractor.

- Construction drawings submitted by the third party not checked by JV Regas company to ensure that these drawings reflect the correct routing of the underground pipeline.

Following the incident investigation the exact position of the pipeline was re-marked. Missing pipeline markers were restored and construction drawings were updated. Effective communication with the third party company was established to coordinate the construction activities potentially impacting the gas pipeline. Weekly pipeline patrolling was established and findings were discussed to determine follow-up.
