LEARNING FROM INCIDENTS AWARENESS ALERT

High Risk Incident – Natural Gas Distribution Pipeline Rupture

GP/AW/2009/02

Gas & Power

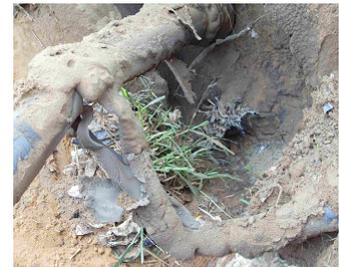
On the 10th September 2008, a pipeline rupture occurred at a 4" branch-off from a 6" gas distribution line (normal operating pressure 22 barg) after 7 years of operation, resulting in a release of circa 1.5 MMscf of natural gas. Following notification of the incident the gas supply was shut off and a crew was sent out for inspection of the pipeline. The area was cordoned off to restrict access to the site. Fortunately nobody was hurt or injured and resumption of gas supply to customers in the area was successfully restored after isolation of the defective line the day after.

Analysis of the incident concluded that the most probable cause for the pipeline failure was a high stress level at the failure location attributed to uneven settlement, in combination with the presence of a welding defect:

- The high stress level at the tee can be explained by differential settlement of the well-supported 6" distribution line constructed along the elevated road embankment (dry stiff soil and a nearby valve pit providing additional support as well) and the 4" branch line constructed in seasonally swampy terrain, outside the elevated road embankment at a significantly lower level.
- The welding defect could be due to use of off-spec material and/or the quality of welding performed during construction.

- Design and construction of pipelines must take into account apparent differences in soil conditions (settlement) to avoid situations with localised high stress levels at T-joints.
- As-built and up to date documentation must be kept in a secure place during the complete life time of the project as defined in the [Asset Integrity-Process Safety Application Manual](#).
- Before resuming operations following a process safety incident, a statement of fitness must be developed by the asset manager as mandated by the [Asset Integrity-Process Safety Application Manual](#).
