## Incident Investigation Summary

**Responsible Managers** David Wright  
**Incident Reference No:** Compass Ref.1106/09/NG  
**Person Responsible for National Implementation:** Adrian Chapman

Hatton Compressor Station – Power Factor Correction Unit.

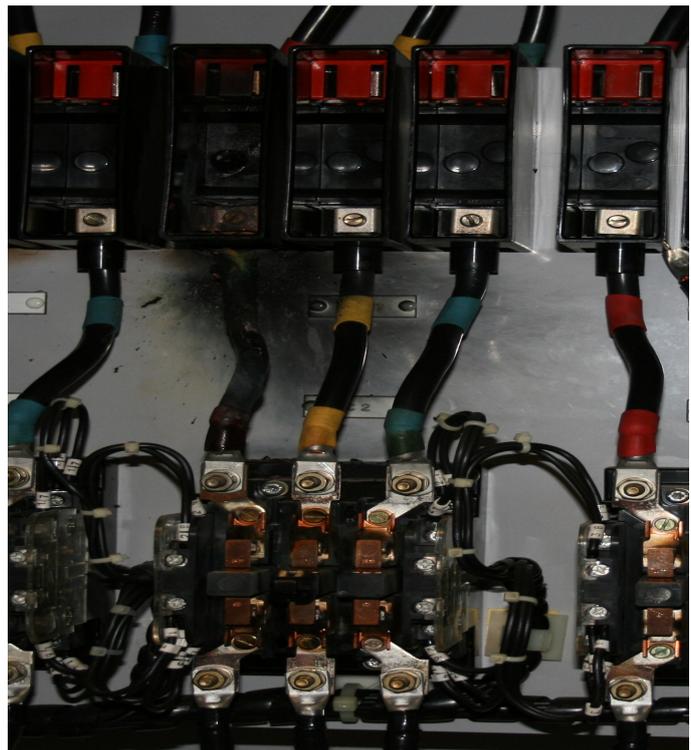
At Hatton Compressor Station staff noticed an acrid burning smell which was emanating from the inside of the power factor correction unit. The internal mains fuses, wiring and contactors had suffered from over heating.

The cause of this was in the design and type of crimps or incorrect crimping tool used for the connections at the above points. Some of the sleeves which have been crimped onto short lengths of 25mm mains wiring prevent full face to face contact between the crimp and the securing grub screw in the fuse holder.

Electrical maintenance staff to be reminded of the maintenance requirements detailed in T/PR/Maint/11026 Work Procedure for Power Factor Correction Equipment and T/PRM/Maint/11001 Work Procedure for General Requirements Electrical. Appendix D

- 25 Check that all cable terminations, including unused cables are terminated as necessary.**
- 26 Check that all electrical connections are tight; including cable terminations and that the correct creepage and clearance distances are maintained.**
- 27 Check cables are installed correctly for the environment/application.**
