## Incident Investigation Summary

Responsible Manager Andy Brook Delivery Manager NE2, MDE - Substations  
Incident Reference No: 13708/09/NG

### BURNT HAND FROM CONTACT WITH 48V TERMINALS INSIDE BATTERY CHARGER

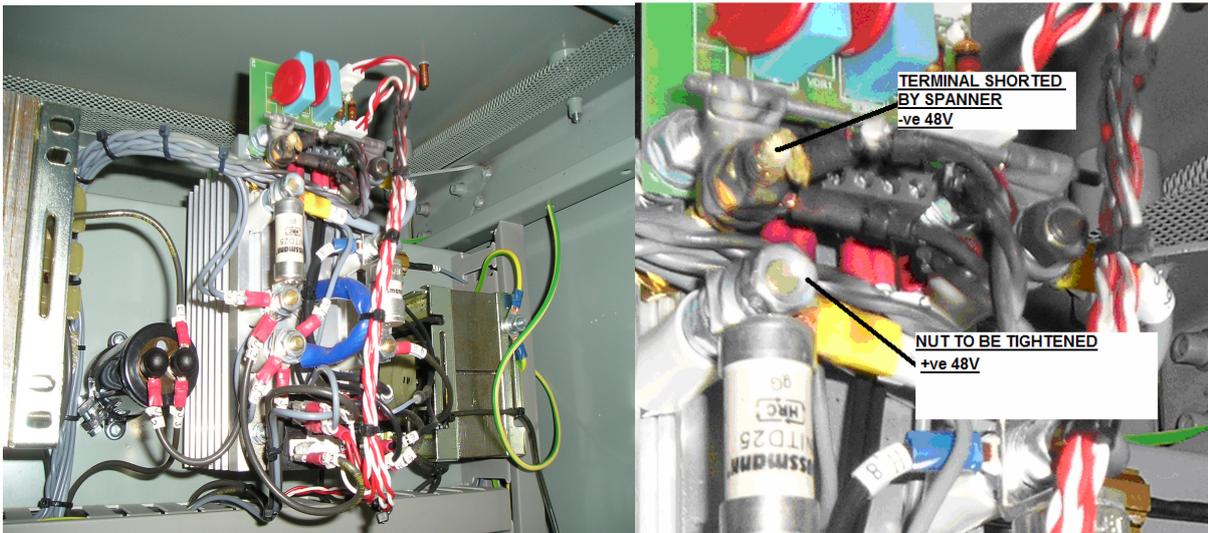
Whilst replacing a blown 48V 25 A HRC fuse, contact was made across two terminals with an uninsulated spanner. This was done with the 240 AC supply isolated but with the battery connected. The installation had no further means of isolation and the exposed terminals had no shrouding or insulation. The replacement fuse, although the correct rating, was of a different style to the original and whilst the main body was longer the distance between the mounting holes under the nuts was exactly the same. This small change in detail prevented the use of an insulated spinner or socket to carry out the work and unfortunately for the individual the uninsulated spanner bridged the gap between the terminals which were at opposite polarity. Bridging the two terminals caused an arc between the spanner and the two terminals which led to burns and a cut on the right hand index finger from the heat of the arc and with the rapid withdrawal of the hand causing the finger to catch on the terminals and components in the vicinity. The injured person required treatment for his injuries at the local hospital A&E department.

- The dangers of exposed live terminals inside equipment, even LV, and that whilst contact with 48V D.C. by the person does not in itself lead to great risk, if contact is made across the positive and negative terminals with a metallic object then large currents WILL flow leading to arcing and burning as had occurred here.
- The requirement to work insulated wherever practicable.

The issues with the poor design of the charger involved are being taken up with the suppliers of these types of equipment to obtain design improvements and additional insulation, screening and warning notices.
