Incident Investigation Summary

Incident Reference No: Compass 11238/09/NG

Ring Lock Closure Seal Failure on a High Pressure Pig Trap at Gt. Wilbraham AGI

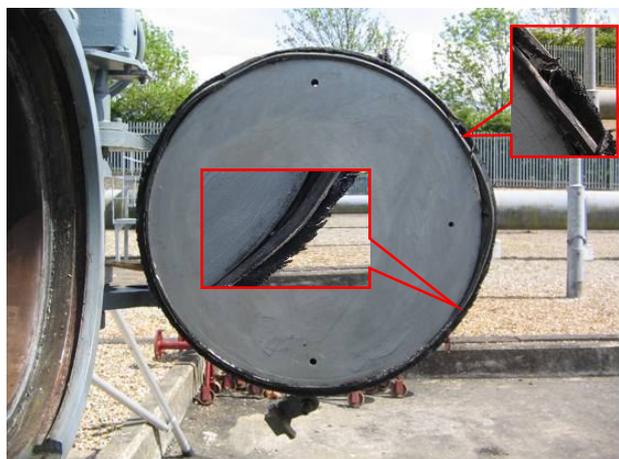
Safety bleeder lock showing evidence of heavy paint deposits

Evidence of 'corrosion like' deposits found within the valve quadrant.

- Evidence of heavy build up of paint deposits on the safety bleeder locking plates, which are critical mating surfaces with the locking rings. Therefore, being incapable to take these critical measurements.
- The safety bleed locking plates were found to be undersized, which resulted in the locking rings not being fully expanded within the closure mechanism.
- The pig trap door was not centrally located within the neck of the closure mechanism, thus allowing an additional gap to develop at the top of the door causing the chevron seal to be extruded under pressure.
- Unable to obtain effective cavity seal on valve for isolating pig trap, as valve quadrant found to be full of 'corrosion like' deposits.

1. Staff are reminded of the importance of following Work Procedure T/PR/MAINT/5029 to ensure:
 - a. particular attention should be paid to the cleanliness of safety bleeder locks and locking ring draw bolts etc. Guidance on the operation and maintenance of ring lock closures is available in a video on the Infonet: http://ngtuk/dist_networkstrategy/default.asp?action=readnew&preview=true&id=1150&bhcp=1
 - b. pig trap isolation valves are in the correct position prior to maintenance, in accordance with Section 6.2 (6.2.1.) to avoid future incidents.
2. Ensure only new seals are installed or are at least <12months old and have been stored correctly in accordance with the GD Engineering Ltd storage guidelines.
3. Check the integrity of the seal prior to installation into the door closure.
4. Ensure an increasing trend for ALL Pig Trap Compass/Defect reporting.
