Incident Investigation Summary

Responsible Managers **Tony Jackson**
Incident Reference No: **30921/09/NG**
Person Responsible for National Implementation: **Russell Wilcock**

Damage To A Pig Trap During Pig Loading Operations

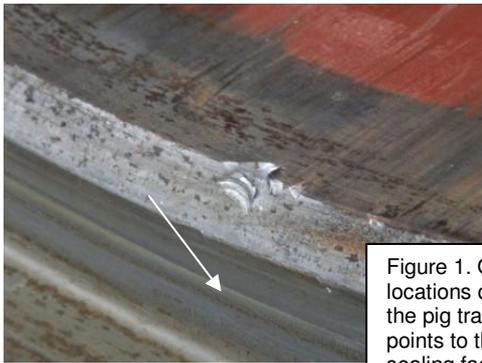
During a recent pigging operation at Felindre Compressor Station, one of Rosen's inspection tools became jammed as it was being loaded into the pig trap. It was eventually inserted but caused gouge type damage (Figure 1) to the inside of the trap adjacent to the face used to seal against the pig trap door. The tool being used was Rosen's Axial Flaw Detection (AFD) pig (Figure 2), also known as the Transverse MFL tool. This was the first time National Grid had used this tool and it is different in design to the corrosion detection tool we normally use during inspection (the CDP tool). In this case the damage caused was superficial, but had the sealing face been damaged the required repair would have been substantial.

Figure 1. One of the locations of damage to the pig trap. The arrow points to the adjacent sealing face.

- The damage to the pig trap was caused by magnet-sensor arrays moving into the gap/step between the end of the pig loading trolley and the bore of the pig trap, in the area of the door closure and then being forced against pig trap by the hydraulic ram used for loading the pig.
- This problem can be avoided by using a pig loading trolley with a tray that extends into the bore of the pig trap, thereby bridging the gap/step. This was employed in a subsequent inspection starting from Felindre and worked well, no damage occurring to the pig trap.

1. With immediate effect, Transverse MFL tools (Rosen's AFD tool) are only to be loaded or unloaded using a trolley with a tray that extends inside the bore of the pig trap. Rosen have a temporary modification in place for the trolley for the 1220 mm tool (48"), and could effect a similar modification for the trolleys of other diameter tools.
2. National Grid will engage with Rosen to ensure that a long term solution is developed to the issue of loading trolleys and trays. Extended loading trays that provide protection to the pig trap should become the norm whenever any kind of inspection to is loaded to or from a pig trap.

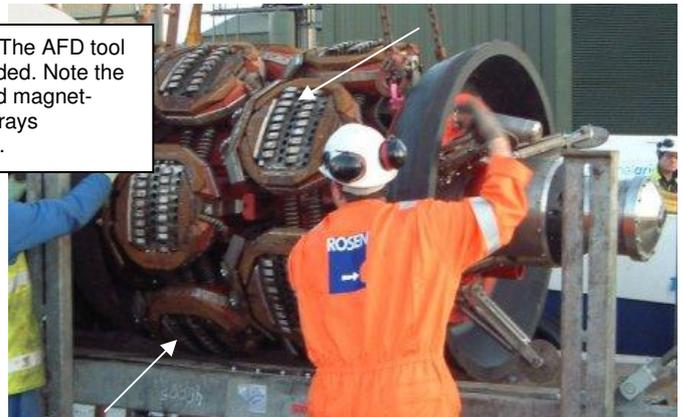
Figure 2. The AFD tool being loaded. Note the articulated magnet-sensor arrays (arrowed).
