Incident Investigation Summary

Responsible Managers N. Bennet/ A. Jackson
Incident Reference No: Compass 2947/09/NG
Person Responsible for National Implementation: Paul Williams

Gas leak from a valve drain point at Herbrandston AGI

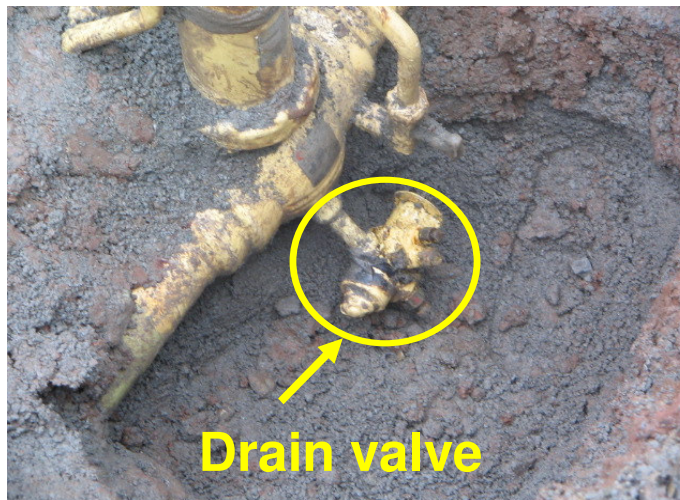
While commissioning the new AGI pipe work, a body drain valve on a buried rider ball valve was found to be leaking gas.

The body drain point valve on ball valve number 460117 had been left in the open position following the construction hydrostatic testing and drying operations.

Project Inspection and test plans and work method statements should clearly identify and define individual role responsibilities to ensure that all valves that are in the correct position following the hydrostatic test and pipe drying operations. **Action - Project Manager**

Preventative control measures should be implemented for all valves that are to be buried, such as an inspection and check list system, carried out immediately prior to backfill to ensure that all valves that need to be closed have been closed. **Action – Project manager**
