Sunoco Marcus Hook Refinery Ethylene Unit Fire - May 17, 2009 Lessons Learned

**API Subcommittee on Inspection
Dallas, TX, November 11, 2009**

**By Art Jensen, Mechanical Reliability Specialist
610-833-3901, ajensen@sunocoinc.com**

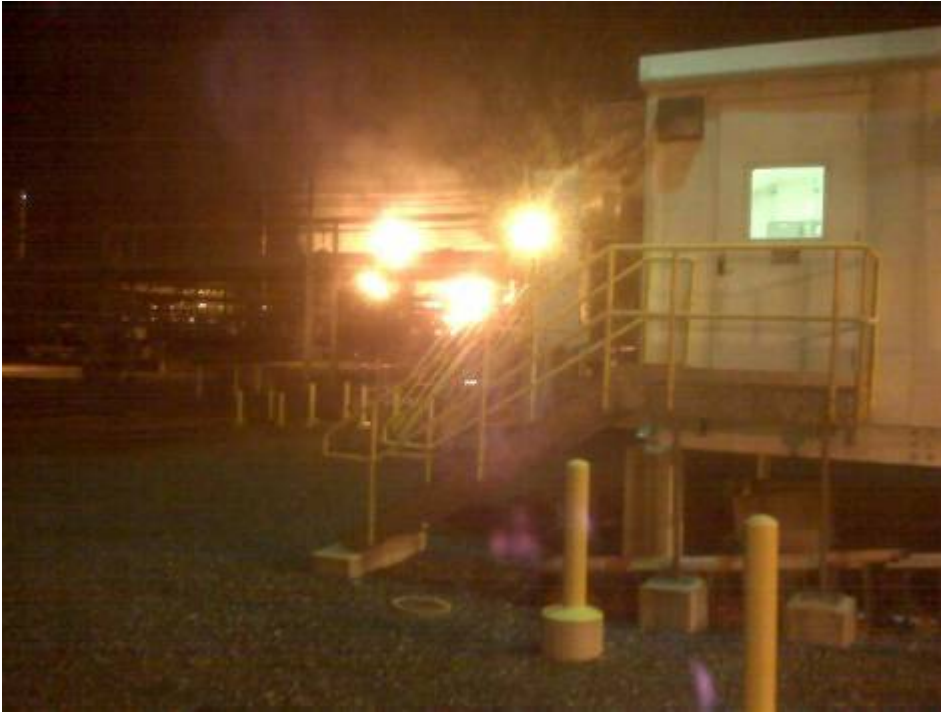
Photo on left was taken from an eyewitness camera phone within one minute of the initial release and fire. Distance is approximately $\frac{1}{2}$ mile from the ethylene unit.

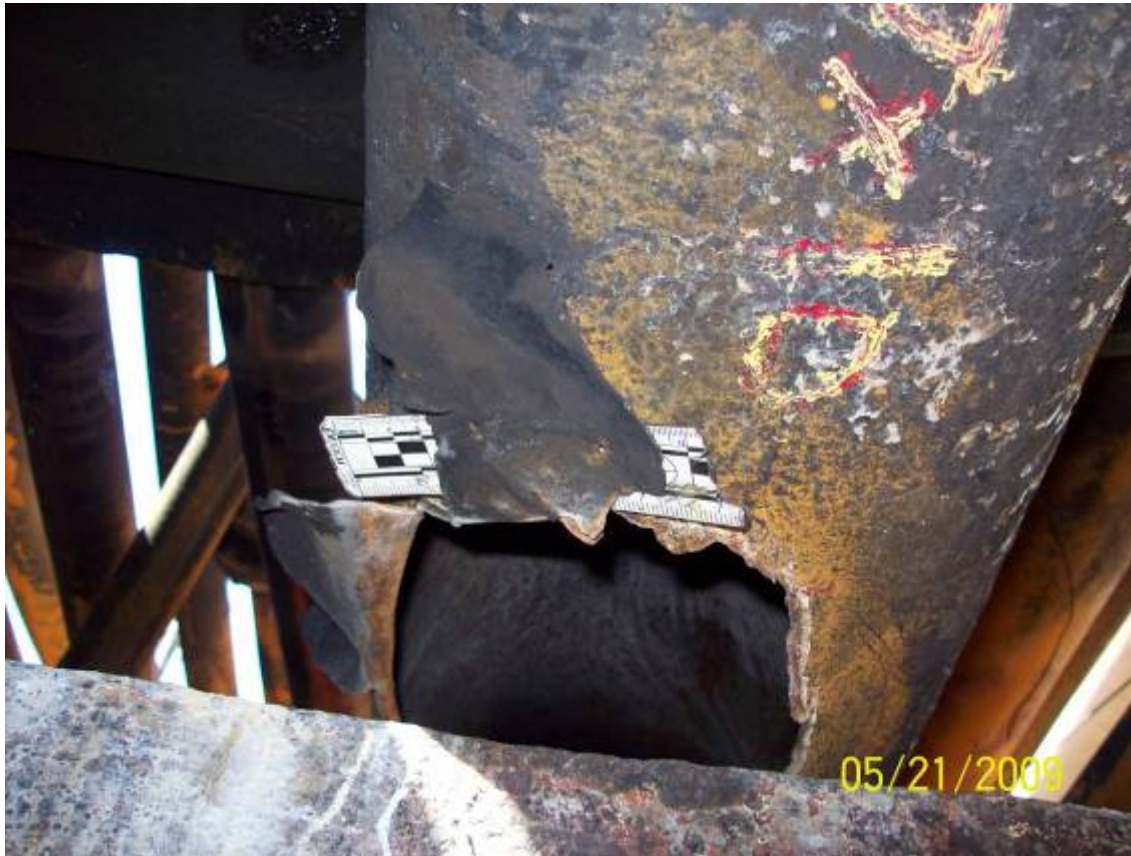
Physical Evidence: Initial Failure

- Pipe failure on the 210A/B/C process drier common outlet line.
- This is the **only** failure found which is **not** a secondary failure from short term overheating.

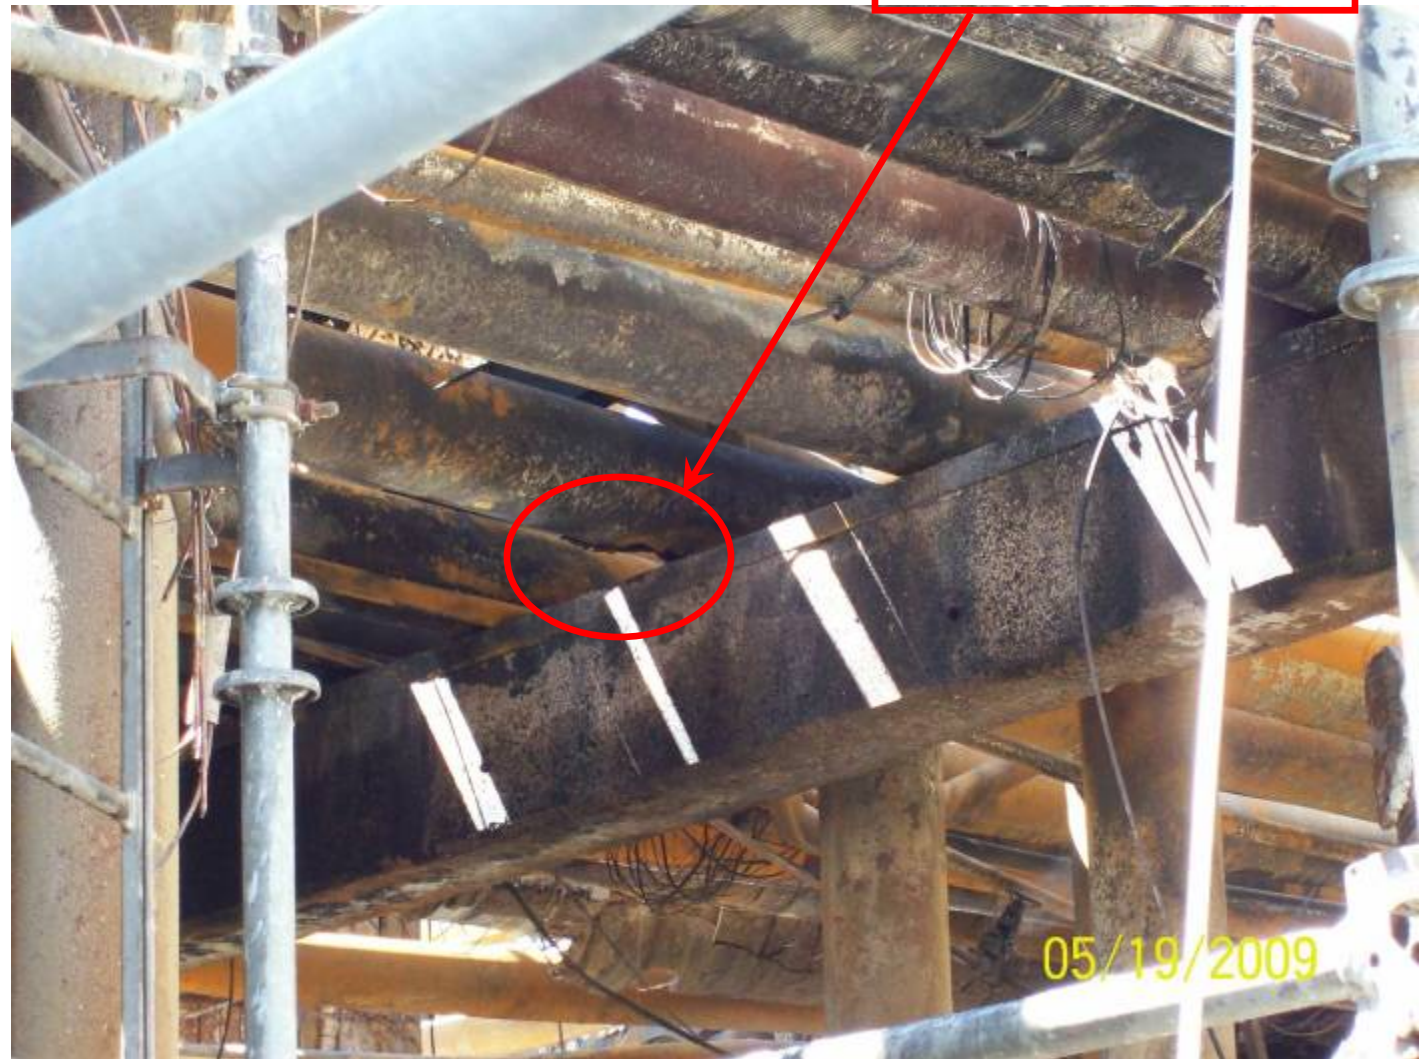
- Reduced amount of heat damage in the area around the failure indicates “too rich”.
- suggests a very large fuel source.

Side view of initial
10" line leak.

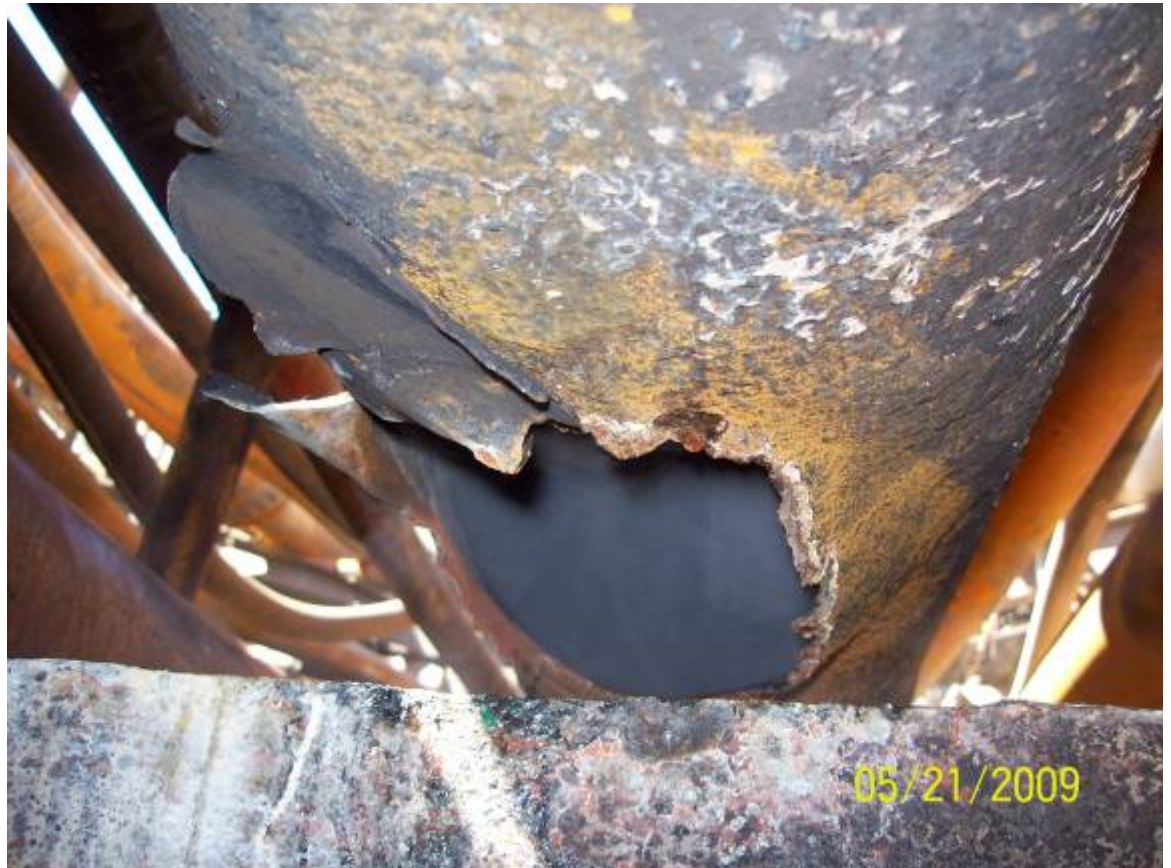
- The location of the failure was at the bottom of the line at pipe rack support.
- Failure mode is pipe wall thinning and rupture due to localized contact area external pipe corrosion.

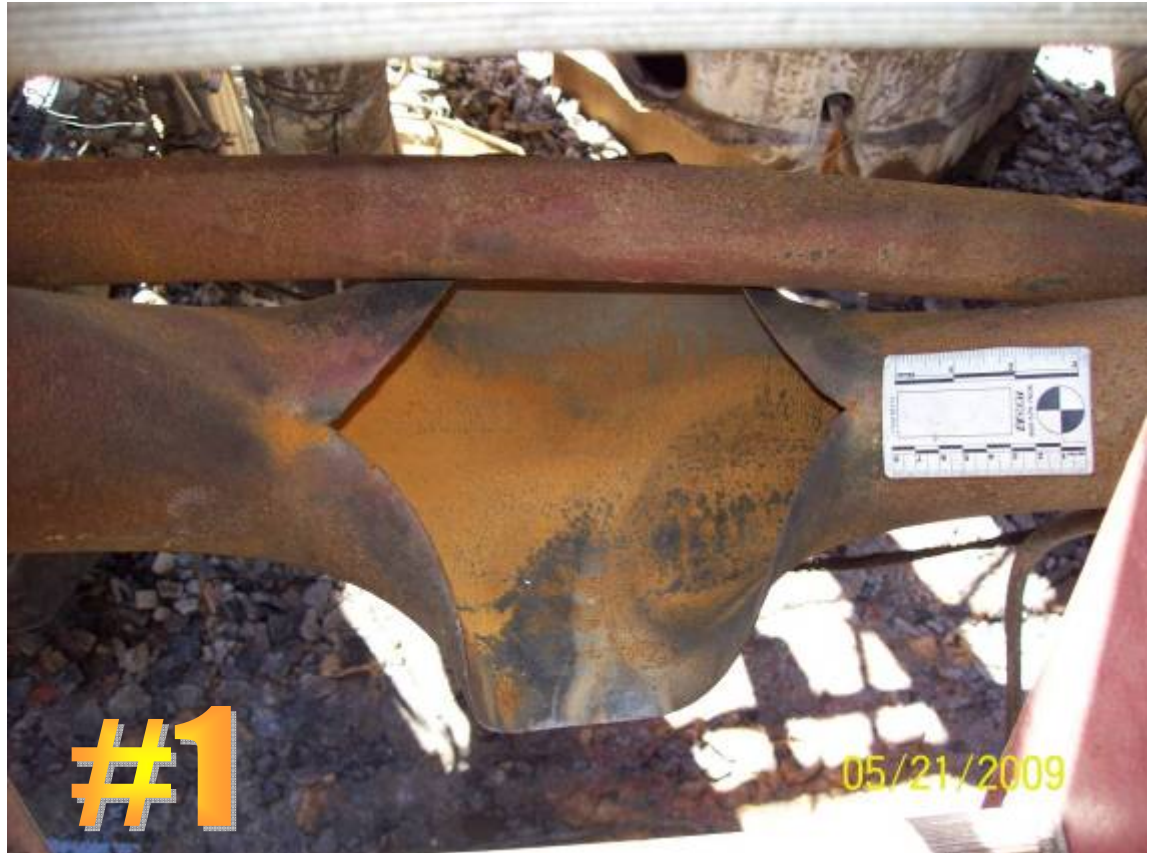
- #1 - 4" 100 psig propane liquid line from 15-2 gas plant.
- Process data indicates this line failed ~3 minutes after the initial failure.

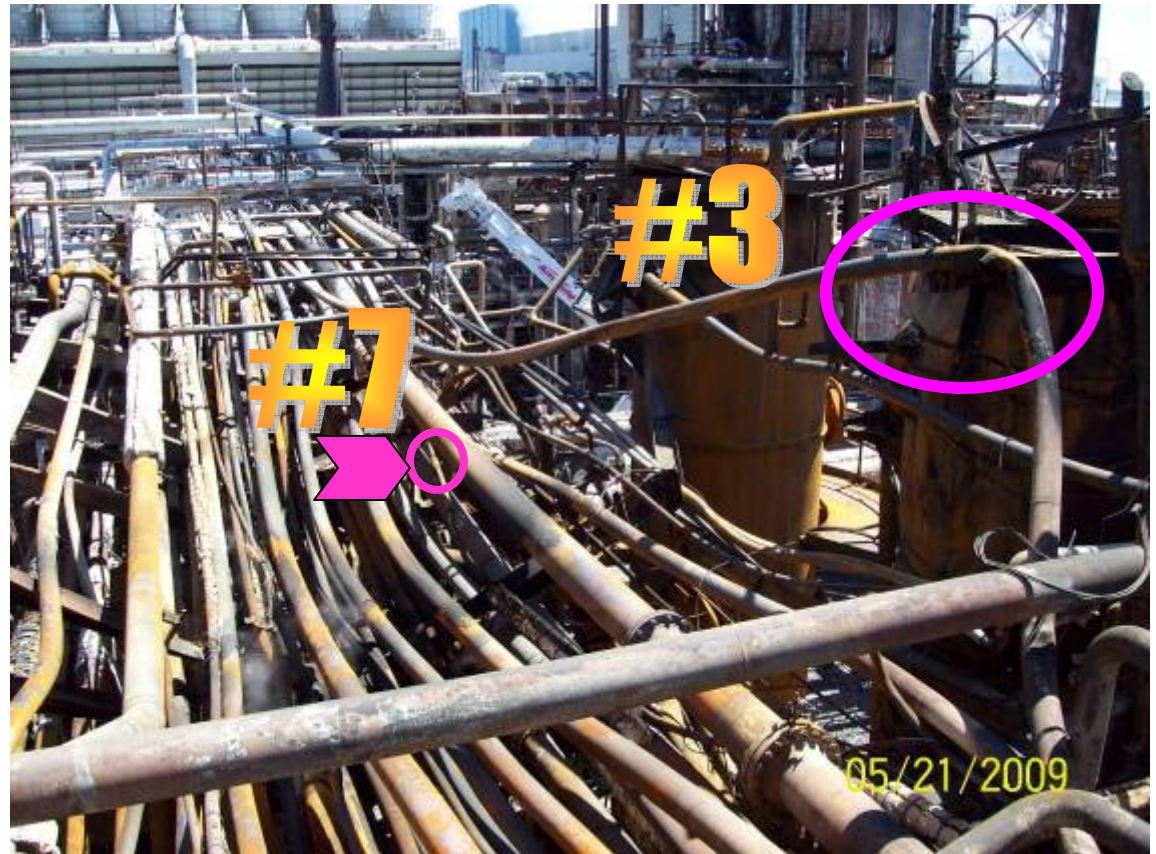
6" High Pressure Ethylene Line Fish Mouth

- #3 - 6" 450 psig ethylene gas product line.
- This line failed ~6 minutes after the initial line leak.
- The line itself is deformed due to reaction forces from the leak.
- #7- Failed 2" Spent Caustic Line.

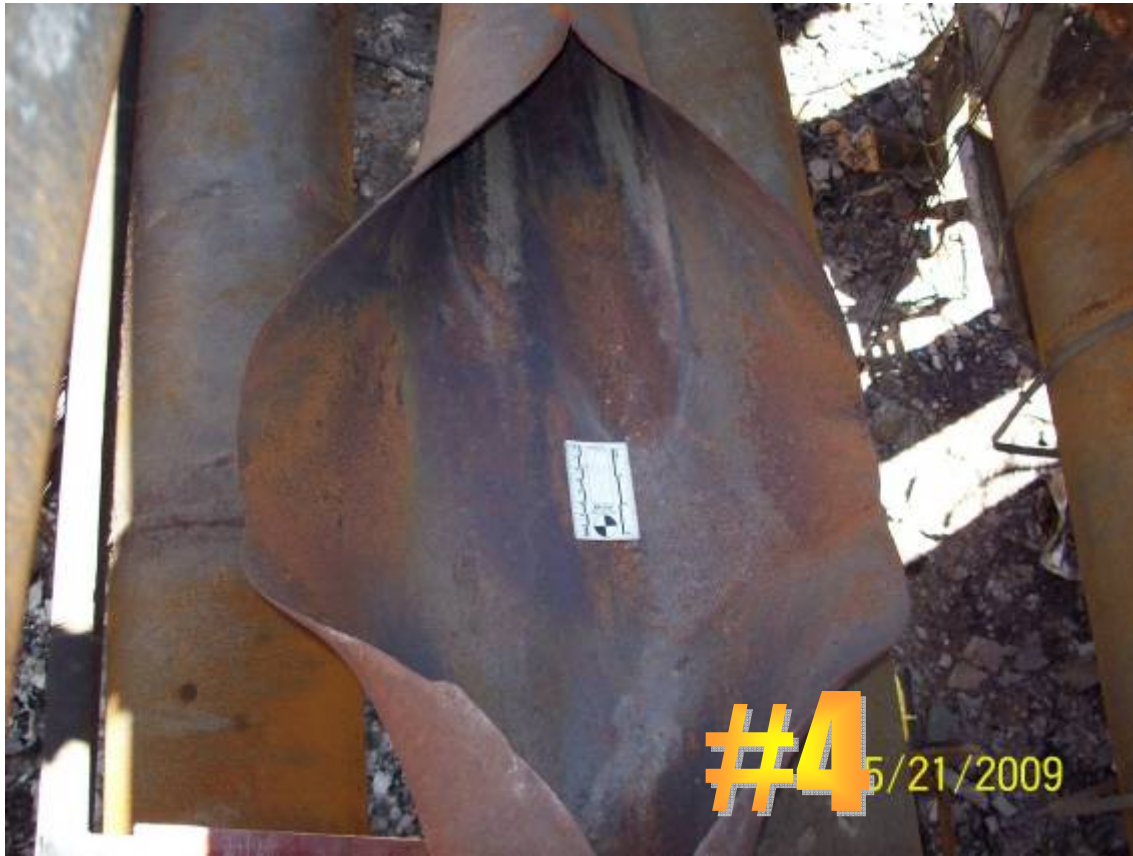
850# Steam Fish Mouth

- #4 - 12" 850 psig steam line failure.
- This line failed ~8 minutes after the initial leak.

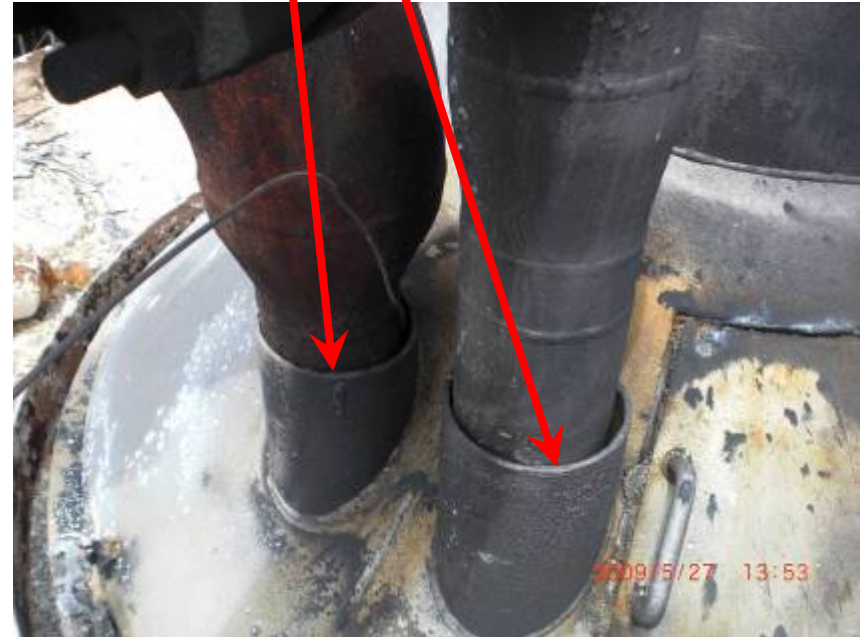
- Top of fire box would be slight negative pressure.
- Stack flue gas temperature was ~1000F at the time of the fire.

Gaps at coil inlet and outlet

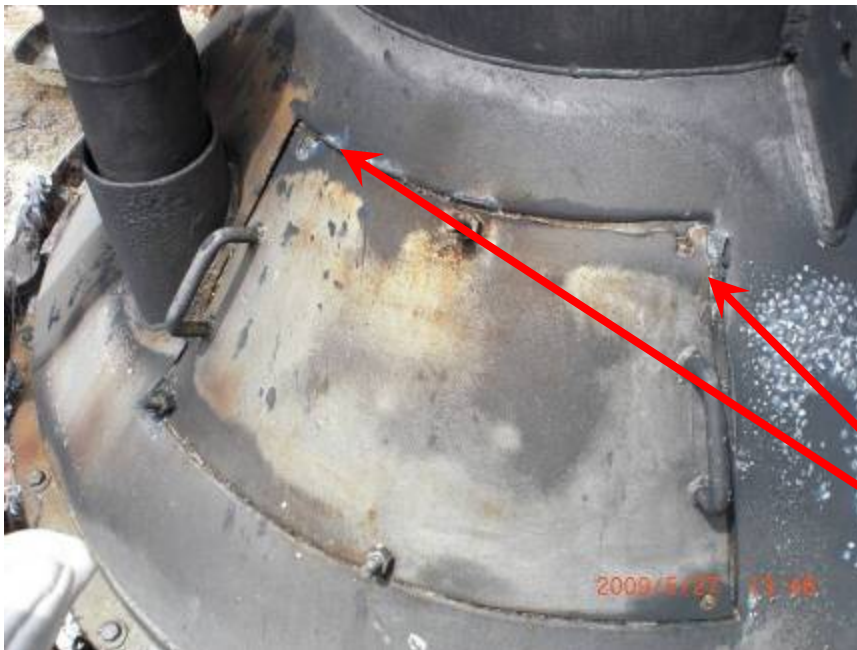
- Heater shell leaks could pull vapor cloud into the ignition source – and then flash back out.

Gaps around access door

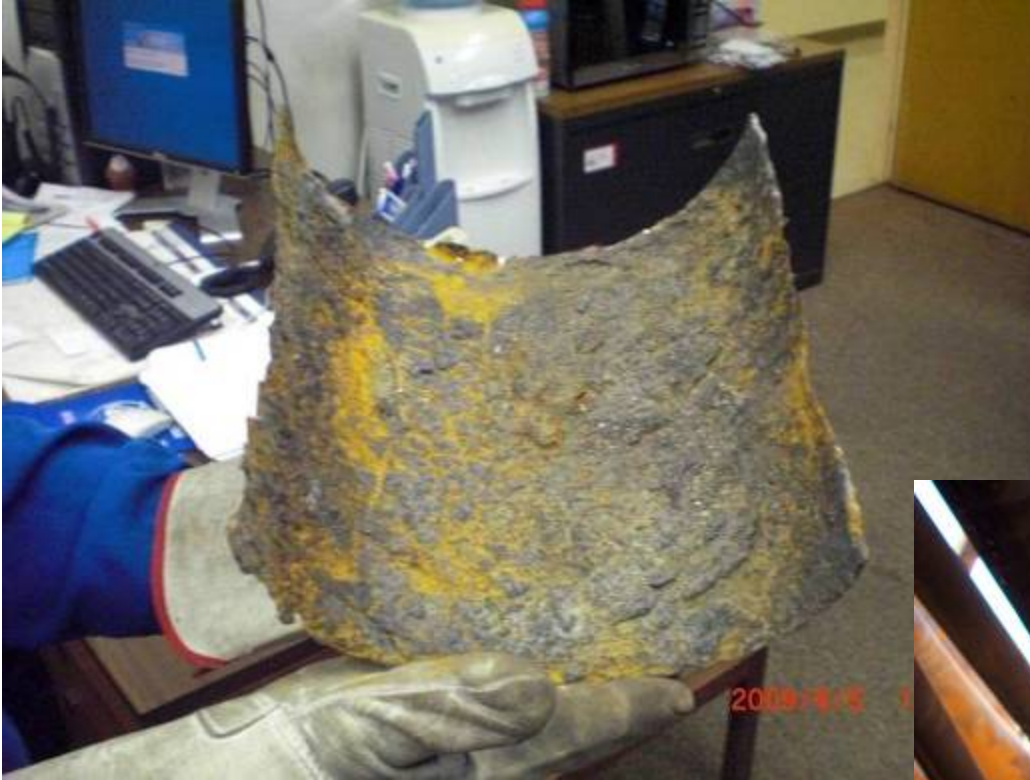
Loose sleeve under pipe at failure location

- Sleeve is 9-1/2 inches long and provided extended area of contact corrosion.
- Large corrosion area explains large initial “blowout” failure.

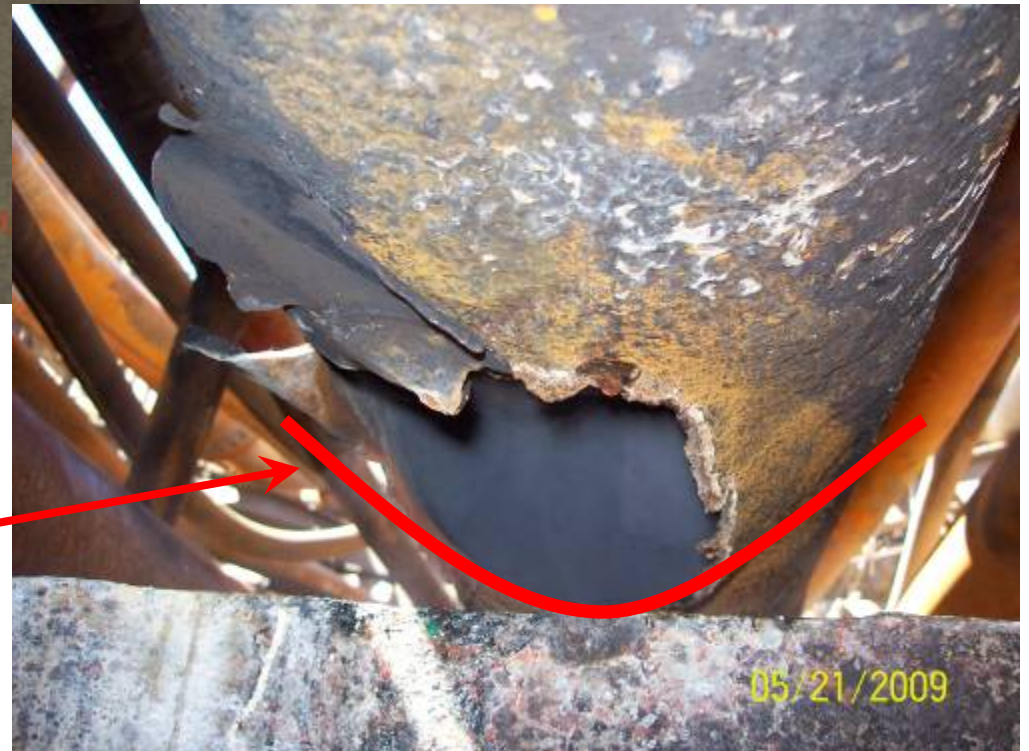
The loose sleeve was found under the failure (resting on top of the pipe support) the morning after the fire.

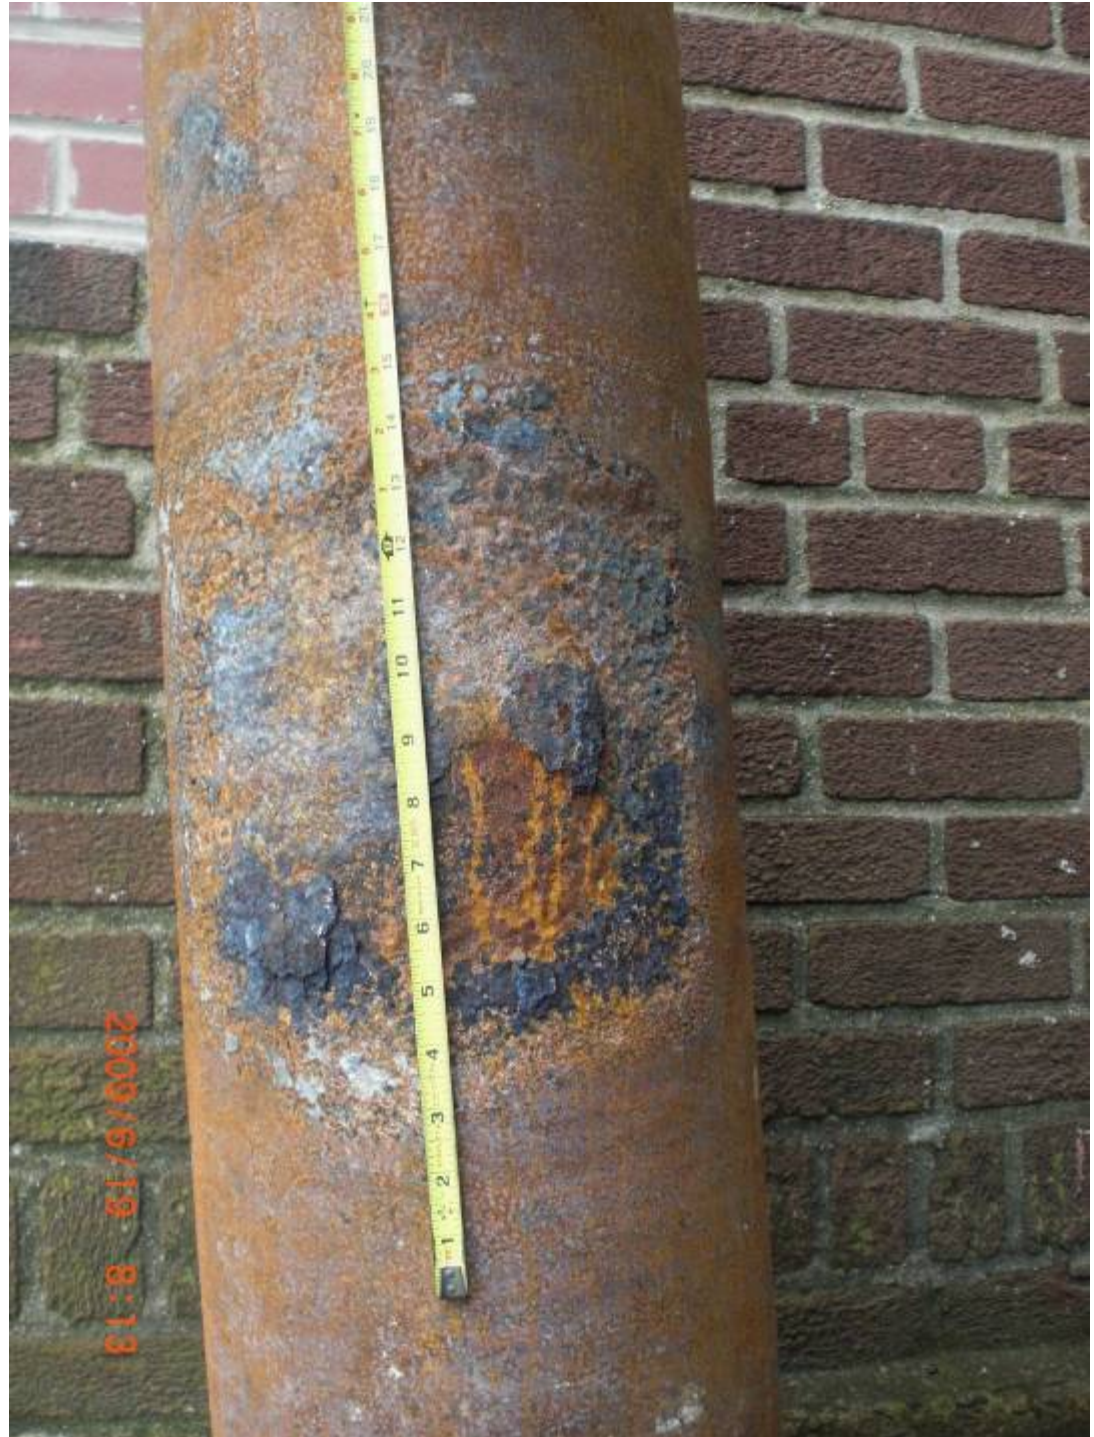
- This 10" diameter line was found at another location in the plant with similar large area of contact corrosion (this location had not yet failed).
- Believe similar loose sleeve was under this line, but the sleeve could not be found after the fire event.

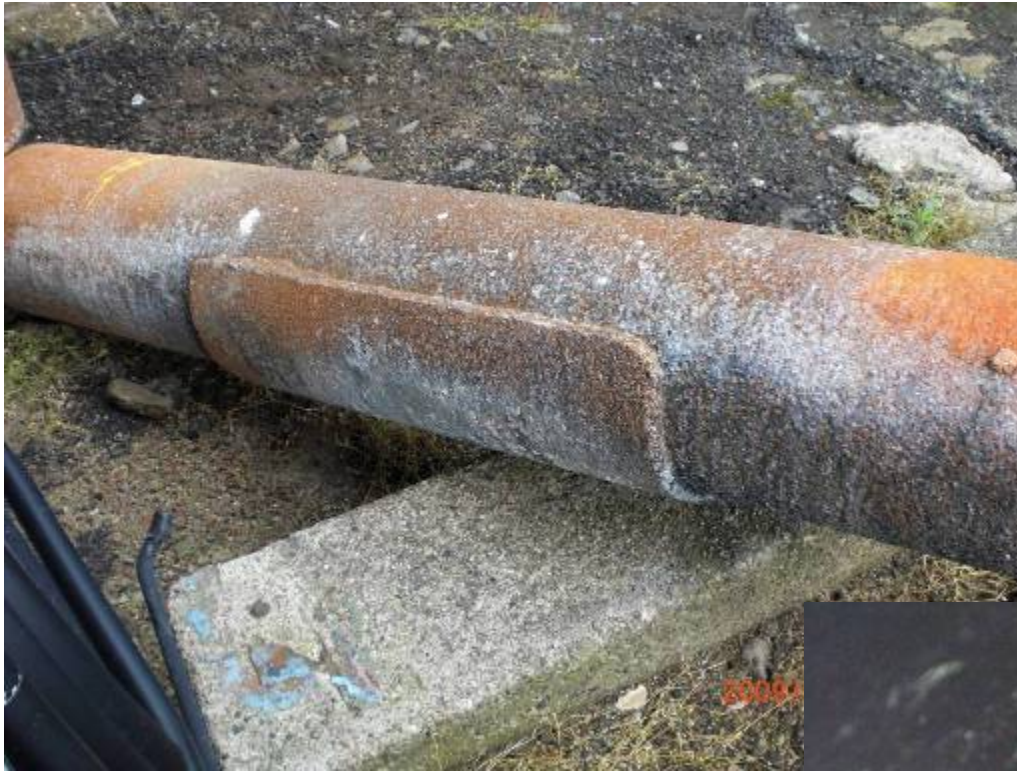
8" methane gas line with external patch repair at pipe support location (repair patch was pre-1990).

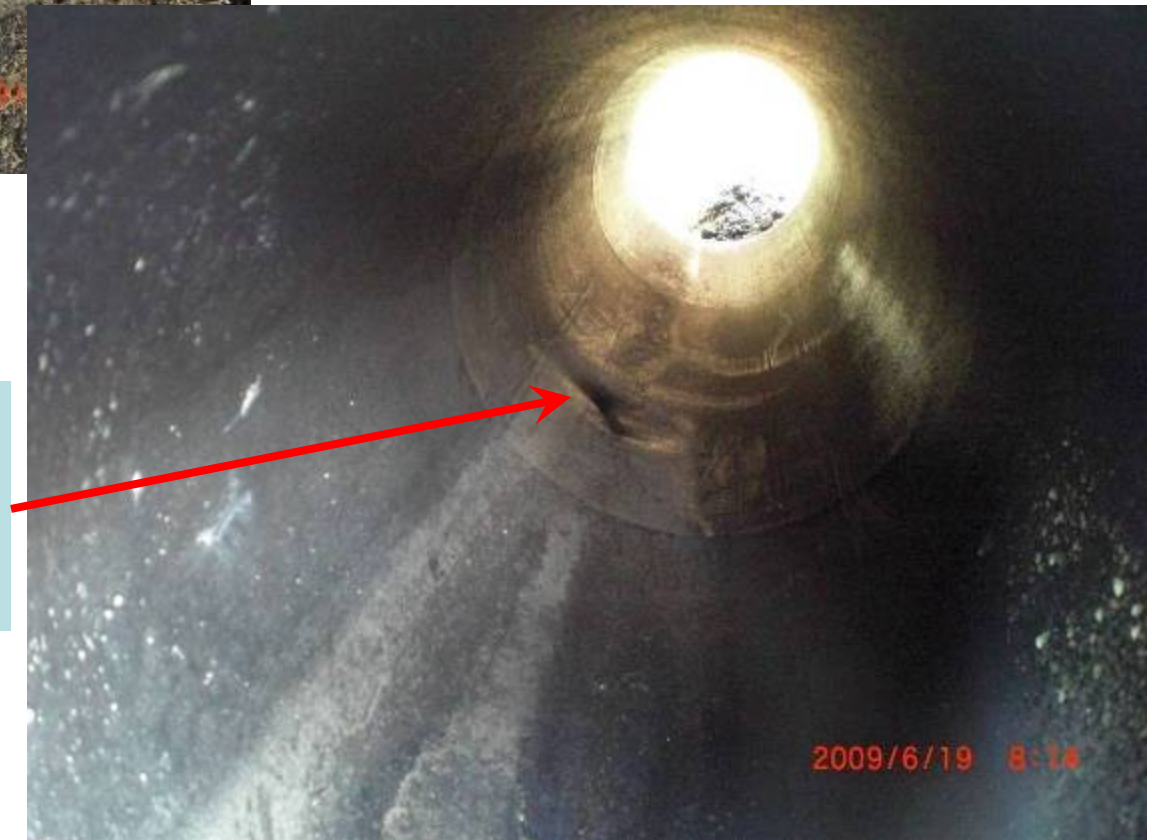
Inside of line shows ~1" hole under the repair sleeve.

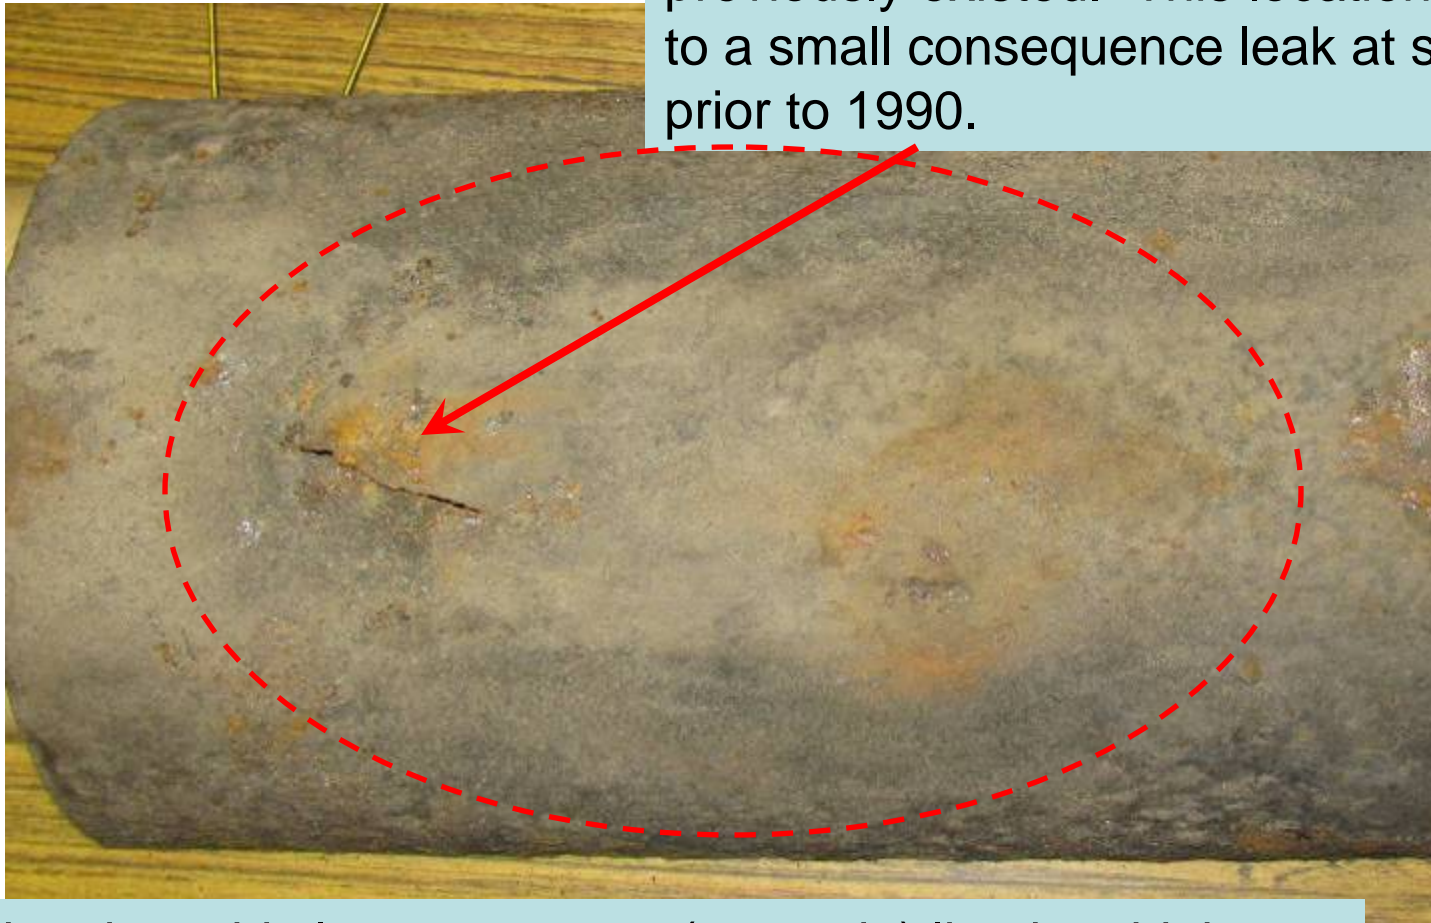
After the repair patch is removed from the 8" line there is evidence of a similar large contact area corrosion where a loose sleeve previously existed. This location progressed to a small consequence leak at some time prior to 1990.

Note how this lower pressure (~80 psig) line has higher probability of a smaller failure, where high pressure (~480 psig) line has greater potential for a large blowout rupture.

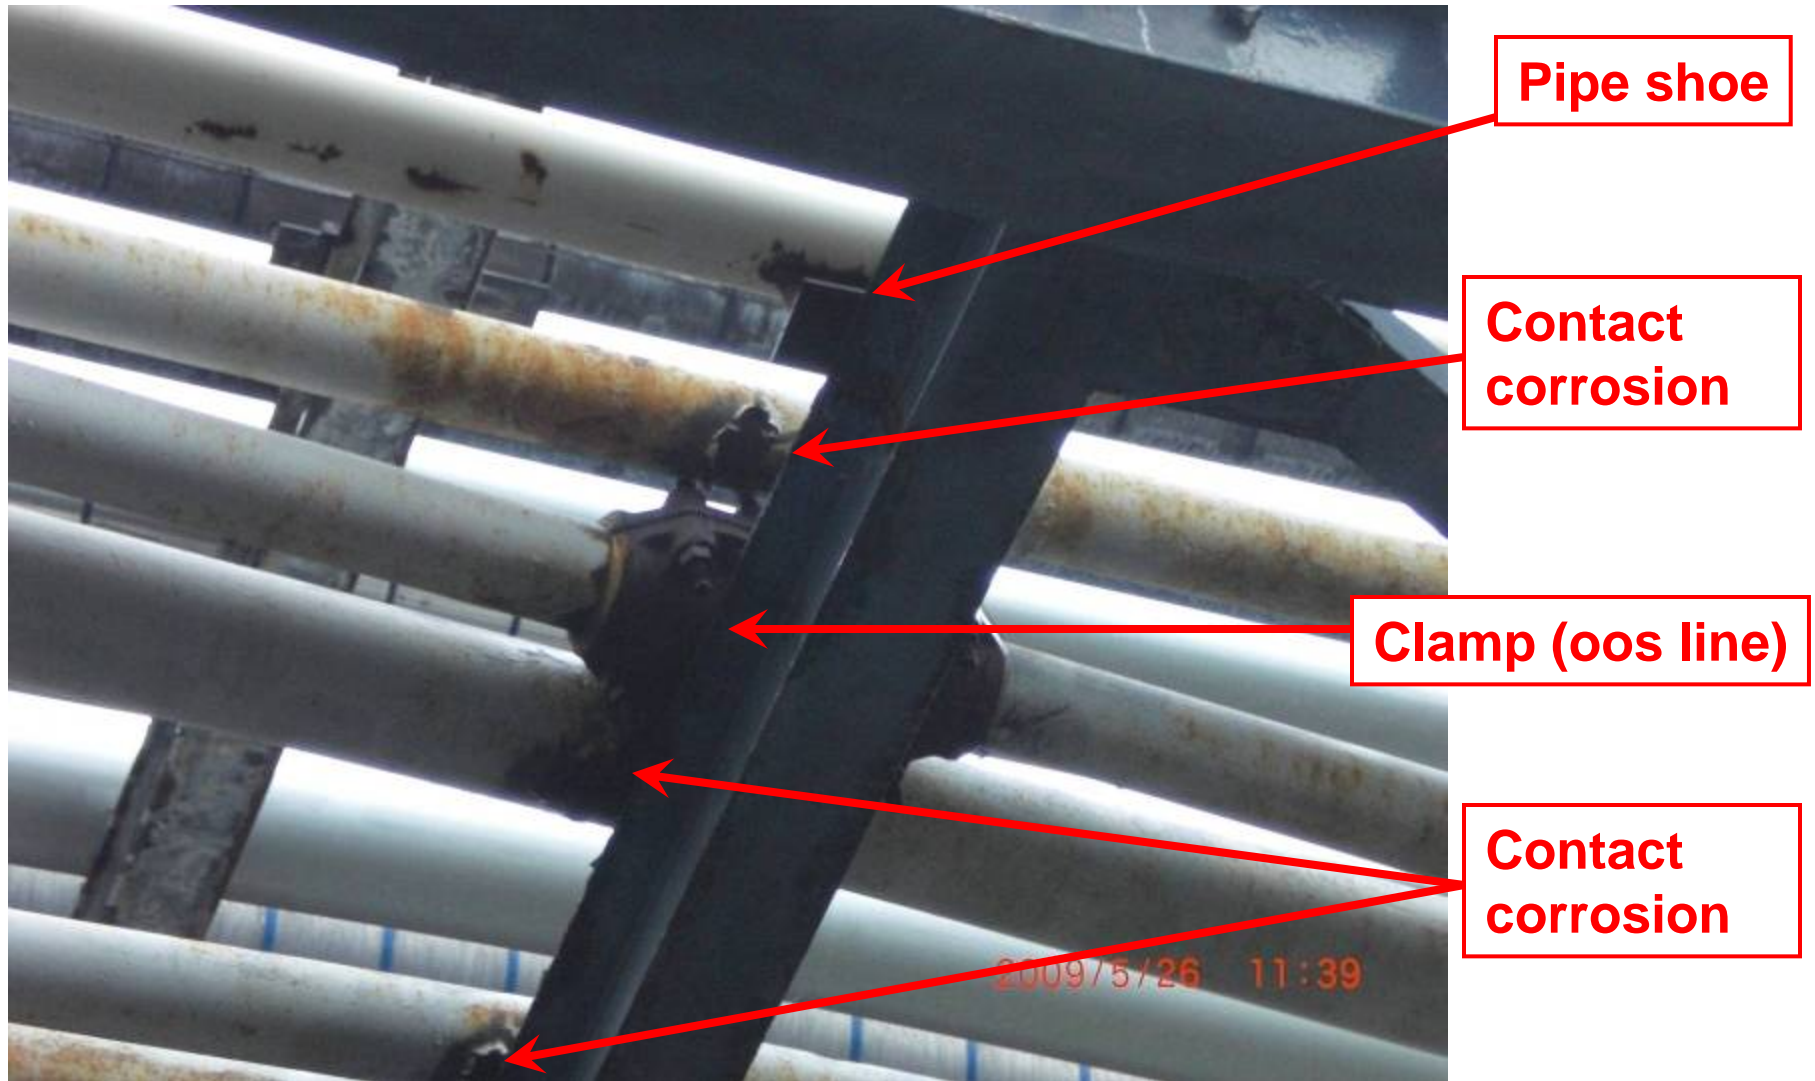
- Other examples of contact corrosion common in refineries.

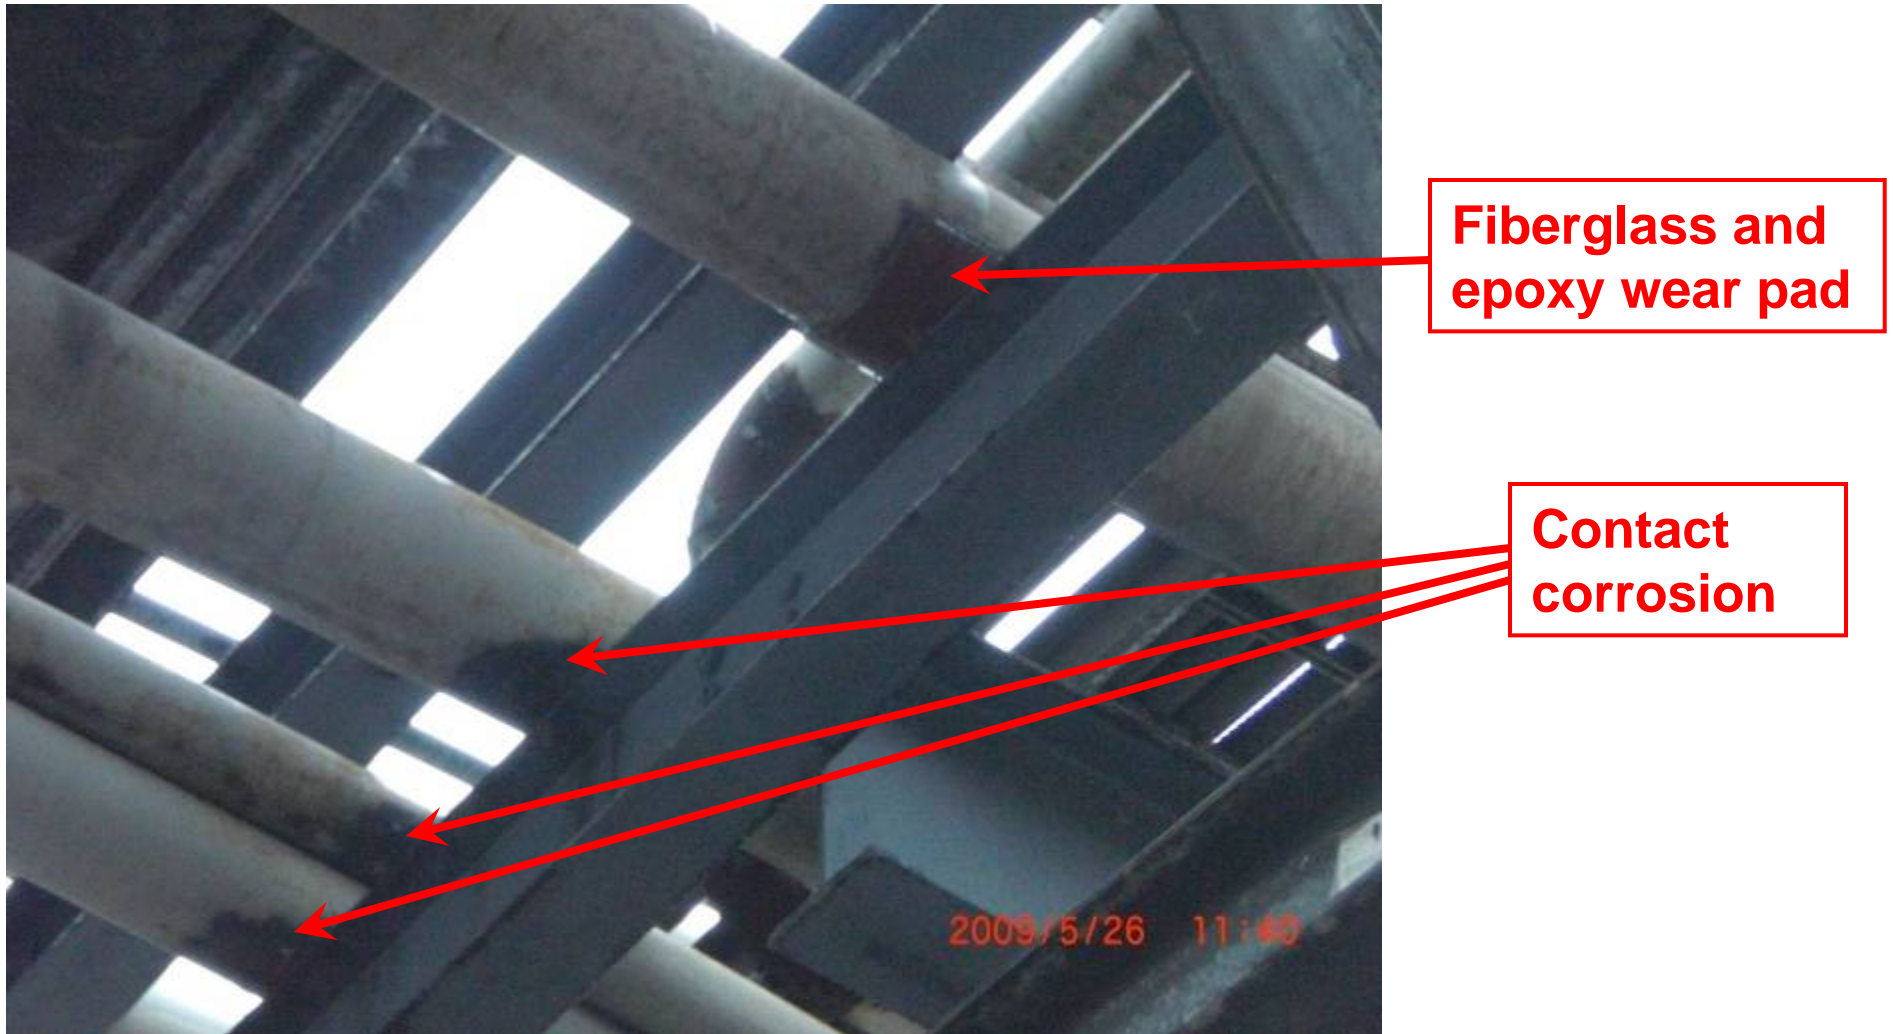
- More examples of contact point corrosion.

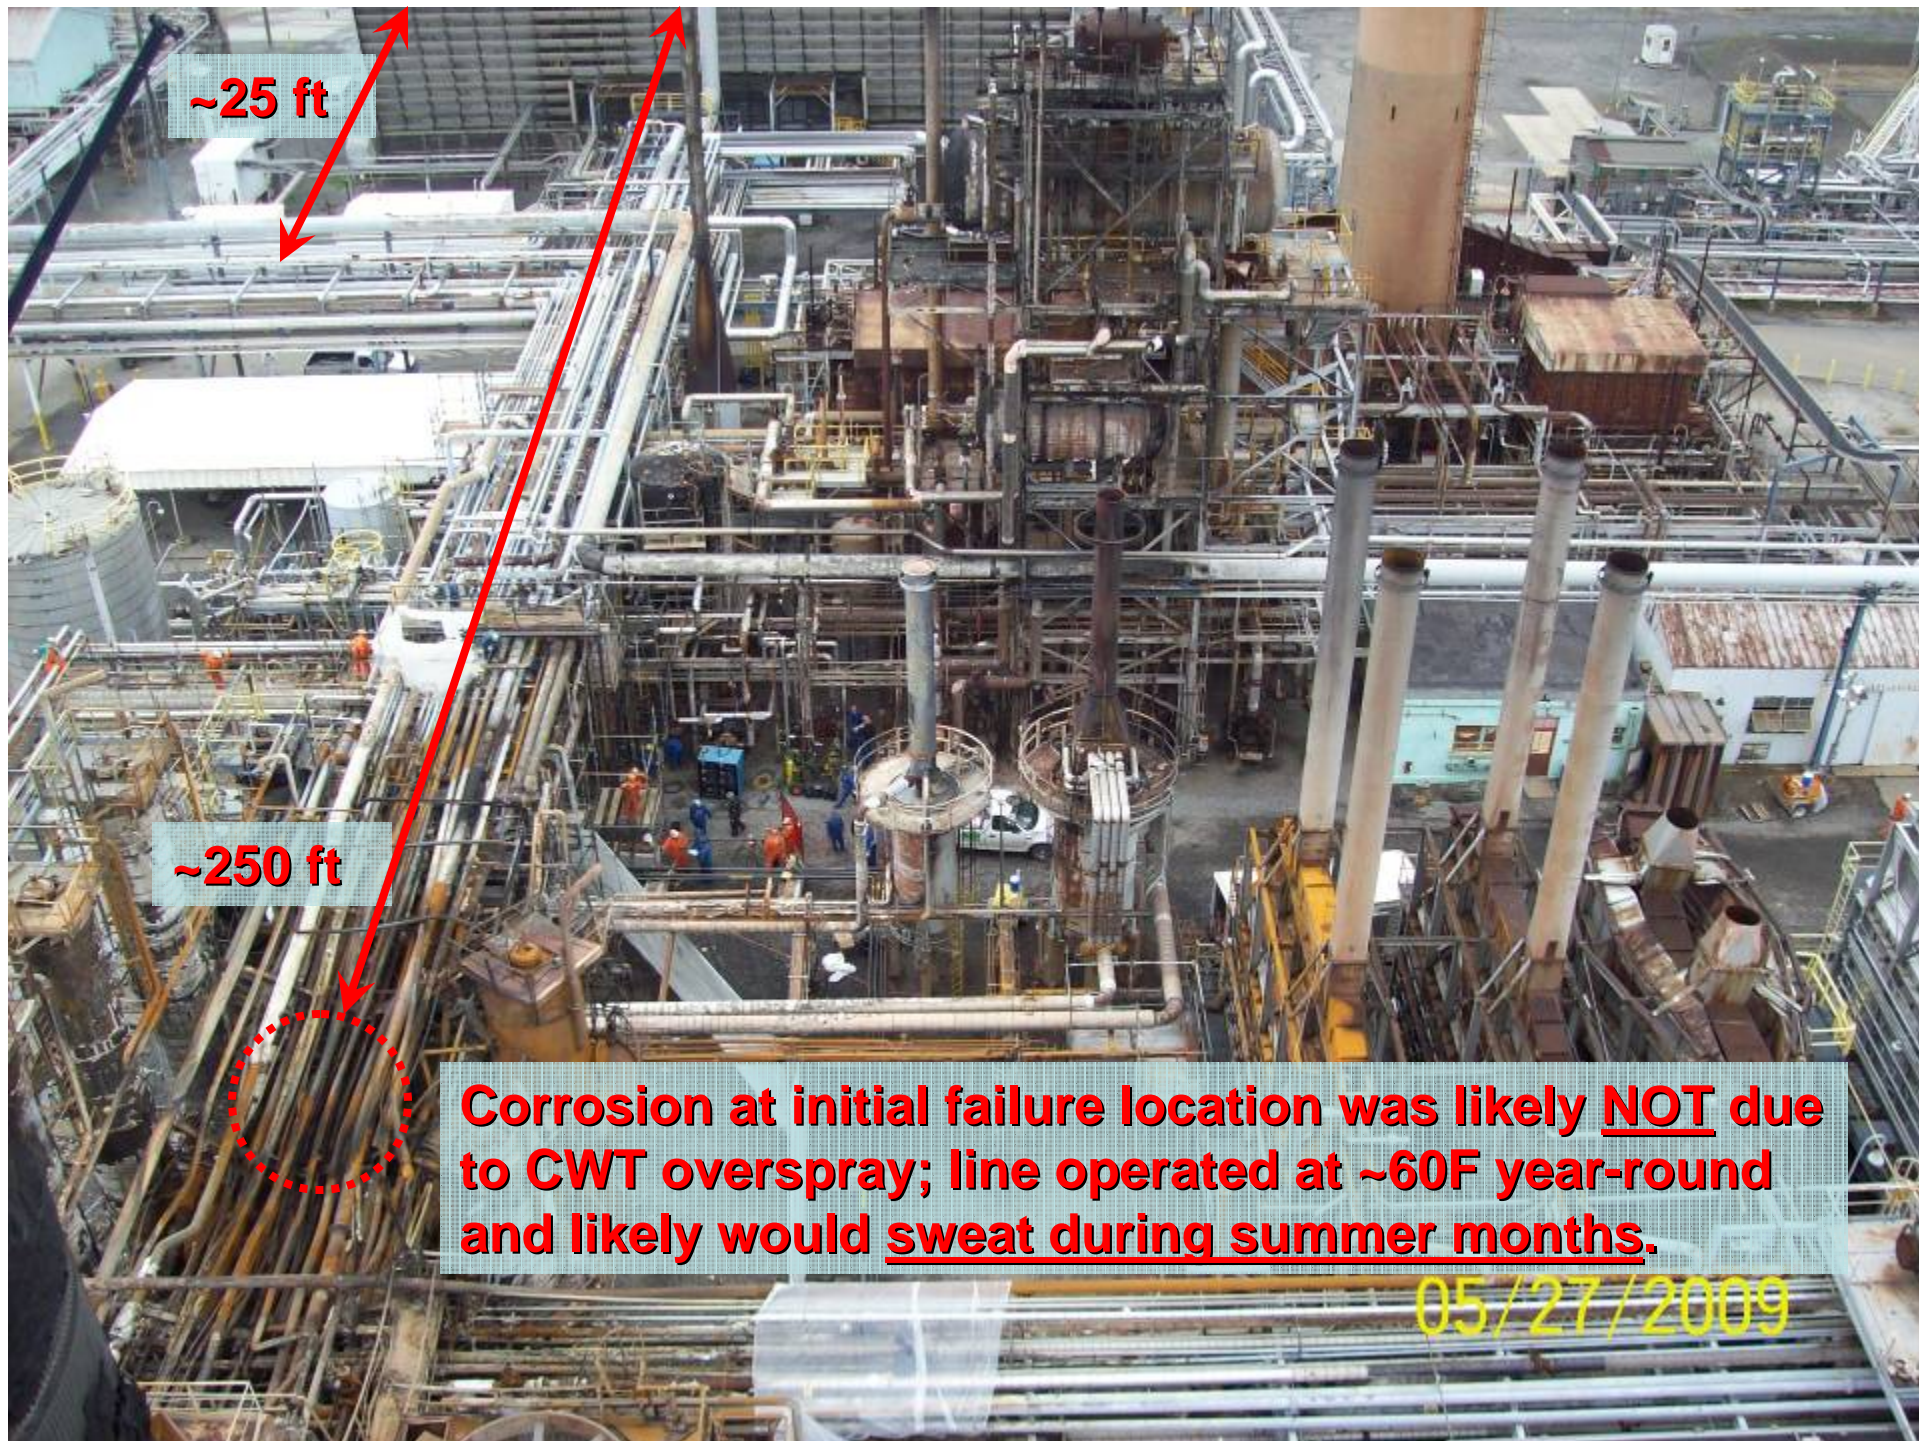
Corrosion at initial failure location was likely NOT due to CWT overspray; line operated at ~60F year-round and likely would sweat during summer months.
