UKOPA SAFETY ALERT

JCB Impact on above ground section of High Pressure Pipeline

18th February 2010

UKOPA/SA/10/0053

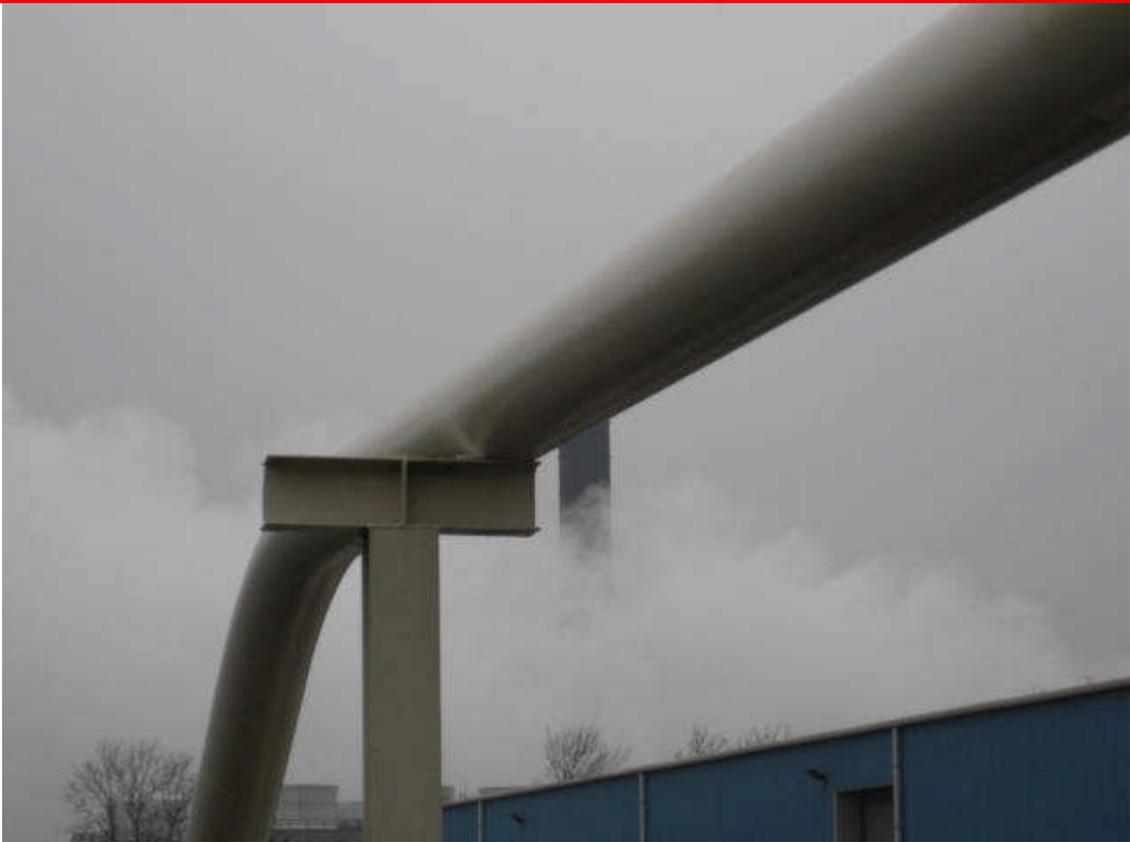
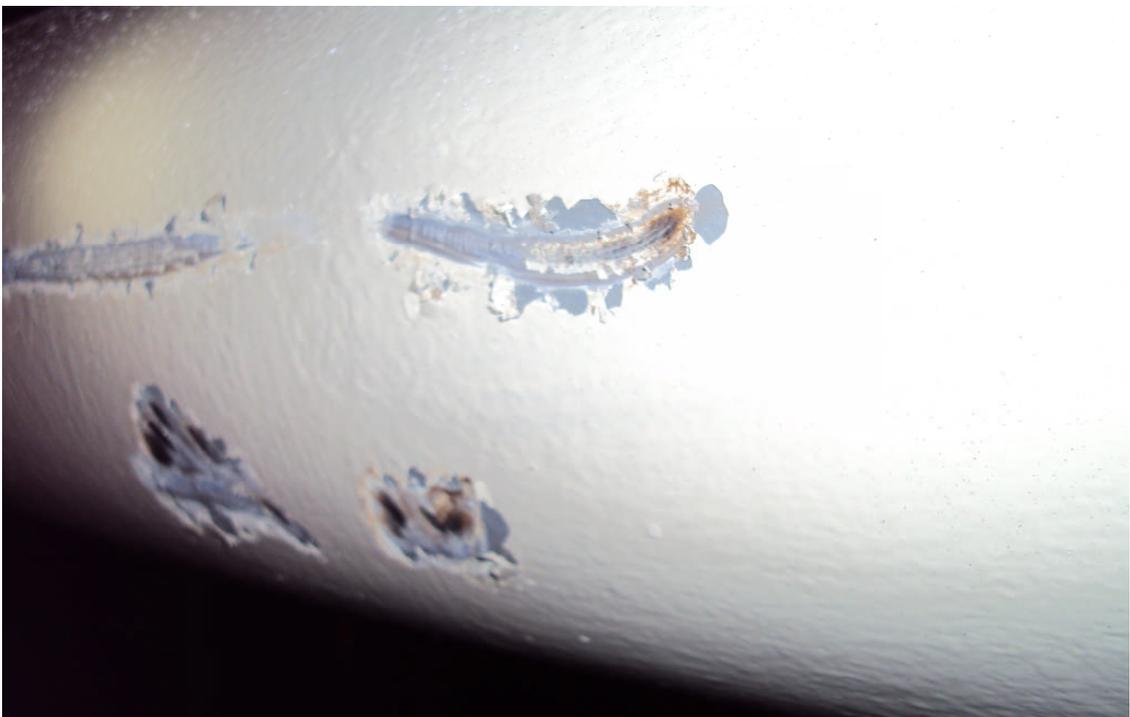
- An approved refinery contractor collided with the pipeline above ground section with a JCB on the 18th February during excavation works. Activities were alleged to have been restricted to hand digging only, however, the contractor used the JCB to 'drag' spoil to an area away from the excavation and in doing so, the boom 'elbow' collided with the side of the pipeline.

- Resultant impact caused coatings damage down to bare metal and horizontal displacement across the vertical support.
- Pipeline isolated - Block valve (Refinery south terminal) closed.

- Initial results from tests reveal no evidence of cracks. Minimum thickness measured at 7.3mm, average thickness measured at 7.6mm.

- X-Ray carried out on impact area and two circumferential adjacent butt welds.
- No crack like indications noted.
- Further inspections carried out by pipeline inspectors, mechanical engineers and fitness for service engineer.
- No concerns relating to horizontal displacement or impact.
- Pipeline lifted back to original position.
- Normal operations resumed approximately 24 hours from incident.
- HSE notified.
- Refinery to conduct appropriate investigation.

- Ensure that the contractor's risk assessment and method statement covers complete range of activities.
- Any change of working method must be reassessed for additional risks / mitigations.
- Ensure that appropriate levels of competence are demonstrated for the task in hand.
- Ensure that equipment used is suitable for task in hand.
