UKOPA SAFETY ALERT

Cause of Appomattox Natural Gas Pipeline Failure

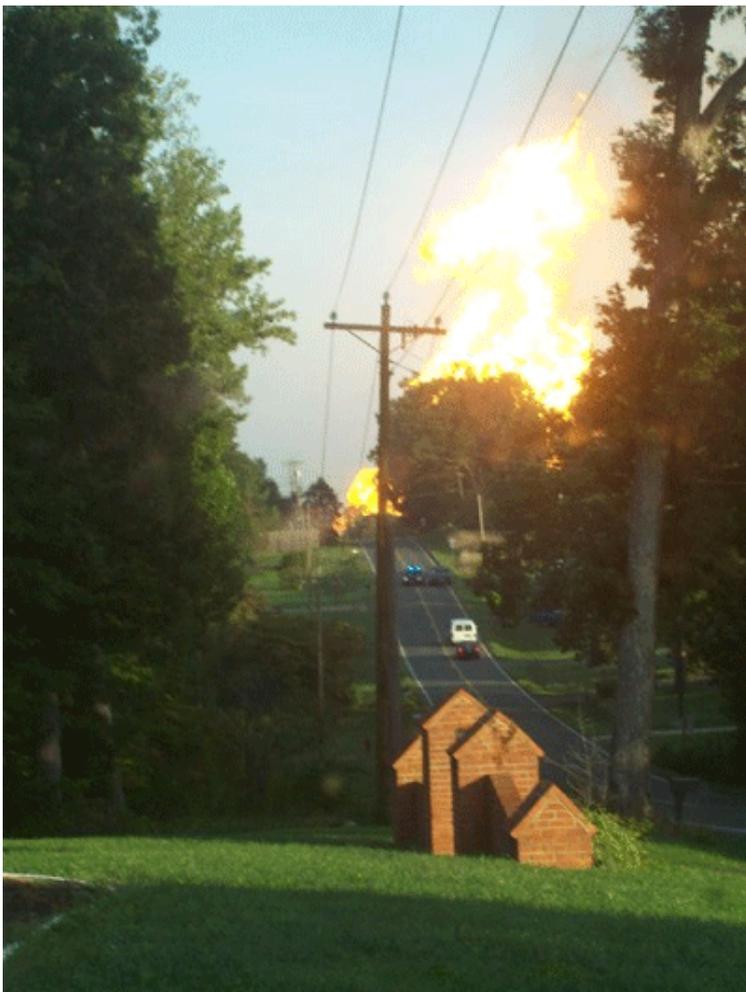
A 30" (762mm) diameter natural gas pipeline operating at 800 psi (55 bar) ruptured at Appomattox, Virginia, on 14th September 2008. The pipeline was one of three pipelines transporting gas from the Appomattox compressor station. The resulting fireball injured 5 people, destroyed 2 homes and damaged 6 others.

The cause of the failure has been confirmed as external corrosion, which reduced the local wall thickness by 50 – 75%. Corrosive soil conditions, warm gas temperature and failing asphalt coating contributed to the failure. In addition, rock in the backfill shielded the pipe from the applied corrosion protection current.

All metal loss indications greater than $\geq 50\%$ wall thickness detected by in-line inspection tools should be investigated in areas of reduced corrosion protection or shielding from corrosion protection (e.g. due to disbonded coating, rocks in the backfill etc) regardless of the signature assigned to the recorded inspection data.
