San Bruno Pipeline Failure

UKOPA Safety Alert October 2010

UKOPA/SA/10/0055

Natural Gas Pipeline Failure, San Bruno, California, 9th September 2010

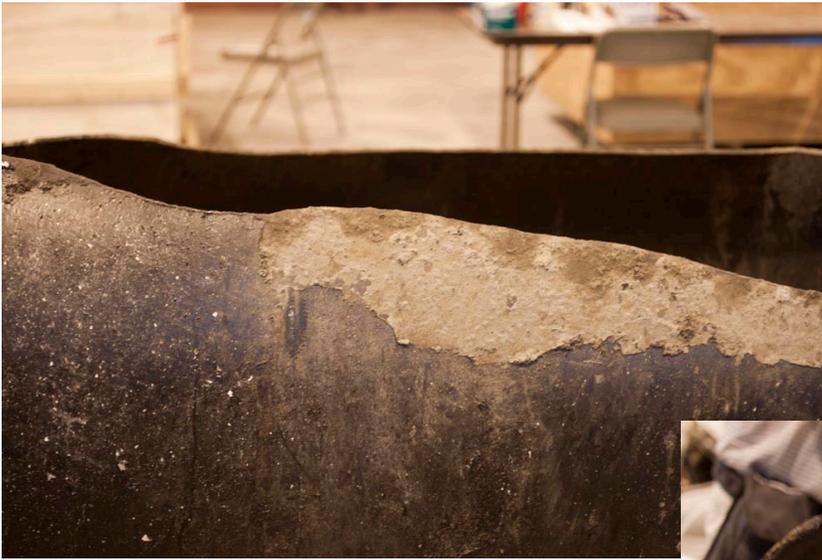
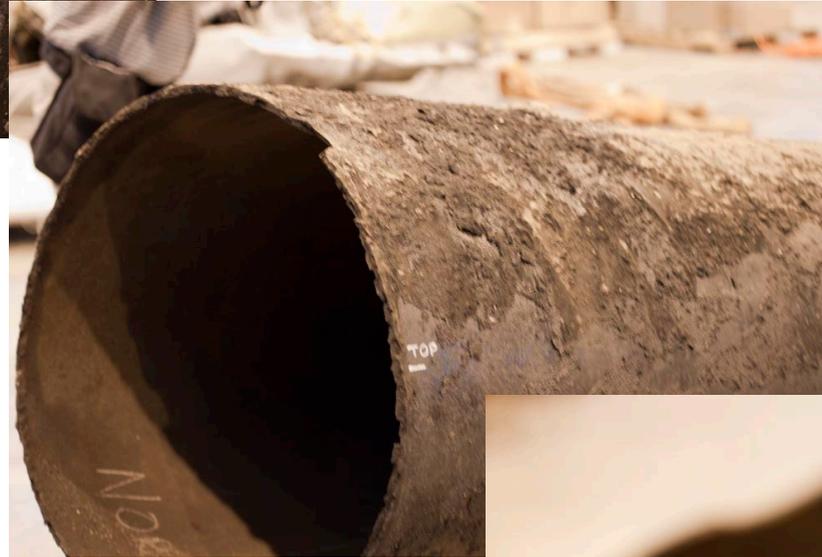
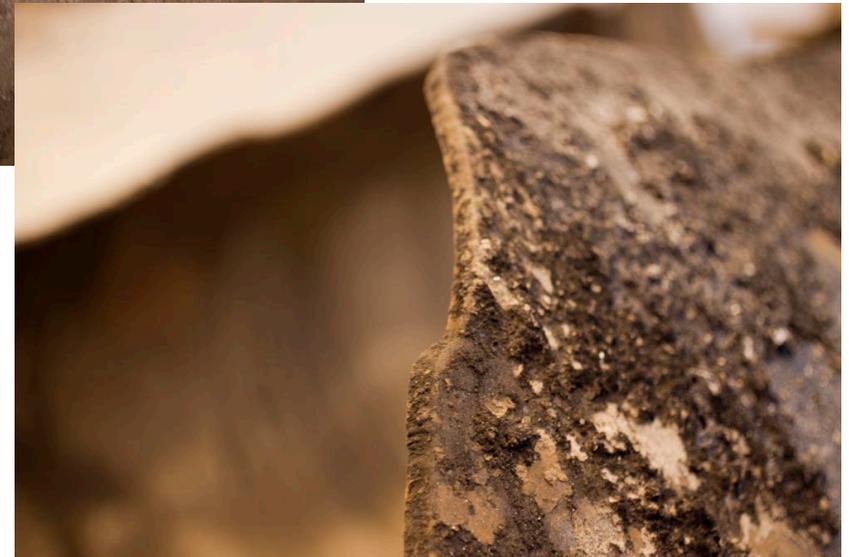
Photographs of failed section made available by NTSB

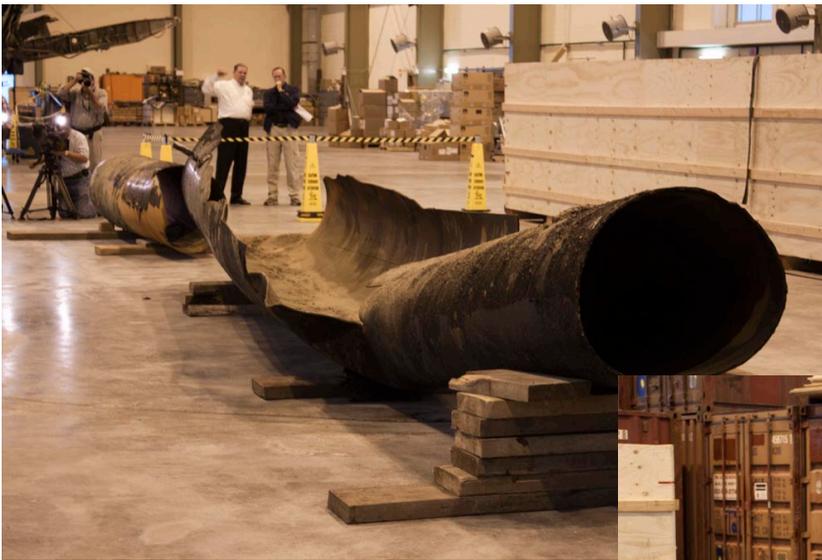
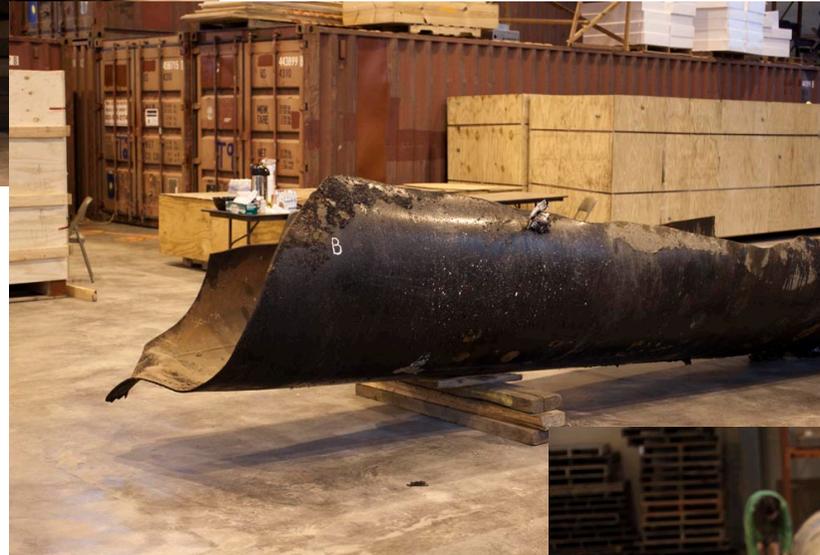
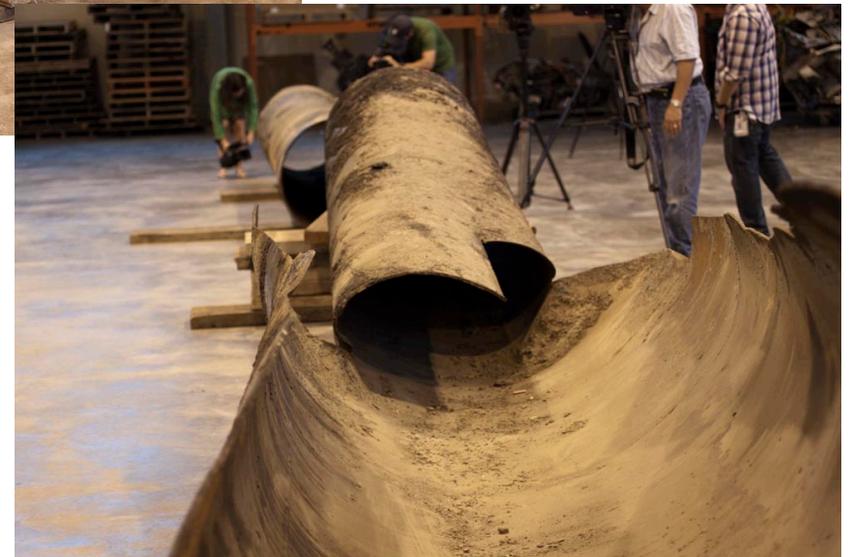
Photographs of failed section made available by NTSB
