Incident Investigation Summary

Release of Gas from Calibration Gas Bottle

Responsible Manager: Mick Jarvis
Incident Reference No: 1622/10/NG
Person Responsible for National Implementation: Andrew Fishburn

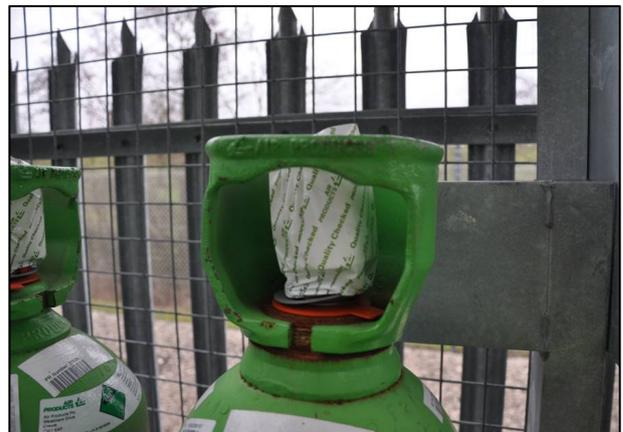
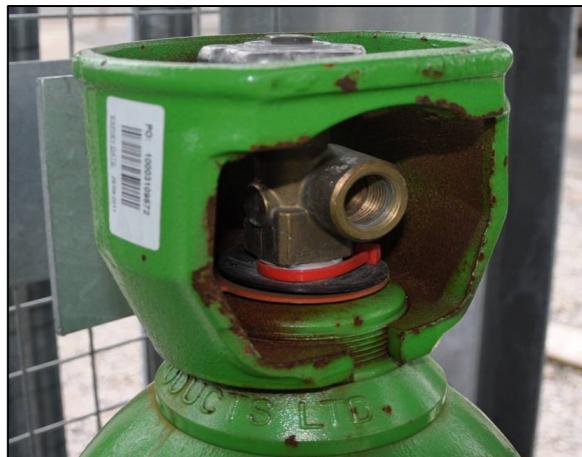
While removing the shrink wrapping on the isolation valve of a test gas bottle containing "zero air" at 200bar (pure air with no contaminants or hydrocarbons), an unregulated release occurred from the bottle through the bottle isolation valve.

The pictures opposite show the cylinder with and without the shrink wrap.

Although the bottle isolation valve was closed, it was not closed tightly. The action of removing the shrink wrap inadvertently moved the isolation valve a fraction of a turn, resulting in a brief release of contents.

The valves on all transportable gas bottles should be checked for closure tightness before undertaking any task, including transportation on site, removal of any form of seal or temporary closure, etc

Where possible, tasks should be undertaken in a suitably ventilated area, preferably outside, with the valve outlet facing away from personnel. Appropriate PPE should always be worn including protective glasses and gloves.
