# Incident Investigation Summary

Incident Reference No: 312388

## Electrical incident whilst carrying out testing at St Fergus Terminal

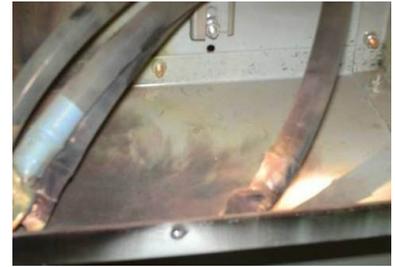
Site personnel were carrying out a number of phase rotation checks on a modified low voltage distribution board which was part of an ongoing construction project. Upon commencement of a test, the section being checked short circuited causing the protection to operate. No personnel were injured and the fault was contained within the rear terminal chamber of the circuit.

Pic1: Cable shorted in rear of panel
