WILTON SITE - SAFETY LEARNING EVENT

Title: Lightning Strike on TPEP

Date of event: 4 August 2012

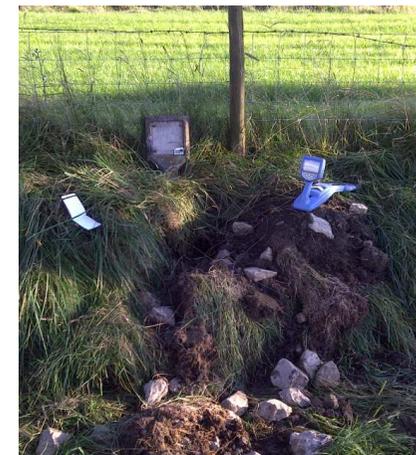
On Saturday 4th August, the Transformer Rectifier (TR) near Gargrave tripped. The TR was reset by a Pipeline Superintendent on Monday 6th. On Tuesday 7th the landowner at Horton Pasture rang the Pipeline Office to report a ground disturbance adjacent to a pipeline marker. A Superintendent attended the scene to assess the situation. The ground at the marker post had been blown out and the marker post damaged. A CP post upstream had also been damaged. Horton Pasture is around 2km downstream of the TR position. The control room were asked to reduce the line pressure as a precaution until further investigation took place.

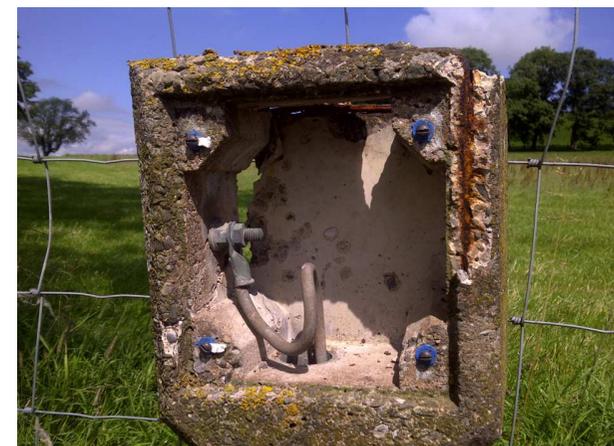
It is thought that a lightning strike hit the CP post, causing the damage seen. The charge from the strike travelled down the CP cable on to the pipeline, travelling upstream to the TR, where the charge exited the line to via the TR cable, causing the TR to trip. The charge also travelled downstream where it found a weakness in the coal tar wrap, at which point it discharged to earth via the wrap.

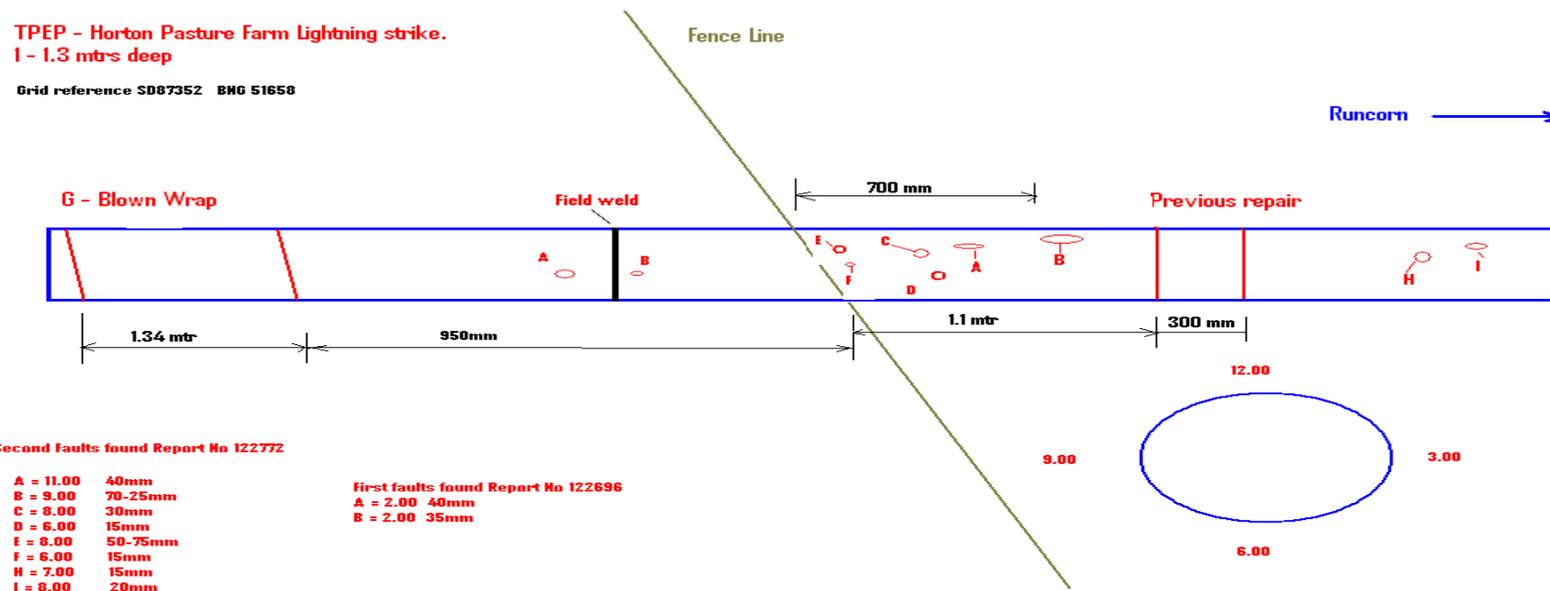
TPEP - Horton Pasture Farm Lightning strike.
I - 1.3 mtrs deep

The pipeline was excavated in the location of the ground disturbance. Initially two small wrap defects were found, but on extension of the excavation a larger section of damaged wrap was uncovered. The areas where wrap had been damaged were NDTd using UT thickness measurements and MPI crack detection. There was no visual damage to the pipeline and nothing untoward was shown up on the NDT. The line was re-wrapped and the excavation back-filled.

Second Faults found Report No 122772

A = 11.00 40mm
B = 9.00 70-25mm
C = 8.00 30mm
D = 6.00 15mm
E = 8.00 50-75mm
F = 8.00 15mm
H = 7.00 15mm
I = 8.00 20mm

First faults found Report No 122696

A = 2.00 40mm
B = 2.00 35mm
