# Safety Flash (2013-A-004)

**Subject:** Damage to 415V Buried Cable

**Site Location:** CE Barry Power Station

**Date:** 09-04-2013

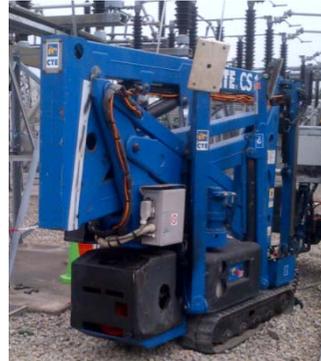
It is believed that this damaged was caused by the operation of the tracked MEWP in the area.

Tracked MEWP

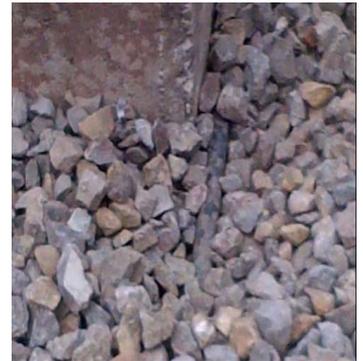
Further investigation ensued and damage to the 415V supply cable, which was only partially buried on the hardcore floor of the switchyard, was revealed.

Partially Buried Cable

- The cable supplying the accommodation units was installed in 1997. It was not installed correctly and was not buried to the correct depth so as not to be damaged during maintenance / vehicle activities within the switchyard.

- Where practicable, check the depth of buried cables, and record (e.g. CDM H&S File information).
- If unsure of cables within any working area, CAT scan the area to identify potential cables. If MEWPs or other mobile plant are to be used within the vicinity, additional protection should be considered (i.e. steel sheet or suitable boards).

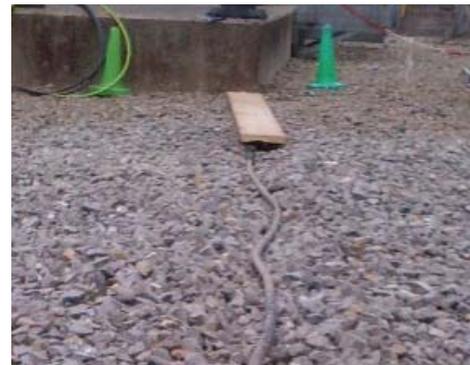
Cable fully exposed post incident

Supply to the accommodation was isolated and a PTW issued to enable jointing operation to commence.
