LEARNING FROM INCIDENTS

2013AW07

April 2013

Misidentification of Pipeline Leads to Crude Spill

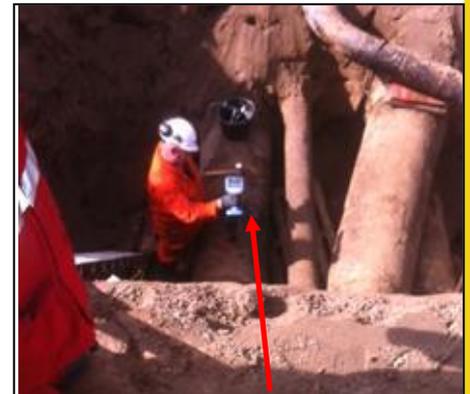
An estimated 1-5 m³ (6-30 barrels) of crude oil were released from a third-party, off-plot pipeline in September 2012. The line had been mistakenly identified as an abandoned Shell pipeline, and a 5 mm (1/4") test hole was drilled into it.

While the contractor and Shell Pipeline Services were working to identify the owner of the line, the operator of the pipeline started to pump crude and the line started to leak. The leak continued for over an hour until the operator of the pipeline was identified and the pump was shutdown.

Figure 1 – Pipeline that was drilled and leaked
Post incident photo

- A nearby 24" third party pipeline was misidentified as the 20" Shell pipeline. The radio detection tool provided inaccurate or erroneous data. After the incident, testing and advice from the radio detection tool manufacturer indicated that the proximity of the pipelines and/or the thickness of the insulation layer in the Shell pipeline could cause such an error.
- The contractor coordinating the work and the Shell Pipeline Services employee believed that the radio detection tool was accurate and reliable.
- They did not use a secondary means of identifying the line such as:
 - Excavation of the pipeline area and identification of each pipeline by its owner, or
 - Measuring the diameter of the line. (Since the pipeline was partially uncovered, the difference in size of a 24" line and the 20" line was not apparent.)

- If an area has multiple pipelines present in close proximity to one another, radio detection tools should not be the sole means of identification. Consider working with other pipeline owners (to the extent they can be identified) to facilitate excavation of adjacent pipelines in order to confirm identification of the proper pipeline before conducting work. This is a regulatory requirement in some locations.

- The pipeline work did not use a permit to work process, since it was outside the refinery fence line. In such circumstances, the DSM process isolation and permitting standards should still be applied for work on or near M pipelines carrying hydrocarbons or other hazardous substances, as applicable.
