**Safety Alert No: Jan 01**

**Subject:** Fire on-board Hummingbird FPSO EV 162913

**Platform/Site/Area:** Hummingbird FPSO UKNS

**Date of Incident:** 27<sup>th</sup> December 2013

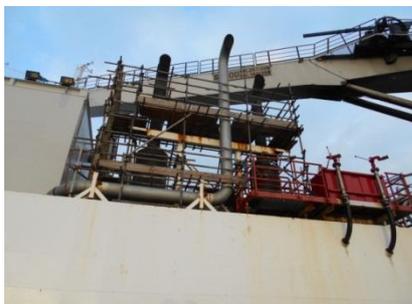
Both diesel generators (“DGs”) were being run simultaneously in addition to an OPRA turbine due to the offload power requirements. Under normal circumstances, 2 OPRA turbines would be operating with a DG on under light load as a backup. As only one OPRA turbine was operating, the 2 x DGs were operating at higher loads / exhaust temperatures than normal.

It appears that the scaffolding board adjacent to or in direct contact with the exhaust of the first DG started to smoulder, causing hot embers to be blown into the general waste skip, which then caught fire.

Scaffolding boards and DG exhausts in-situ.

1. Scaffolding boards should be removed from the structure around the exhausts, leaving only the boards adjacent to the walkway on the deck level (heat protection to personnel);
2. General waste, and soft plastic skips should be relocated from their current location;
3. The damaged light fitting should be isolated, until replaced, and cables should be checked for damage;
4. The DGs should be tested to ensure exhaust integrity within the DG room, following the exhausts being exposed to higher running temperatures; and
5. Both DG exhausts should be replaced with new units as soon as possible.

It is further recommended by CE E+P that Operations teams should ensure that scaffold boards or other combustible materials are not placed in direct contact with a heat source.

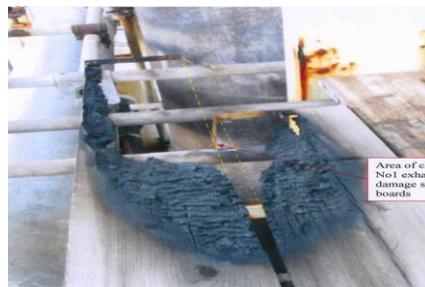
Close-up of charred scaffolding boards

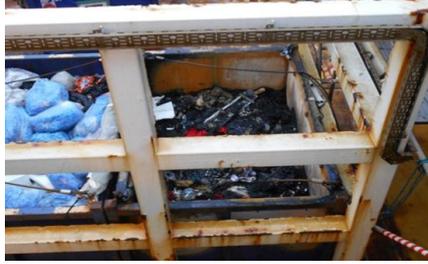
A single flame detector activated in the control room. A production operator was sent to investigate and confirmed that smoke was coming from the general waste skip on the stores lay down area.

View from above skip with fire damage visible.
