**Fatal accident on the G2 construction site****DATE, LOCATION & KEYWORDS**

# HSE ALERT

## 2013-37

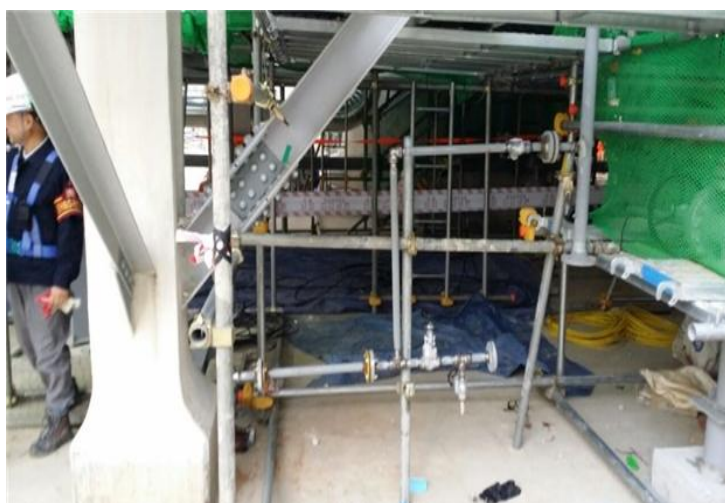
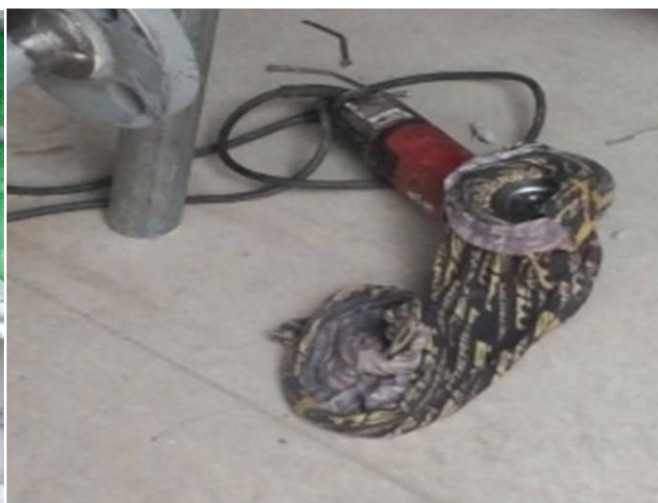
- The contractor worker was working to eliminate the rust on 1 inch piping with a power wire brush before painting.
- The victim was wearing a neck muff to keep warm from cold weather.
- The neck muff rolled into the power wire brush and the victim was suffocated by being strangled his respiratory tract by the muff around the neck.

| Immediate causes | strangulation : a neck muff around the worker's neck rolled into the power wire brush and pressed the victim's respiratory track |

Loose clothing and open (= unprotected) rotating equipment are not compatible !

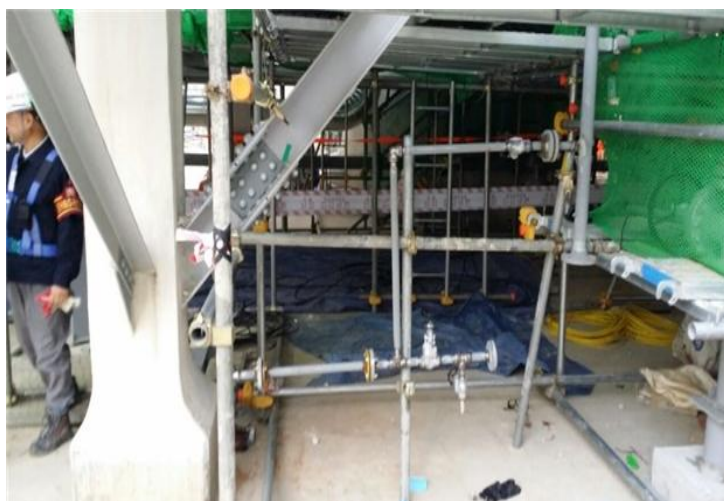
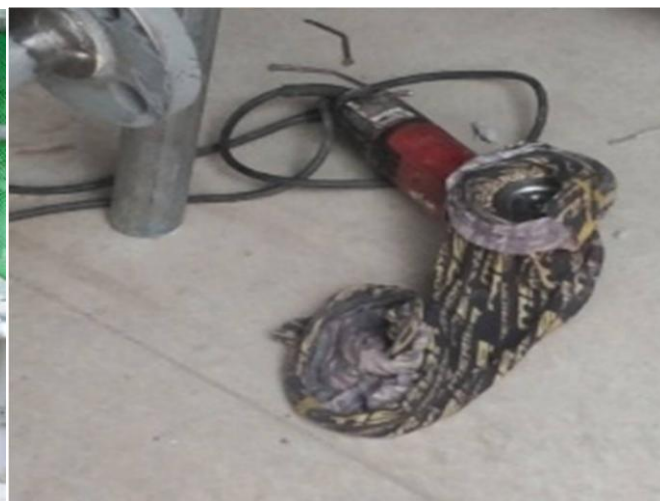
- Un sous-traitant était en train d'enlever la rouille d'une tuyauterie d'un pouce avec une brosse électrique avant d'entamer des travaux de peinture.
- La victime portait une écharpe autour du cou pour se protéger du froid.
- L'écharpe a été emportée par la brosse électrique et la victime a été étranglée par l'écharpe fortement serrée autour du cou.

| Causes immédiates | étranglement : écharpe autour du cou de la personne a été emportée par la brosse électrique et a fortement serré son cou |

Vêtements non attachés et machines tournantes non protégées ne sont pas compatibles !
