## ***Failure of Galvanised Lighting Mast Welded Base Support***

**Platform/Site/Area:** *Drilling Platform 6 (DP6) Weather Deck, Morecambe Bay East Irish Sea*

**Date of Incident:** *13<sup>th</sup> October 2013*

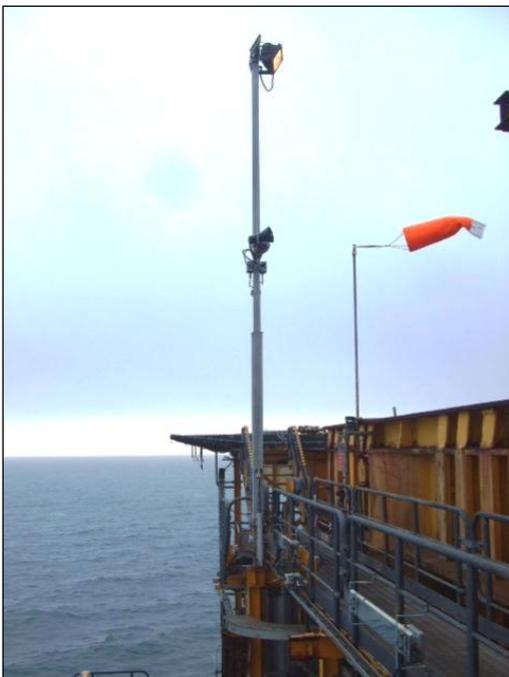
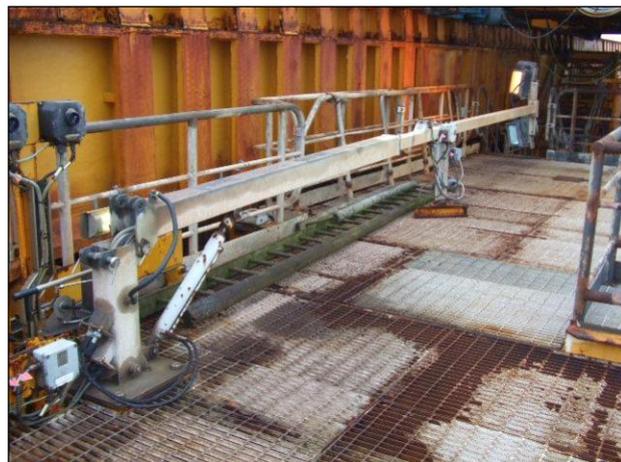
Typical arrangements of a lighting mast in the vertical (operational) and the horizontal (maintenance or storage) positions.

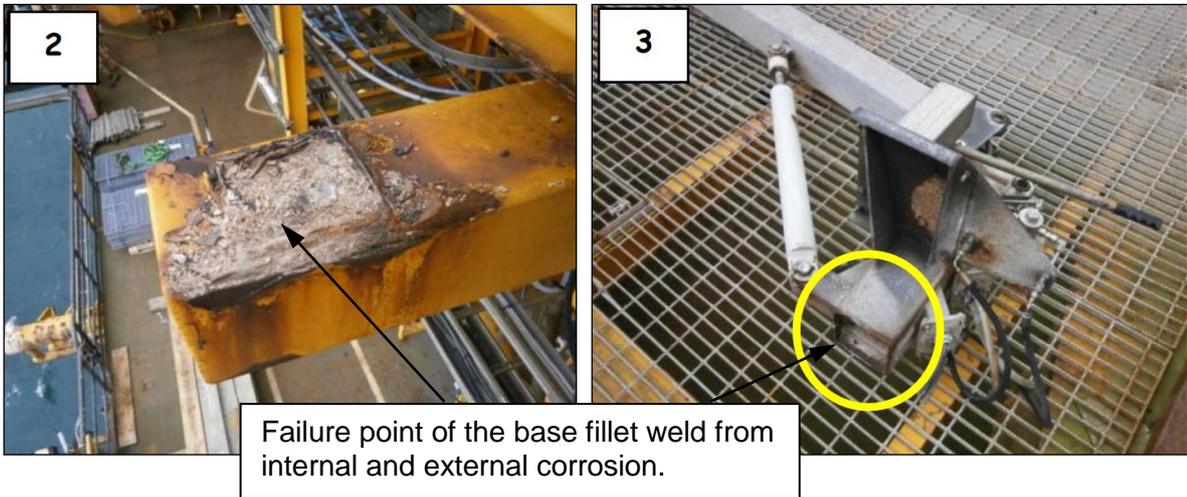
The lighting mast has a construction design that allows the box section to trap rainwater while in the horizontal position that cannot drain away unless effective modifications have been made. The action of welding galvanised components to other carbon steel structures causes a heat affected zone and for the zinc coating of the galvanisation process to melt and vaporise away from the immediate surface area due to the temperature of the welding process. If no surface protection or recoating with a zinc rich system is carried out the area will be subjected to increased corrosion rates.

The weld is also a simple fillet weld on the box section and flat surface with minimal penetration. Wicking of the rain water will occur under the box section flat end and then up the inside line between the weld and the box section which can give rise to internal cracks/weld failure that are not always obvious from external visual inspections especially if the external surface coating has been recently maintained.

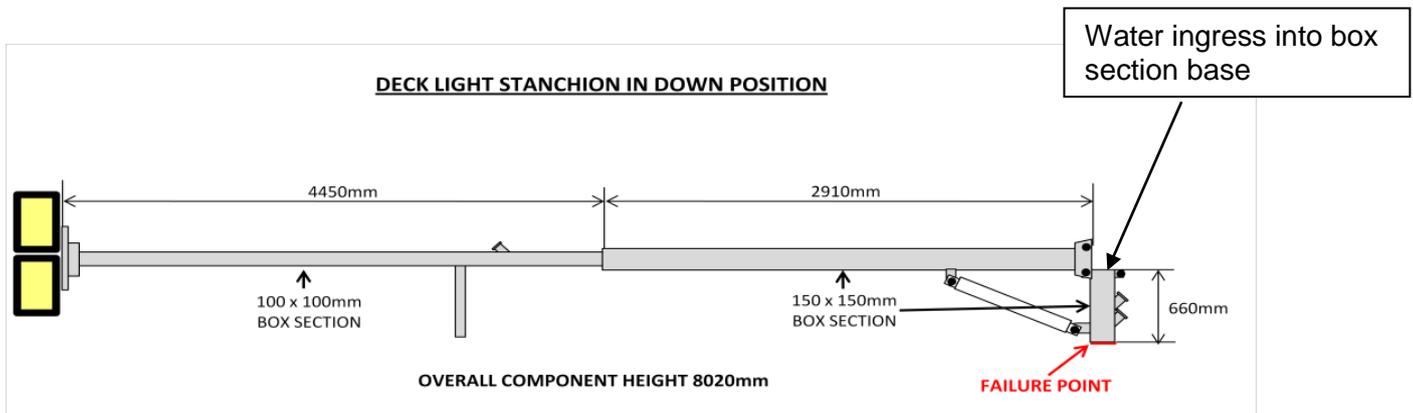
Other masts installed on the platforms have an improved design where the box section base is welded to a mounting plate then galvanised and bolted to the platform steelwork. This style has a significantly reduced corrosion rate and still fit for purpose.

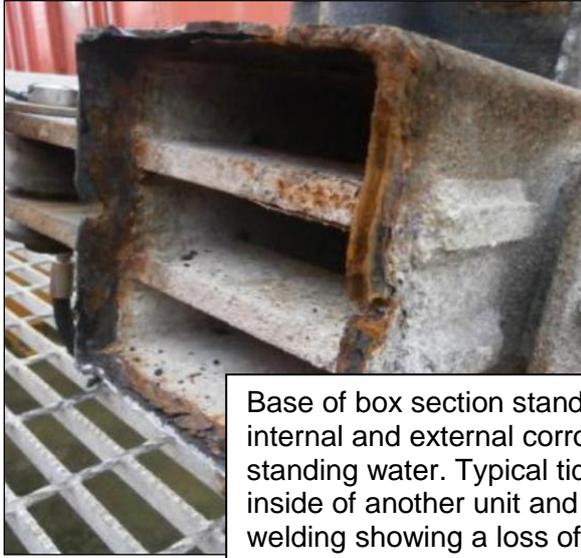
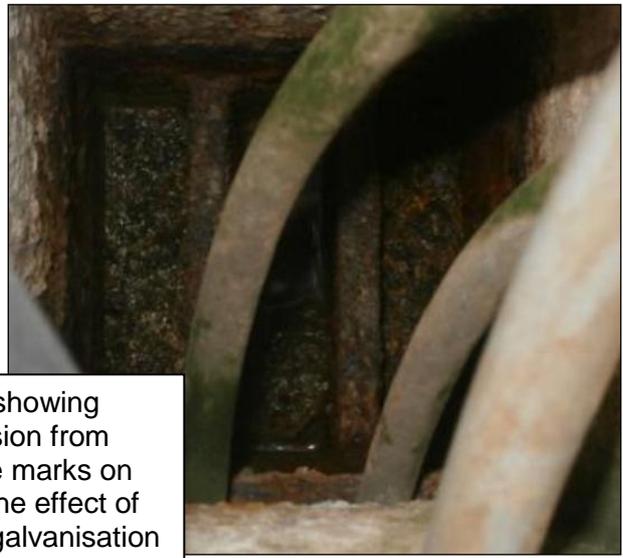
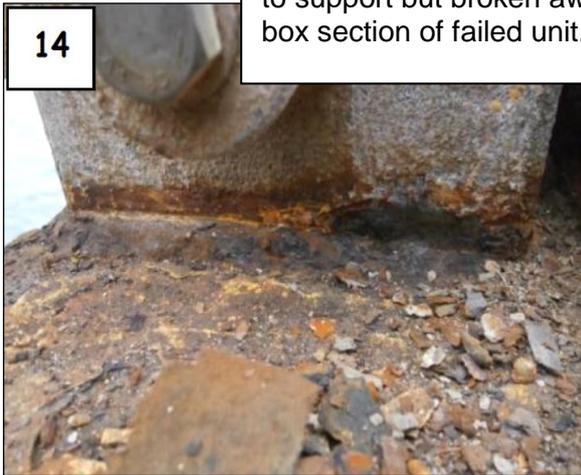
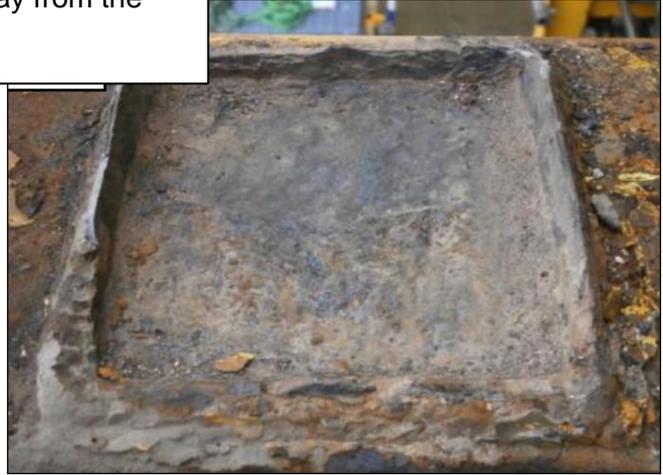
Base of box section stand showing internal and external corrosion from standing water. Typical tide marks on inside of another unit and the effect of welding showing a loss of galvanisation just above the weld with corrosion developing between the weld and the box base. Remaining weld connected to support but broken away from the box section of failed unit.

- 4. Carry out suitable Fabric Maintenance externally and where access allows internally, to protect surfaces prone to dissimilar metals/HAZ corrosion from atmospheric conditions/water ingress*

- 5. Carry out suitable inspection techniques such as MPI, Eddy Current or Alternating Current Field Measurement (ACFM) to confirm weld connection still has integrity in similar situations. Review the inspection technique for the application as not all methods can be reliable in some cases. Provide a suitable certification process for these items to give Operations confidence that units are fit for purpose.*

- 6. Protect the entry points from water ingress and/or provide suitable drain points to prevent water build up inside.*
- 7. Any lighting units or equipment that are suspected of having internal/external corrosion build up that will affect the structural or pressure boundary integrity should be suitably supported, isolated electrically and mechanically as appropriate, recorded in local isolation records/certs and subsequent timely plans put in place to repair, replace or remove.*
