Health & Safety Red Stripe Bulletin

072b/13/LPB

FIRE IN COOLING TOWERS DURING MAINTENANCE STOP - AUGUST 2013 - SEGAL, FRANCE

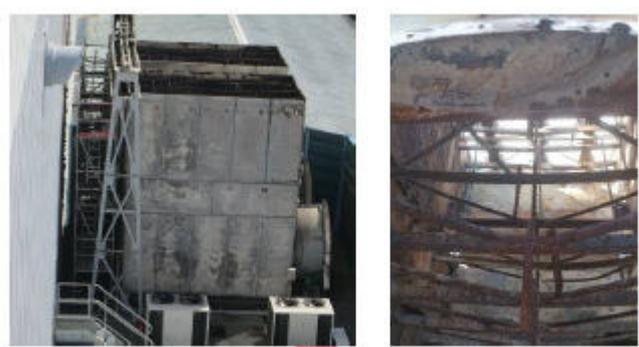
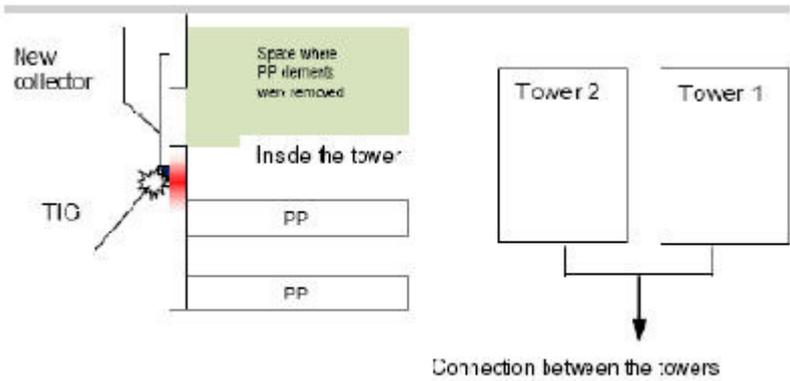
TIG welding was used to avoid extra sparks and to get an overlap between the casing and the new collector. The worker was welding when the fire started: +/-50% of the welding was already done. The droplets separator elements, which contain polypropylene, were not completely removed. The heat conduction generated by the welding was strong enough to set fire to the polypropylene elements.

The fire in tower one was propagated to the second tower via the water exhaust pipes that link both towers.

Although the work was being done in one of the towers, the second one caught fire due to the connecting pipe. Both towers were destroyed. The blaze stopped when the polypropylene calorific load was consumed. The extinguishers of 9kg in the place of work were insufficient to overcome the blaze.

Recommendations	Person Responsible	Completion Date
* Indicate the level of inflammability of the polypropylene material.	Plant Managers/Engineers	31/12/2013

* Put a yellow triangular warning sticker 'DANGER HOT WORK' on the cooling tower to indicate the hazards.	Plant Managers/Engineers	31/12/2013
* Follow the rules of the hot work permit. In particular the rule that describes the minimum distance between the inflammable elements and the heat source of at least 10m.	Plant Managers/Engineers	31/12/2013

* In case of hot work on cooling towers, make sure they are properly insulated.	Plant Managers/Engineers	31/12/2013
* The role of a fire watch has to be clearly defined and known. They need to be qualified and clearly visible.	Plant Managers/Engineers	31/12/2013
