## INCORRECT GAS MAIN TIE-IN PROCEDURE

## WHAT HAS HAPPENED:

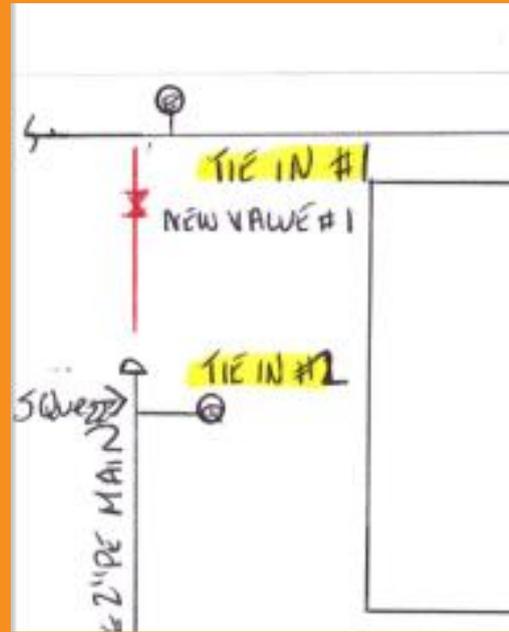
- A team was carrying out a tie-in procedure between a new PE main and existing 3" steel main using a Mueller D5 device.
- The team identified an abandoned 2" instead of the 3" live main and proceeded to weld on a tee for the tie-in.
- Pressure gauges were not installed as instructed in the SOP (system operating procedure) therefore the starting pressure was unknown and the pressure reader on the Mueller device incorrectly identified the pressure of the new PE main as the valve was open.
- Gas was introduced into the abandoned main as the tapping machine completed the procedure.

Extract from the SOP's sketch showing the layout of the tie-in and surrounding area. The 2" main which was tapped instead of the 3" main (running across the top) is not included.

- Pressure gauges were not installed as directed to determine starting pressure – therefore the crew did not know they were working on an abandoned main.
- The plans (produced from the NRG mapping system) were believed to be incorrect when a 2" main was located instead of a 3" but no further checks were made to verify if this was the case.
- Opening of the valve before the tapping procedure was complete meant gas was instantly introduced into the abandoned main.

- Managers to communicate to field operatives they must follow SOP and inform the SOP coordinator if they cannot comply for any reason before proceeding with any further work.
- Ensure pressure gauges are used correctly to assist in ensuring the proper mains have been identified.
