Safety Observation

Crane Lifting Incident

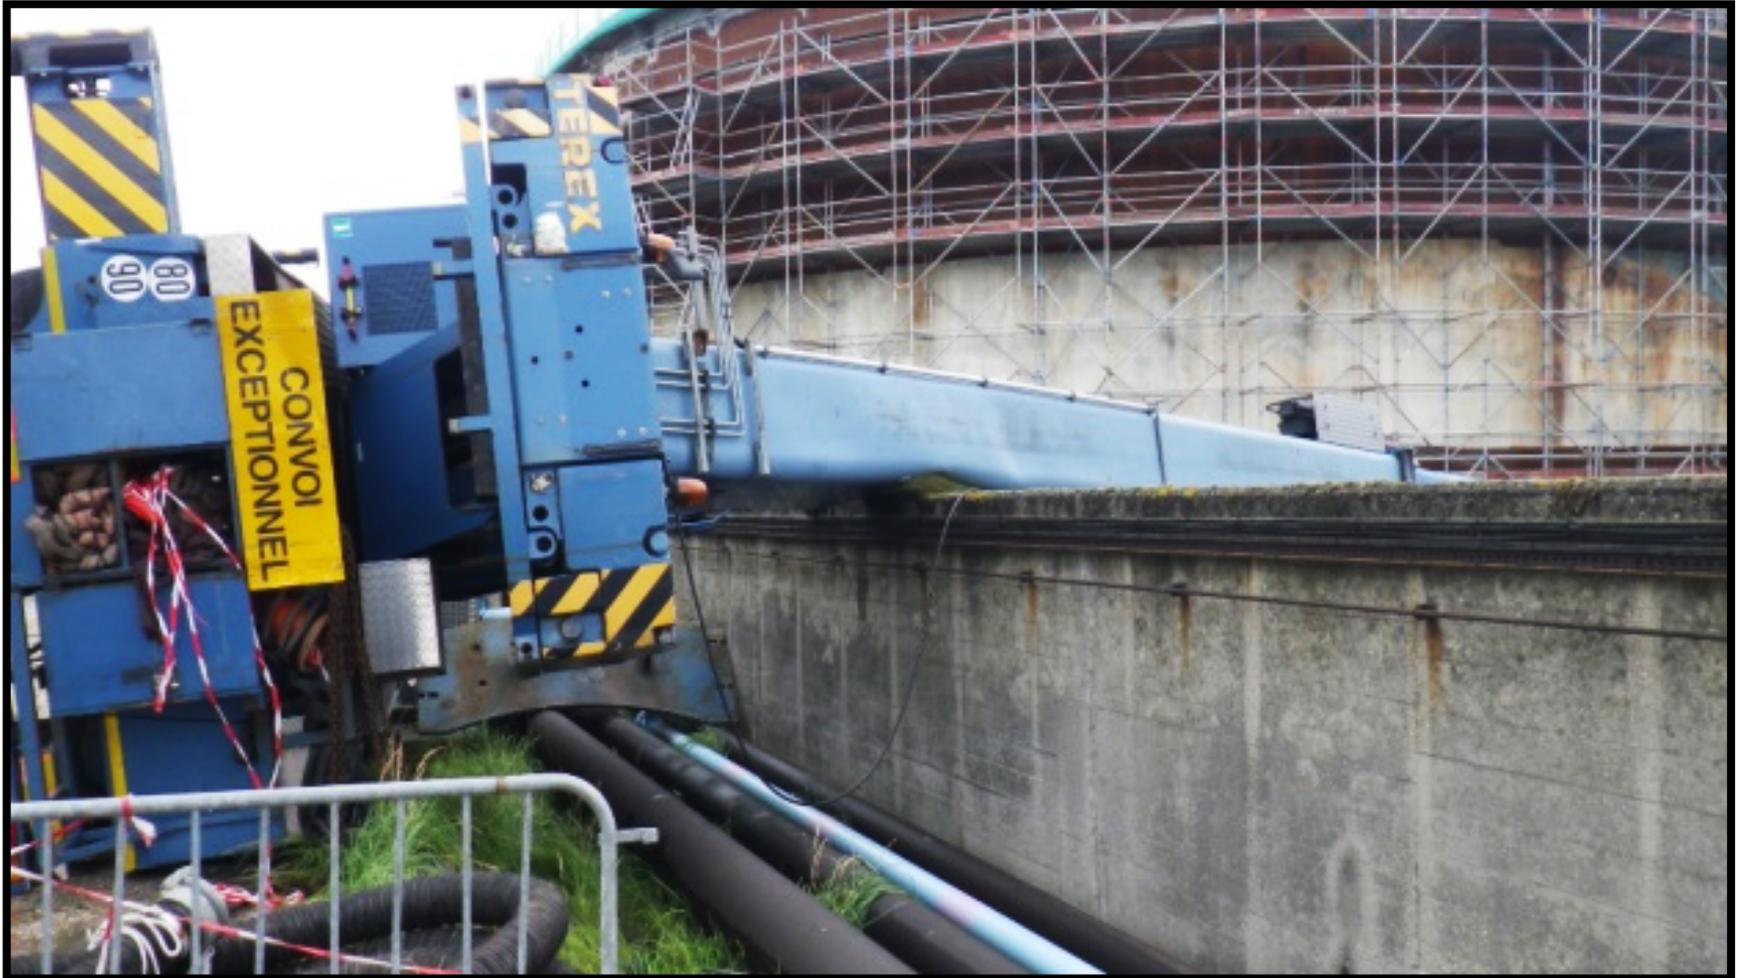
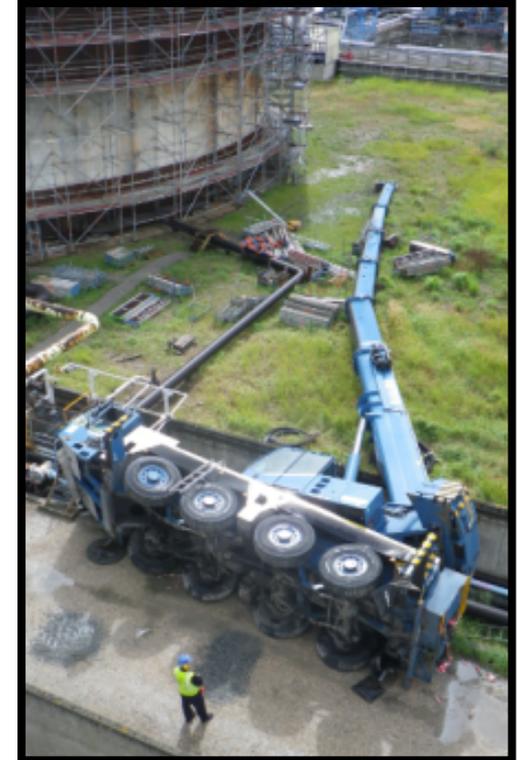
- A contracted crane operator was starting a lifting operation with a DEMAG 80 ton hydraulic crane to transfer material inside a tank bund area.
- While lifting a 1.4 ton load (scaffold material), the crane tipped toward the south and landed on the tank bund wall.

- Crane operator did not follow procedures / standards : crane outriggers 50% extended, although entered as 100% extended in crane control program.

- Procedures not followed
- Enforcement LTA

- Consequence applied for Crane and Lifting company.
- Share incident (define field verifications audits by contractor management).
- Share incident with Crane and Lifting CoP to review/define second barriers standards.
