## IMCA Safety Flash 21/15

December 2015

The focus or theme of this safety flash is lifting. All the incidents involve cranes, lifting or loading operations.

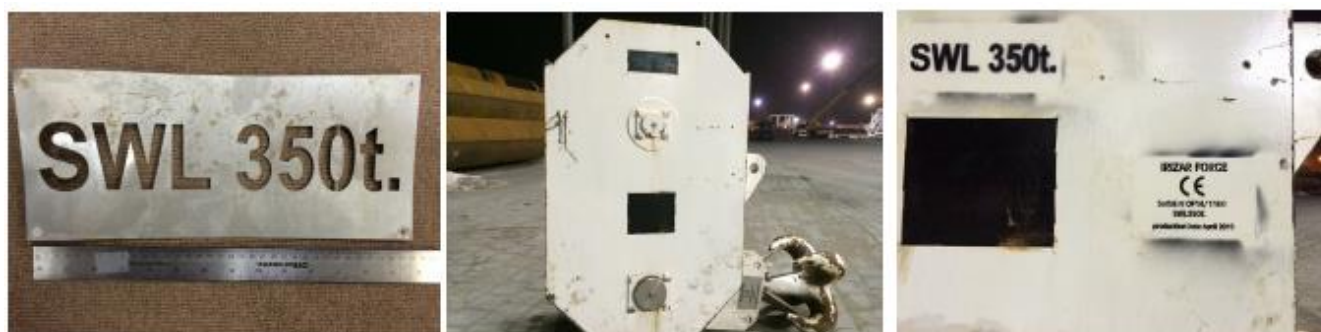
A member has reported a near miss incident in which an object – a steel SWL plate weighing 0.7 kg - fell from a crane block onto the deck. The incident occurred when a crane fast line was being used for loading operations from the quayside. A banksman and two riggers were on the quay in the process of choking off the lifting slings and connecting them to the crane fast line hook. During this task a steel SWL plate (0.7kg) fell from the Crane Auxiliary Block which was not being used at that time. The SWL plate fell from approximately 71m in height and landed at approximately 5m away from the working party. The DROPS calculator tells us that such an object falling from such a height could have caused a fatality had it hit someone.

- ◆ The SWL plate fell from the crane auxiliary block and there were similar plates still on this block and on the main block. Both these blocks, and the whip line block, had all been replaced during the re-fit period to enable the crane to operate subsea for a particular project;
- ◆ The means of securing the plates was of poor design – several plates including the one dropped were attached by four rivets of dissimilar metals (aluminium vs steel) promoting galvanic corrosion process and salt water corrosion;
- ◆ All plates showed signs of corrosion behind the plate – however deterioration of the rivets was not visible on the plate surface;
- ◆ All plates were flush against their fixings and looked secure to any visual inspection;
- ◆ There was no significant weather at the time of the incident.

The plates were removed. SWL and other identifying information was stencilled on the crane instead. There was an inspection of similar hook blocks elsewhere to verify that there were no loose objects or unsecured plates. The crane supplier/manufacturer was informed of the incident (lessons learnt to prevent further reoccurrence).

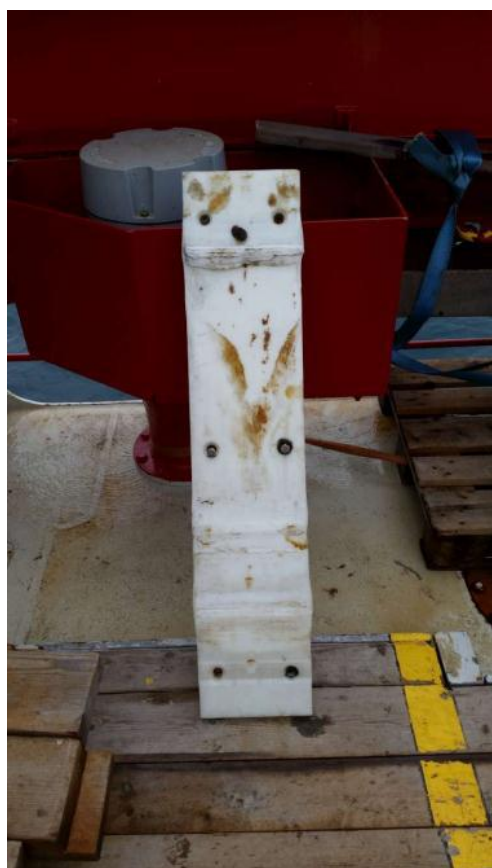
During piling operations on a chartered vessel, the crane had been used to recover an upending tool to deck. After de-rigging the crane, the riggers left the deck, while the crane operator proceeded to park the crane. Upon placing the crane boom in the rest, a Teflon pad weighing 6.9kg, dropped 8.8 meters from the starboard side of the crane rest down to the deck. The pad dropped directly to the deck and landed in an open area, just aft of the crane rest.

*Teflon pad.*

- ◆ Inspection of the dropped pad revealed that sheared parts of only two of six securing bolts remained in the pad;
- ◆ A similar incident had occurred on the same vessel some 10 months earlier, where the pad was found to be loose due to sheared retaining bolts;
- ◆ This earlier occurrence had not been investigated, allowing a repeat incident to occur with greater consequences;
- ◆ The Teflon pads and their retained bolts were inadequately or poorly designed;
- ◆ More frequent inspections of crane rest pads should be conducted to identify defects.

Our member concluded that the fundamental design of the pad was flawed. The purpose of the pad is to buffer impact and movement between the crane and the crane rest to provide protection to the crane boom during parking, stowage and start up. The weakness in the design was demonstrated by the fact that this was the second similar incident to have occurred. Additionally, had the earlier incident been investigated and remedial action taken, this second incident need not have occurred.

- ◆ Inspection of the condition of crane rest pads and associated retaining bolts;
- ◆ Addition of crane rest pads to planned inspection/maintenance routines;
- ◆ Considered the use of secondary retention devices on crane rest pads;
- ◆ Reinforced the importance of reporting incidents in a timely manner;
- ◆ Ensured deck crews took a “Time Out for Safety” (TOFS) to reinforce safe crane technique, including the requirement to bank the crane at all times – including parking and releasing the hook/headache ball from its stowage box.

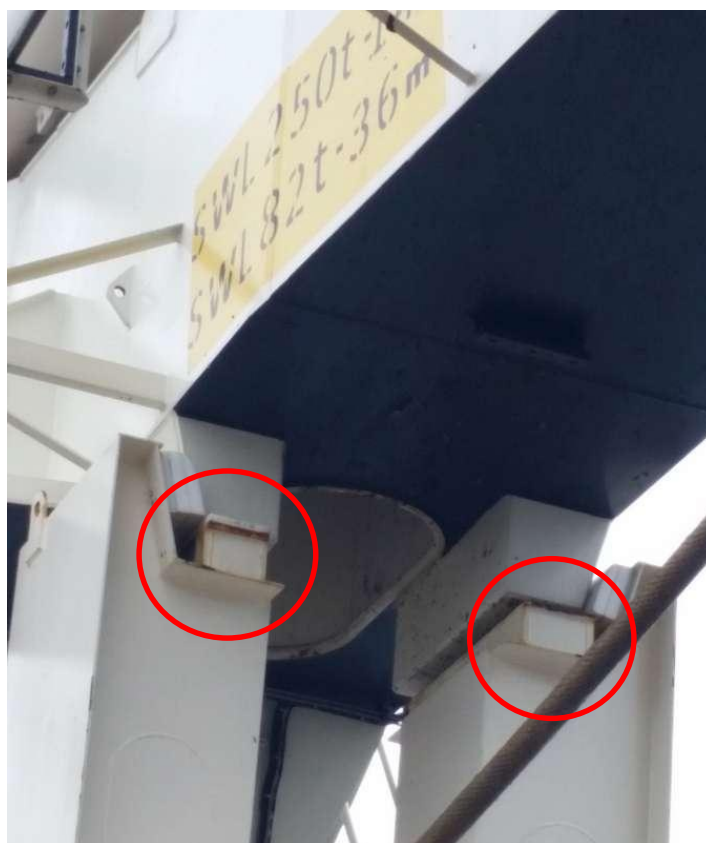
*Location of Teflon pads on crane rest.*

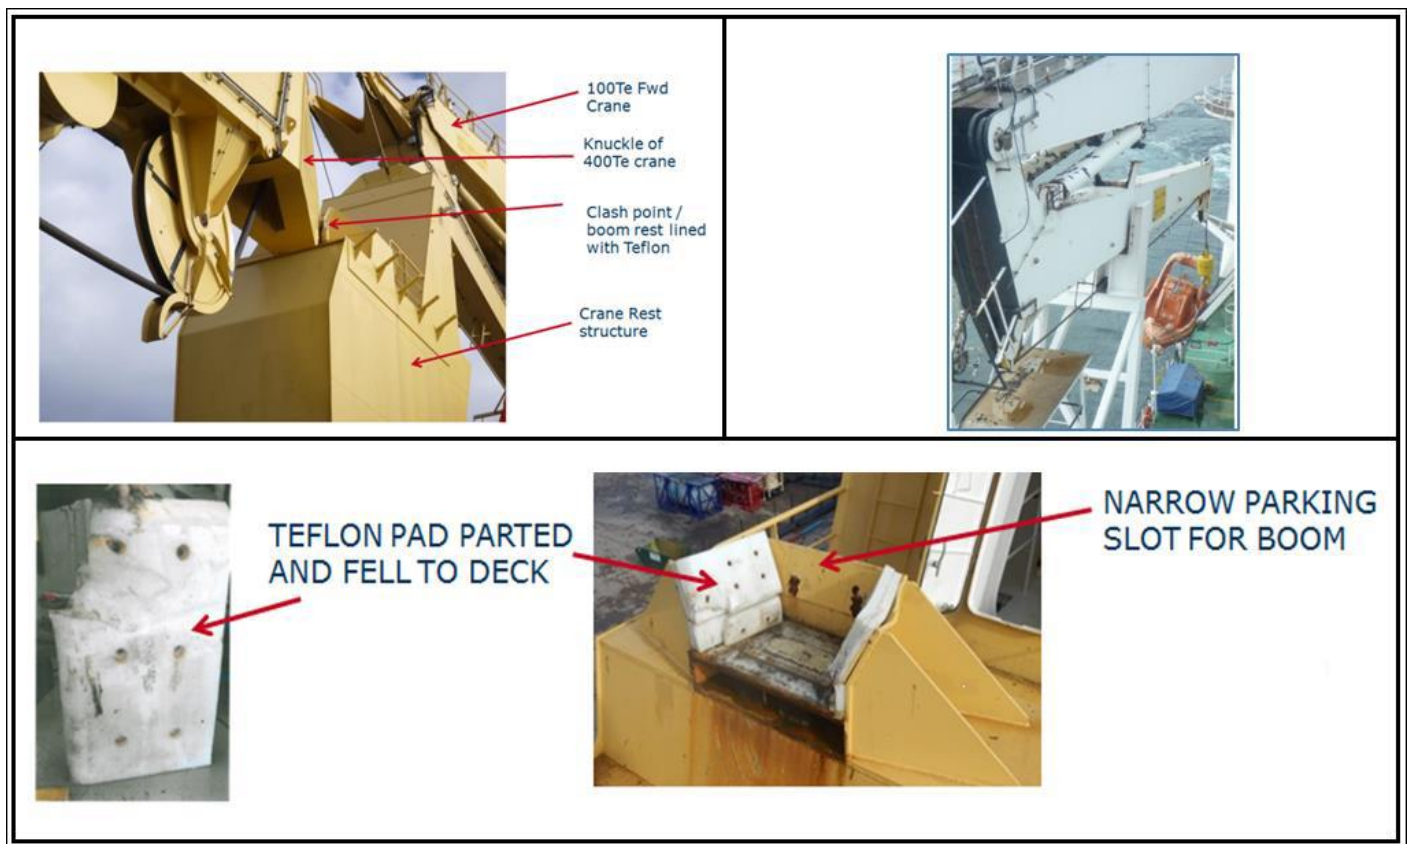
A member reported frequently dropped objects from crane rests during parking and when the crane boom was raised out of the crane rest. The falling objects had been Teflon or wooden landing pads, rubber protection, steel cover plates and nuts/bolts. An example is highlighted below:

- ◆ The crane rest had a tight fit/narrow parking slot for the crane boom;
- ◆ The crane rest protection cracked and although bolted dislodged as a result of everyday contact from the crane boom;

- ◆ Additionally it was difficult to monitor the landing/raising of the crane boom from the crane cabin.

- ◆ Teflon pads have been re-secured using larger washers on the bolts to prevent the bolts from being pulled through the Teflon/rubber, and a secondary chain has been attached to prevent the Teflon/rubber from falling to deck;
- ◆ Area around boom rest barriered off before parking/raising the crane boom;
- ◆ A dedicated spotter has been used to monitor the crane parking/raising operation;
- ◆ Cameras installed to aid inspection of the crane boom rest and assist parking/raising.

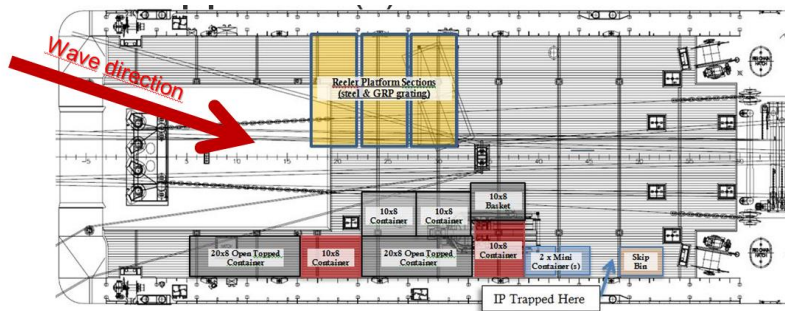
Plan view of vessel.

During this time the deck crew continued work on securing the cargo. Two Able Seamen (ABs) working on the deck decided that the sea fastening arrangement was not adequate to restrain the two mini containers located at the forward end of the deck. Additional rigging was required to rectify this, and one of the ABs left the deck to go to the nearby rigging store. The tension on the tugger winch was released to facilitate installation of the new rigging. A large wave crashed over the back deck of the vessel and travelled along the length of the deck, with the force of the wave causing movement of some of the landed cargo. The movement of this cargo resulted in the ABs becoming trapped between a mini container and a skip bin, with fatal consequences.

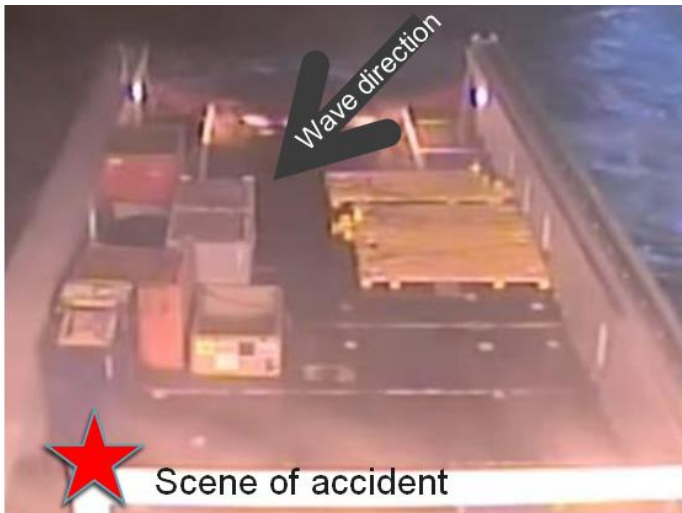
Photographs showing scene of incident.

- ◆ Working in and around unsecured cargo had become part of a familiar routine;
- ◆ A vessel with an open stern being used for cargo operations;
- ◆ Wave struck cargo;
- ◆ Cargo shifted 3-4 m on deck aft to forward;
- ◆ The crewman involved did not get out of the "line of fire" or hear the bridge warning over UHF radio.

- ◆ Vessel operations in the 500m rig zone are not recognised as Simultaneous Operations (SIMOPS) for the rig and vessel. There was no process in place to ensure effective communications, load sequencing, deck layout planning, cargo securing plans and optimizing time of vessel alongside rig in Dynamic Positioning (DP) mode;
- ◆ The potential for injuries to crew undertaking cargo securing tasks offshore on Anchor Handling Tug Supply (AHTS) vessels (due to open stern) had not been identified as high risk;
- ◆ No risk assessment had been carried out for suitability of AHTS vessels performing cargo operations;
- ◆ The vessel procedure for cargo loading and unloading did not describe a cargo lashing plan, and although there was a risk assessment for cargo loading, there was no specific risk assessment for the work activities associated with the further securing of landed cargo.

- ◆ Further detailed risk assessment for AHTS conducting cargo operations. Risk assessment should include consideration of engineering controls to minimize excessive water on the vessel back deck (stern door or use of other vessel type);
- ◆ A review and update of company adverse weather working guidelines;

- ◆ A review of company cargo loading procedure to include cargo lashing arrangements, and further risk assessment for securing cargo;
- ◆ A review and update of company cargo securing procedure and risk assessment to include the requirement for a lashing plan and load sequence planning with rig before entering the 500m zone.

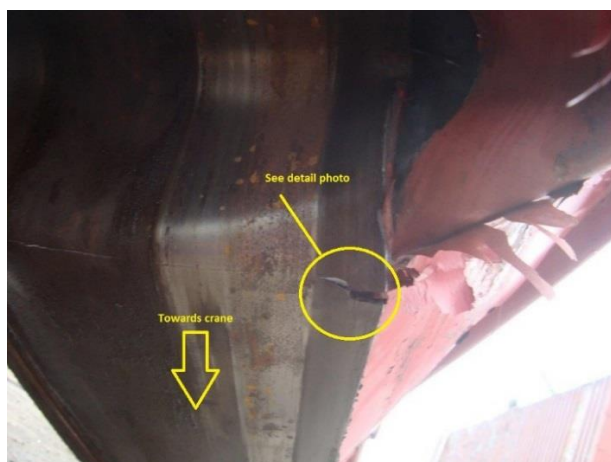
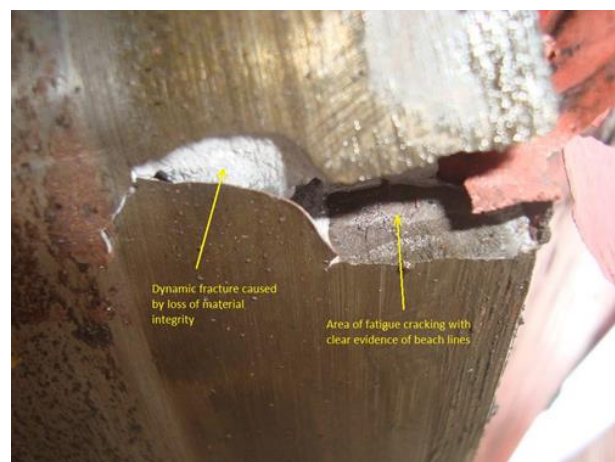
On investigation, it was found that the boom had buckled and cracked. The load was de-rigged safely; there were no injuries, nor was there any secondary damage to the load being lifted, or to the vessel.

- ◆ A large crack along the welded boom section was discovered which appeared to be old fatigue cracking and internal corrosion of the boom which evolved into a catastrophic materials failure;
- ◆ The crane had undergone recent testing by a third party, which did not discover the cracking;
- ◆ Testing/certification of the crane did not include Non-Destructive Examination (NDE) of critical areas;
- ◆ Several management failings were reported but none of these directly contributed to the incident.

The main cause of the incident was found to be material failure.

- ◆ Reviewed the crane planned maintenance system;
- ◆ Researched capability and cost of NDE to determine an appropriate amount of inspection versus risk.

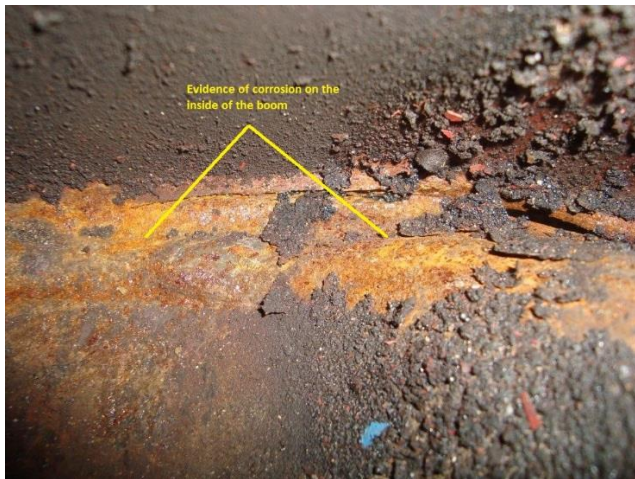
*Showing close-up of corrosion*

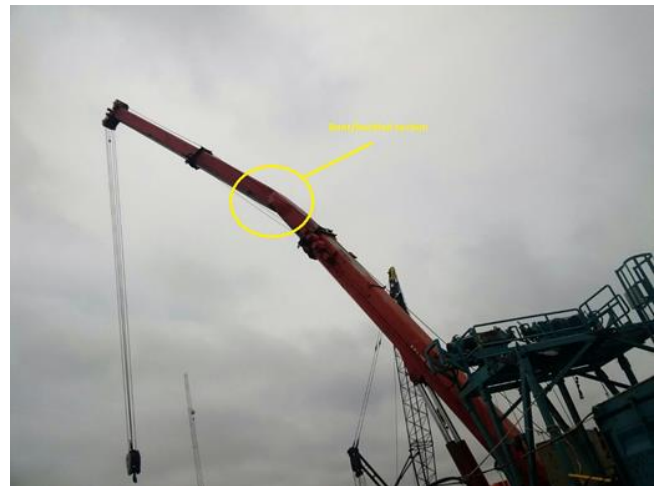
*Showing point at which crane boom buckled (marked)*
