## IMCA Safety Flash 23/16

September 2016

### Focus: Dropped Objects

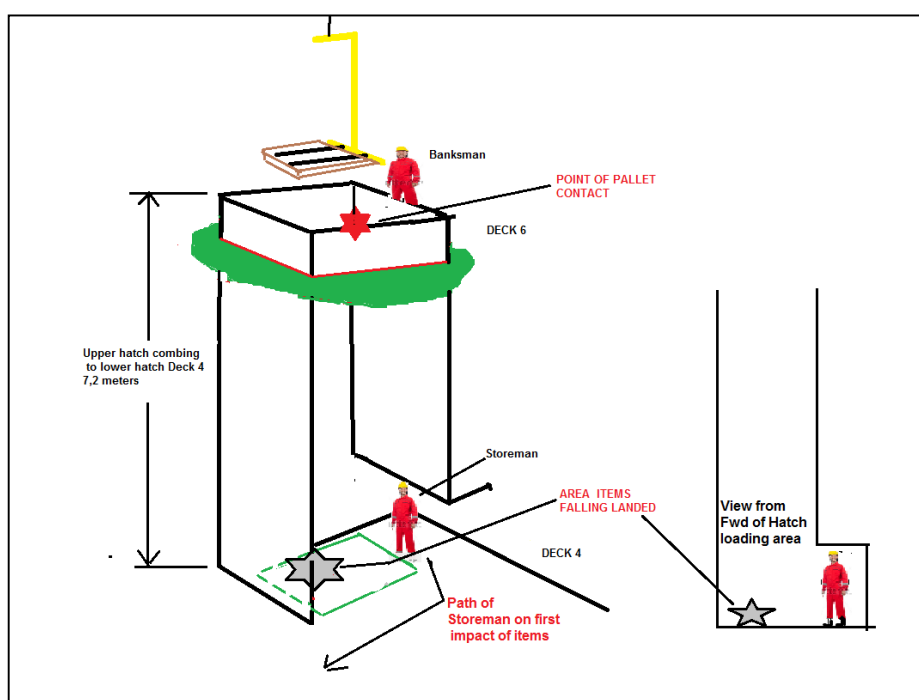
A member has reported an incident in which a pallet shed its load during lifting operations, resulting in 900kg of groceries falling 7m to the deck below. The incident occurred during a routine lifting operation from quayside to vessel. Whilst attempting to lower a pallet laden with stores through a deck hatch, the load contacted the corner of the hatch, damaging the pallet. The cellophane wrapping split near the bottom, and the majority of the 902kg contents fell 7.2m to the deck area below. The front right corner of the pallet was hanging off but did not fall.

- ♦ The risk assessment did not make reference to the practice of a staged progression;
- ♦ As a result of the above, the load had a sufficient degree of freedom to contact the side of the hatch and damage the pallet, resulting in the contents dropping to the deck below.

- ♦ There was insufficient detail recorded in the lift plan and task risk assessment;
- ♦ Personnel responsibilities were not adequately established during the TBT;
- ♦ The load was not sufficiently secured on the pallet – a lifting chain was not used;
- ♦ The crane operator took no action when he noticed the pallet lifting frame chain was not being used;
- ♦ There was no pause above the hatch to secure and centralise the load before lowering.

The **root cause** was found to be **complacency** during “routine” tasks.

- ♦ Ensure all personnel involved in an operation attend a toolbox talk (TBT) before taking part in the activity;
- ♦ The TBT should sufficiently outline roles & responsibilities of those involved;
- ♦ Reinforce the 'STOP THE JOB' philosophy to work teams prior to conducting an operation;
- ♦ Review lift plans and task risk assessments for routine lifting operations, ensuring they are up to date and there is sufficient detail surrounding:
  - control of loads
  - roles & responsibilities of personnel involved
  - securement of loads

- lifting of pallets
- “Line of Fire” and confirmation of clear areas during blind lowering;
- ♦ Review the method for securing pallet loads ensuring it is adequate for the proposed lift;
- ♦ When lowering through a blind hole, adopt a staged progression to the lift allowing for the load to be stabilised and centralised before lowering;
- ♦ Communicate with your work team that time constraints should not impede the safe progress of an activity. If there are concerns regarding time constraints and the viability of completing a task, this should be raised with the offshore management team or supervisor.

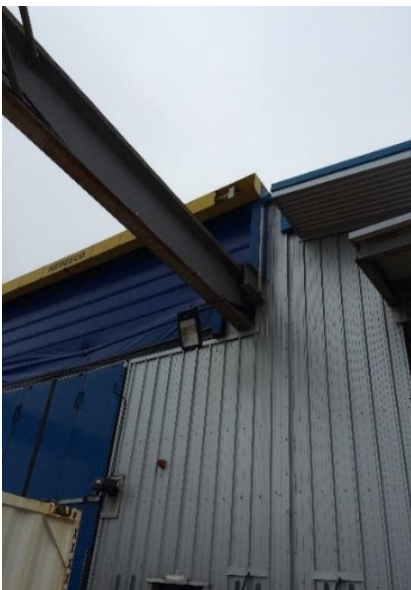
A member has reported a high potential dropped object near miss incident. The incident occurred in a workshop location ashore. A section of metal panelling, which weighed 5.6kg, came loose from the hood of a large industrial automatic rolling door and fell 7-10 meters to the ground. It landed right in front of the fire exit of the workshop.

*Item dropped approximately 7-10 meters from above the main roller shutter door*

- ♦ Fallen panel was replaced and appropriate secondary retention (self-tapping screws) installed;
- ♦ The remaining panels were all examined and self-tapping screws were fitted as secondary retention;
- ♦ A preliminary dropped object survey was carried out, and annual checks on the hood panel were introduced.

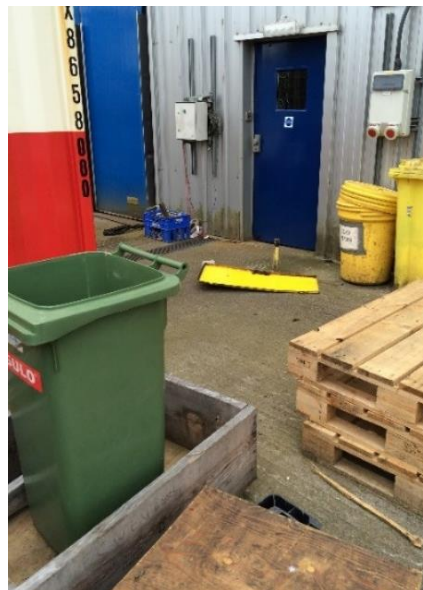
*Hood panelling had dropped in front of the main fire exit*

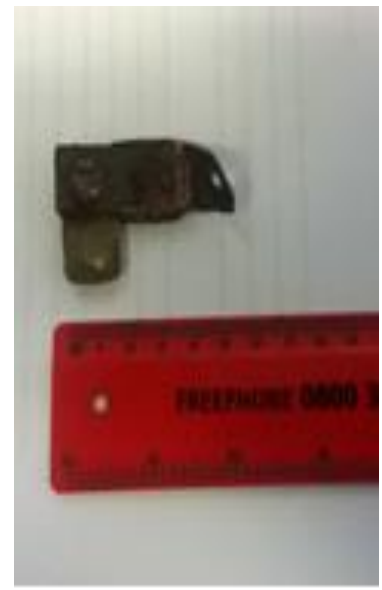
*One of the rusted fastening brackets*

- ♦ Fastening brackets were rusted; this rusting was caused by water ingress;
- ♦ There was no secondary retention fitted - a practice advocated by DROPS;
- ♦ Whilst the rolling door itself was subject to planned maintenance and inspection, the system did not extend to the hood above the door, which had not been inspected since its installation approximately 15 years before;
- ♦ No dropped objects survey had taken place, which could have identified the actions required to ensure the safety of the item.

The **root cause** of the incident was found to be **failure to identify the requirements** to ensure the safety of this large automatic rolling door – including maintenance, inspection and secondary retention.

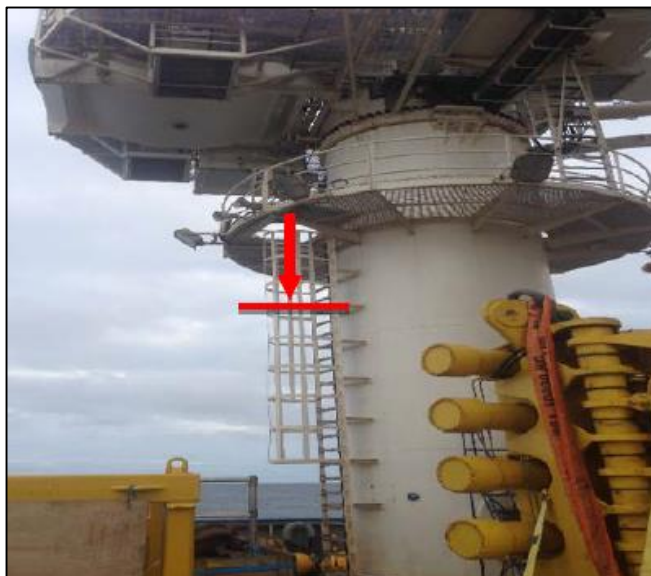
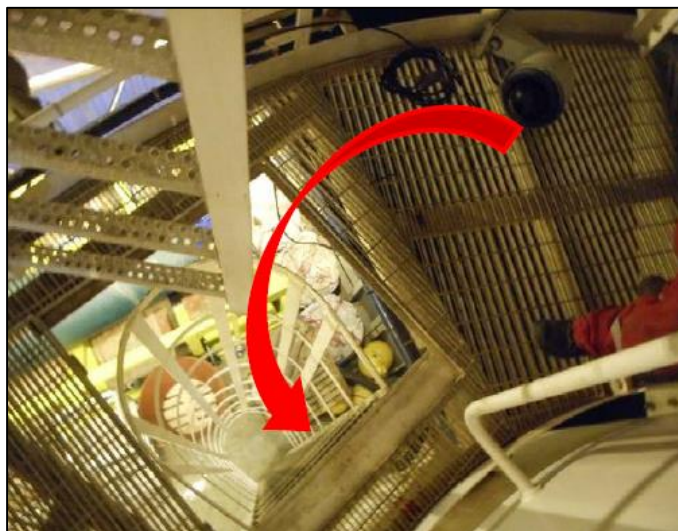
As the crane was rotated, one of these ladders caught the CCTV camera that had been secured to the walkway following maintenance during the previous shift, pulling it approximately 1 meter to the access hatch, where it fell before being arrested by the data cable.

- ♦ The CCTV camera had been removed from its mountings the day before the incident to allow investigation of reports that it was not working properly;

- ♦ The faulty camera could not be repaired at the time and as such, was secured to the crane walkway using tie-wraps;
- ♦ The access hatch located on the walkway was left in an open position while crane operations were ongoing. This is common practice and is done to allow suitable access/egress to and from the crane in the event of a crane breakdown or if a rescue operation is required. The crane design prevents the hatch from being opened when one of three ladders are positioned over it, restricting access/egress;

- ♦ The work conducted on the camera and the status in which it was left was not communicated to the crane operator or the project construction crew at shift handover/TBT. The on-shift crane operator was not made aware that work had been conducted on the crane pedestal and did not identify the CCTV camera during the pre-use inspection;

- ♦ There was a lack of awareness and risk perception of the hazard presented by the rotating ladders;
- ♦ A more thorough pre-use inspection of the walkway would have discovered the potential dropped object;

- ♦ Improved communication – particularly at shift handover – between all parties would have raised awareness of the operation;
- ♦ Had this operation been conducted under a permit to work (PTW) or the correct process followed for routine duty activities, awareness of the operation would have been greater. It is important to highlight that control measures had been implemented by those conducting the work to ensure safe execution of the task and that these were removed when the worksite had been deemed safe;

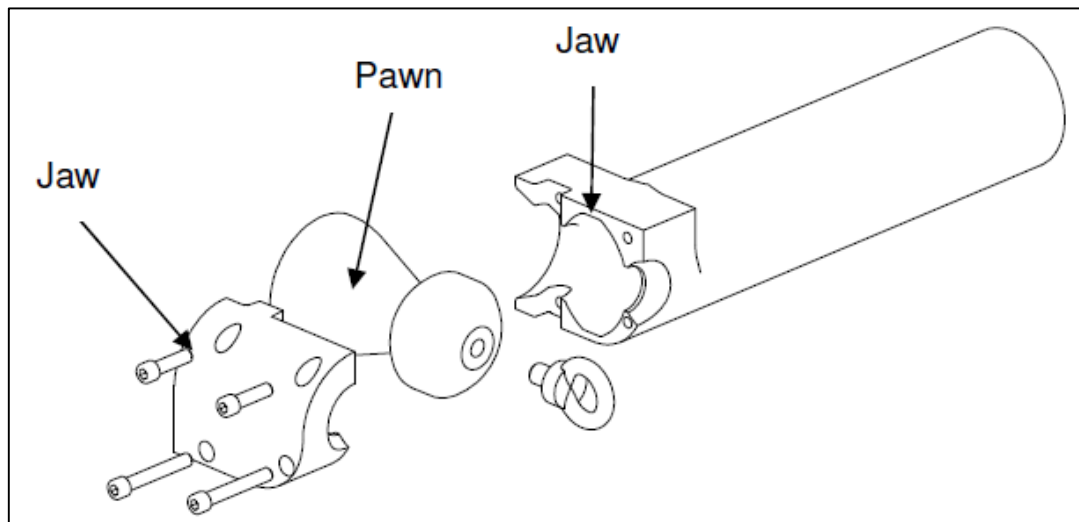
These bolts have failed on a number of occasions during spooling or laying operations resulting in dropped objects. One contributing factor being considered is the suitability of these bolts for the activity.

- ◆ Use of a brand new set of bolts for each spooling operation;
- ◆ Careful checks to be made to ascertain that all bolts are new and inspected for defects before each assembly operation;

- ♦ Further close attention to be paid to the engineering details of the bolts and the torque settings of the split head elbow.
