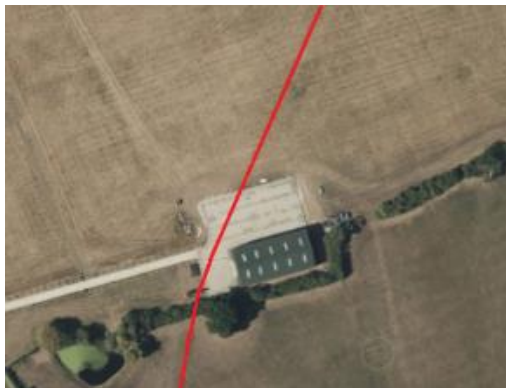
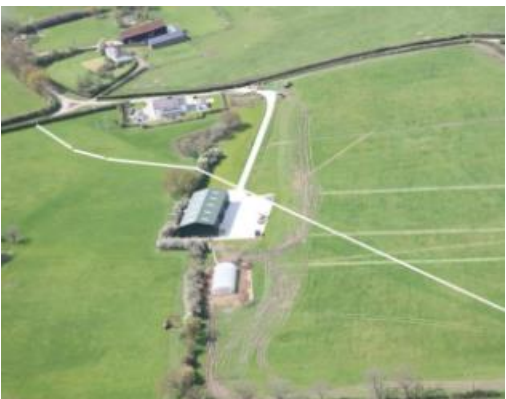
- A landowner undertook development works within a gas pipeline easement without the operator's knowledge or permission. A 415v cable was also laid over the pipeline
- The operator undertook investigations to establish that the pipeline hadn't been damaged

- A landowner constructed a barn, parking area and access roadway within a pipeline easement. A 415v cable was also laid over the pipeline. The barn foundation depth was 0.5 m
- The operator's pipeline contractor was aware of the development but assumed that it was outside the easement and that the operator was aware.
- The operator became aware of the development during a routine contract meeting between the operator and pipeline contractor
- The landowner had not responded to annual liaison letters and the operator had not followed this up
- Neither the landowner or landowner's contractor contacted the operator, took note of the marker posts or contacted LinesearchbeforeUdig (LSBUD)
- Once aware, the operator took action to ensure that the pipeline hadn't been damaged – the pipeline coating was inspected, and a depth survey was undertaken. Further investigations are planned.

- Operators are advised to visit or phone landowners that do not respond to annual letters
- Operators to consider the level of reliance placed on their contractors to identify infringements
- Operators to reinforce the message to landowners that it is their responsibility to check for pipelines on their land and that they need to contact the operator prior to any works near pipelines

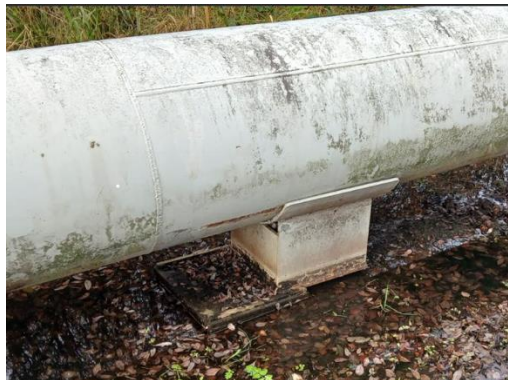
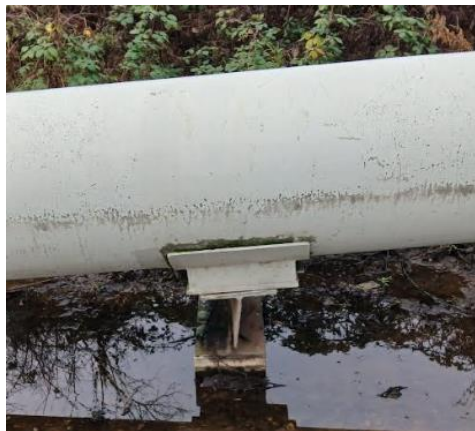
- A 28" diameter oil pipeline moved due to removal of an 'anchor'
- The pipe supports also moved causing damage

- The over-ground section of a 28" diameter oil pipeline is supported on saddles
- Thermal expansion is not a major factor due to the oil being at a constant temperature
- A road crossing (formed off soil and hardcore) was present over the pipeline at the next bend downstream.
- The road crossing was removed for unrelated works and not reinstated. The unintentional consequence was that the pipeline was no longer fixed.
- The force on the bend due to internal pressure caused the pipeline to move once the 'anchor' that the road crossing had provided was removed
- Damage to and movement of several pipe supports occurred
- A plan has been prepared to repair/replace the damaged pipe supports and check the pipeline for damage

- Operators should be aware that removing ground cover from an above ground pipeline may allow it to move causing damage to supports

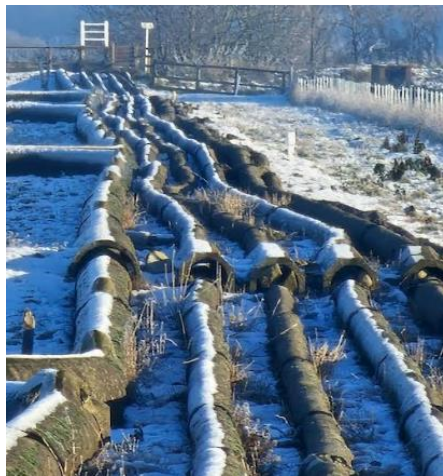
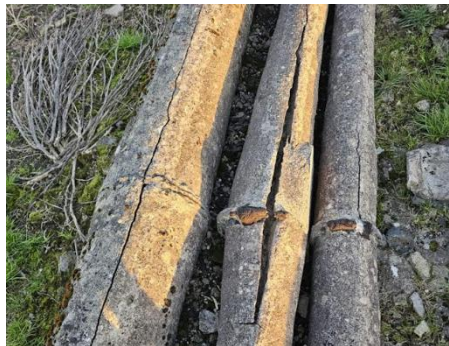
- Thermal expansion and contraction caused cracking of the concrete casing on multiple pipelines, despite the presence of expansion loops
- A programme of remediation is ongoing

- Six pipelines were built in the 1960s and run above ground - two remain in use
- It is assumed that the pipelines weren't buried due to marshy ground conditions
- The exact reason for the concrete encasement is unknown but may be to provide protection from external impact or act as ballast to prevent the pipelines from floating
- Although the pipelines have expansion loops, thermal movement has caused cracking of the concrete
- A programme of remediation has been planned. This includes removal of the concrete and coating, inspection of the pipe, repair if necessary and re-coating
- The need for the concrete is being assessed

- Operators are to be made aware that concrete casing may fail when pipelines are exposed to thermal change

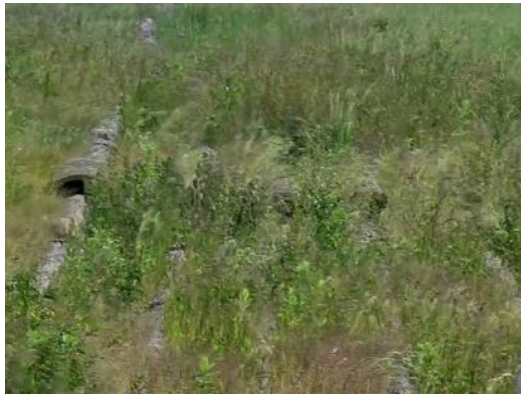
- Tall vegetation in an above-ground pipeline easement was killed with weedkiller. The resulting 'hay' caused a fire hazard
- The dead vegetation was removed

- Due to a change of contract, grass cutting on an above-ground pipe route was overlooked (one cut was missed)
- Due to the height of the vegetation, it was sprayed with weed-killer
- The dead vegetation turned to 'hay', presenting a fire hazard
- The dead vegetation had to be removed

- Operators are advised to check that vegetation management contracts for above ground pipelines include removal of dead material

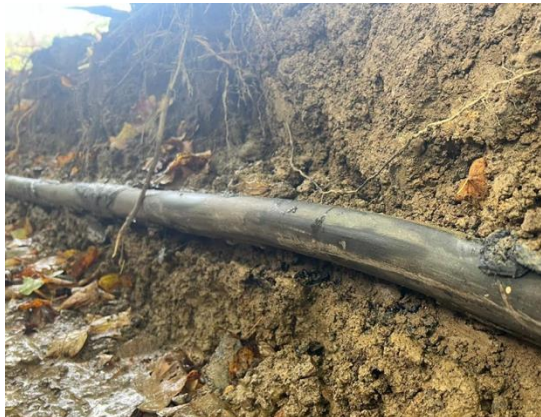
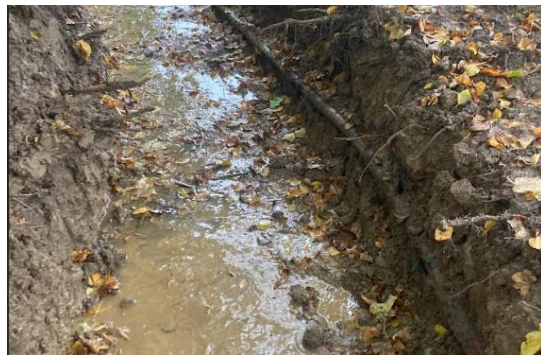
- Whilst installing an overhead cable pole, a utility contractor struck an 18" 25 barg pipeline with a screw auger
- The pipeline was damaged and had to be repaired

- The utility company had carried out a LinesearchbeforeUdig (LSBUD) search, but the company's contractor ignored the findings and did not inform the operator of the works. No site drawings were checked, and nearby aerial markers were ignored

- A hole was bored with a screw auger. On hitting the pipeline (feeling resistance), the contractor stopped drilling, contacted the operator to report a near miss and continued with reinstatement

- The operator's pipeline team carried out safety checks and DCVG (Direct Current Voltage Gradient) surveys and identified coating damage
- The operating pressure of the pipeline was reduced by 15%, in line with procedures.

- The utility company hand excavated the pipeline under operator supervision to allow assessment of the damage (see photo). The pipeline was easy to locate with standard equipment.

- The operator carried out an assessment of the damage and repaired the pipeline with a steel sleeve. Calculations to justify reinstating the pressure to 25barg were undertaken

- Operators to reinforce the message to landowners and contractors that it is:
  - a) their responsibility to check for pipelines on their land
  - b) that they need to contact the operator prior to any works near pipelines

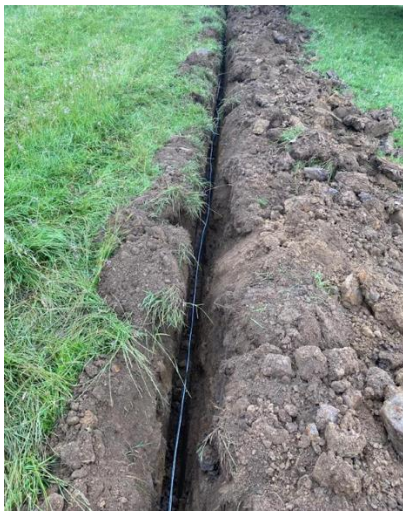
- An operator has used automated Electrical Resistance (ER) probes to monitor AC induced corrosion threats to a pipeline
- High risk locations were mitigated by the installation of zinc ribbons

- The guideline for mitigation against AC induced corrosion is to act when the AC current density is greater than 30 amps/m<sup>2</sup>
- The operator used their newly installed automated ER probes to continuously monitor AC current density. Eight locations were identified as high risk and 120-metre-long zinc ribbons were installed to reduce AC current density (see lower photo)
- Subsequent monitoring by the ER probes has indicated that the AC induced corrosion risk is now acceptable
- When a new development (e.g. solar farm) is proposed to be built adjacent to a pipeline, the operator requires that the developer covers the cost of new ER monitoring probes either side of the development

- Automated ER probes have proven to be an effective means of identifying areas of risk of AC corrosion and providing ongoing monitoring following risk mitigation
