Report Number: 13065

Ranking Scheme for Prioritising the Inspection of Pipeline Sleeves

Prepared for:

Robert Owen on behalf of UKOPA RAWG
UKOPA
Pipelines Maintenance Centre
Ripley Road
Ambergate
Derbyshire
DE56 2FZ

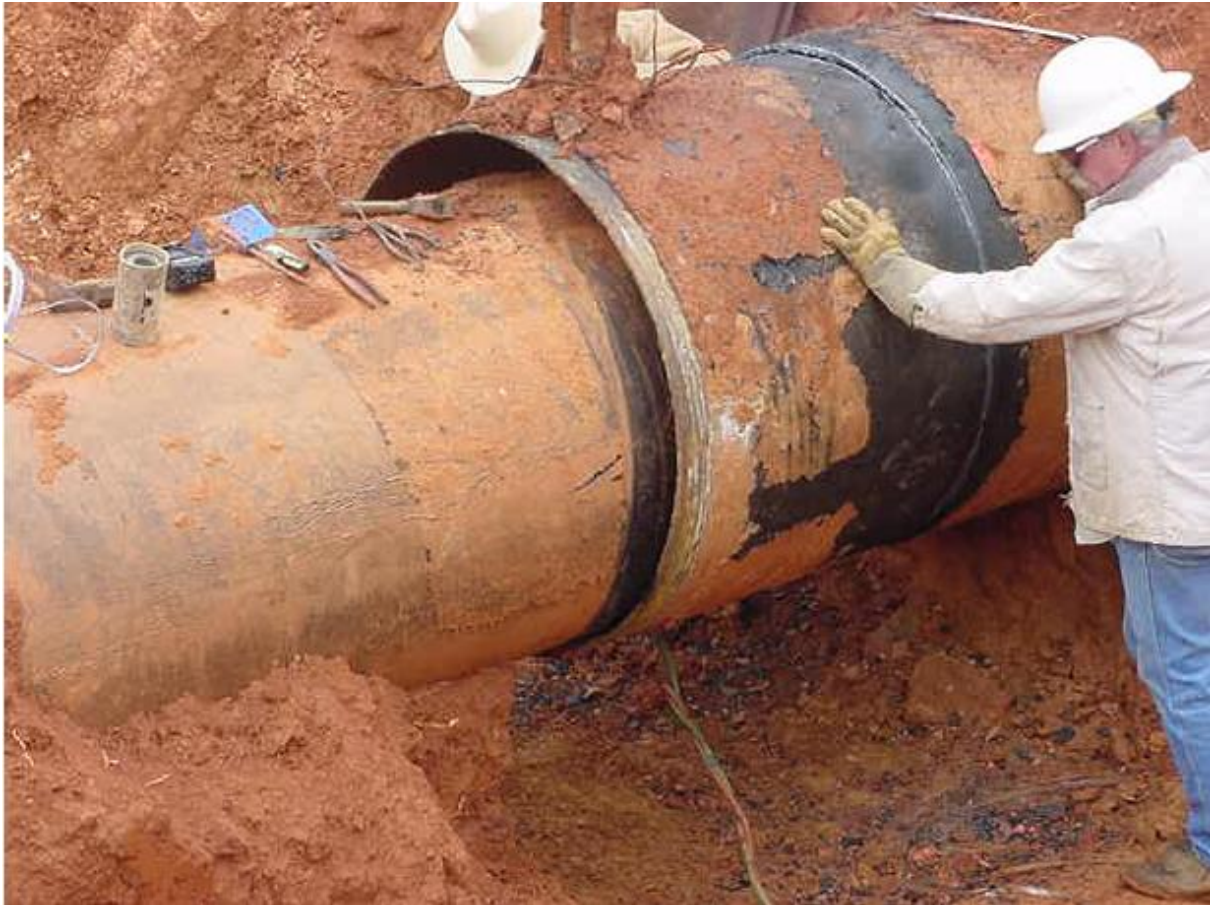
Figure 5: Pipeline and sleeve (NACE)

This presentation by NACE commented on the USA practice and showed examples of sleeves in the USA. NACE indicated that the current practice of installing cased carrier pipe had changed only slightly since the beginning of its use. External loading of the carrier pipe has been eliminated by the installation of heavy-wall casing pipe, and isolating spacers are used to prevent electrical contact between the casing and the carrier pipe. End seals are used to keep mud and water out of the annular space between the carrier pipe and casing.

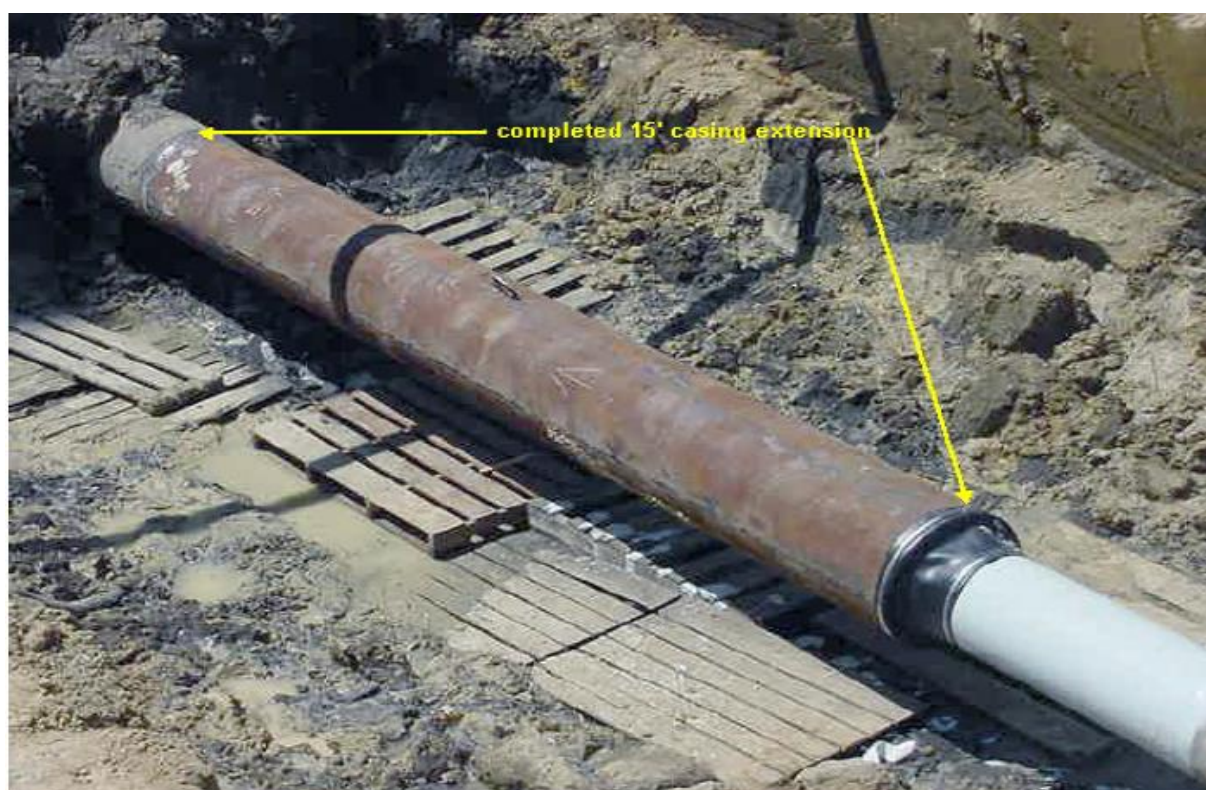
Figure 7: Sleeve extension completed (NACE)

This drawing shows the typical layout of a pipeline within a sleeve for a railroad crossing, including wall thicknesses of outer sleeve:

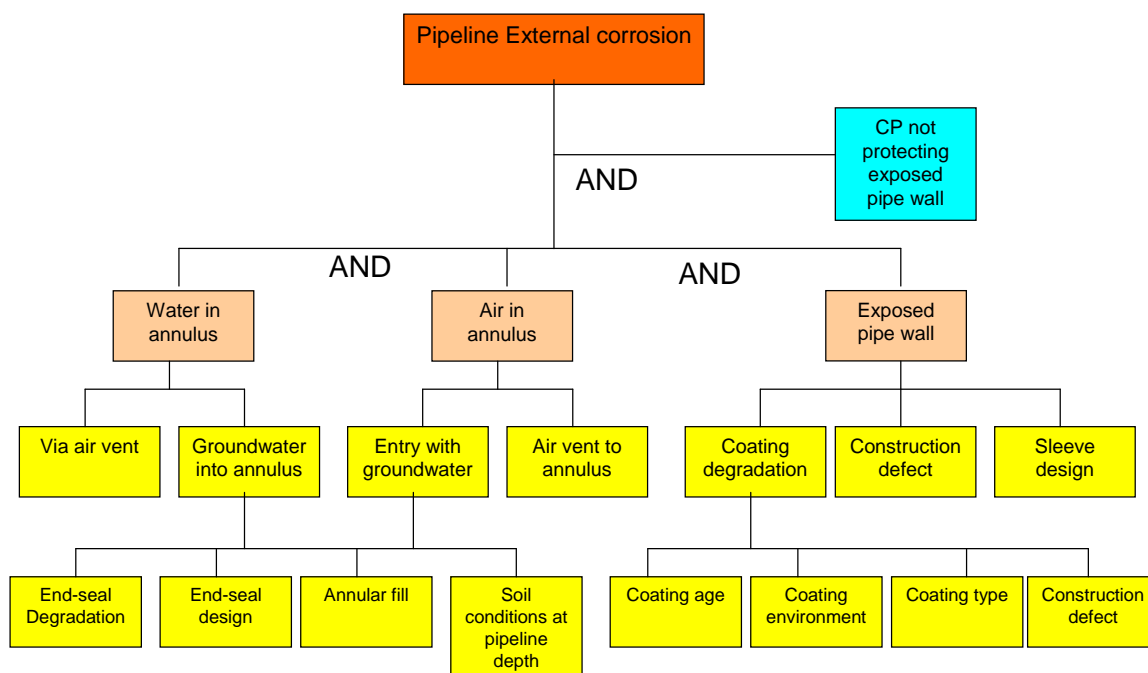
Figure 9: General process being considered in the ranking scheme

It is considered that the primary concern is the ingress of water and oxygen into the annulus between the pipeline and the sleeve with the resulting possibility of corrosion of the pipeline.

If ground water containing oxygen were entering the annulus, it would be considered that the likelihood of corrosion of the pipeline (and the surrounding sleeve if ferric) would be proportional to the volumes of oxygenated water entering the annulus and thus would be related to how well the ends of the sleeve were sealed. A sleeve that was not sealed at the end would enable significantly more water to enter an empty annulus than one where the ends had a small leak, which in turn would be more problematic than a sleeve that was water tight sealed at the ends. Filling the annulus with an inert material such as cement grout may result in water migrating through cracks in the annulus, but the rate of such water movement would be expected to be relatively low, possibly equivalent to that produced by a leaking end seal.
